**DRY DOCK HULL CLEANING / UT
READING & UWILD SURVEY**

NASSCO

UNDERWATER INSPECTION REPORT

Inspection Date : 11/22/2023
Report Date : 11/27/2023

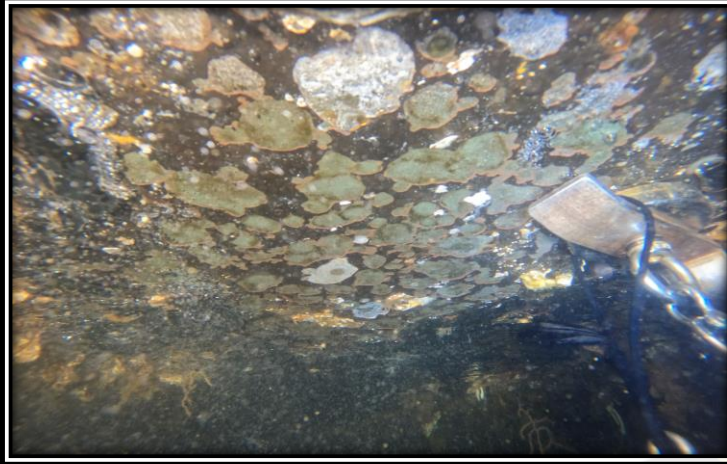
PHOTO 1:

- 60% of the four cleaned transect locations on the dry docks hull were large areas of exposed bare metal and blistering paint. 55% of the hulls weld seems in the cleaned locations had exposes bare metal. There were no signs of pitting in any of the areas of bare metal along the dry docks hull and weld seems.

TYPICAL TRANSECT &
PAINT CONDITION

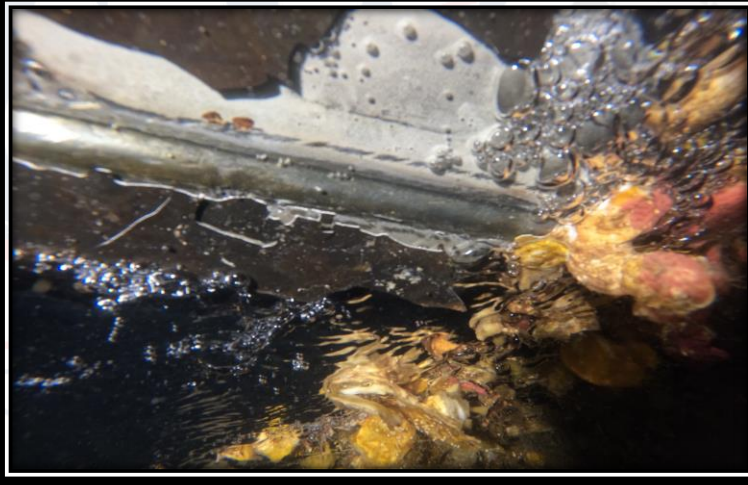
PHOTO 2:

- All transects and weld joints appear to be in good condition. Transect FR 41 had 75-85% bare metal. The bottom paint that is remaining was black in color and has 10-15% blistering in the bottom paint.
- There appeared to be no pitting on any of the areas of bare metal exposed throughout the transects.
- All transects welded seems, appear to be in good condition. The weld seems that were exposed to bare metal did not appear to have any pitting and were still in good condition.

TYPICAL TRANSECT
WELD CONDITION
WHERE BARE METAL IS
EXPOSED

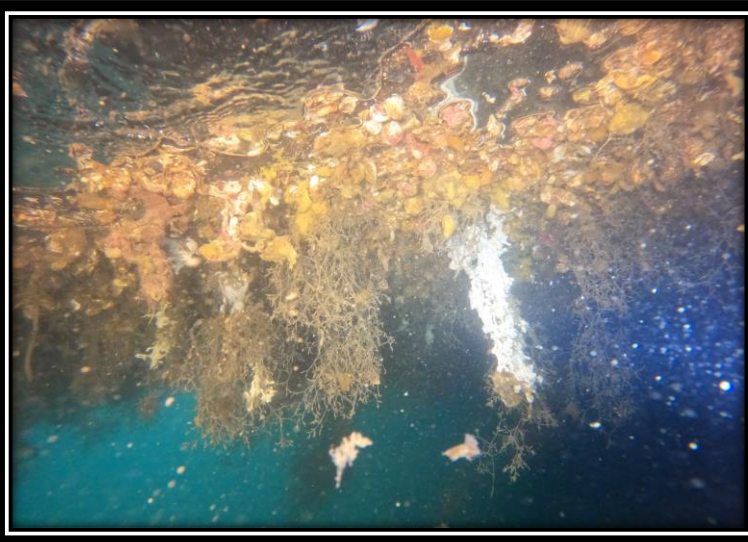
PHOTO 3:

TYPICAL MARINE
GROWTH ON
TRANSECTS

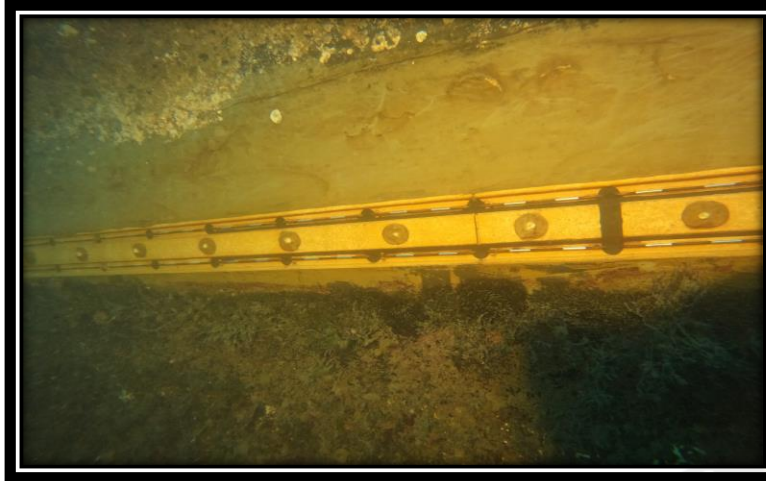
PHOTO 4:

- Impressed current anodes appeared to be in good working condition, with minor calcareous deposits in the anode fasteners. Dielectric shielding was in good condition. Impressed current anodes were bolted to the dock.
- Both port and starboard obsolete anodes were not present.
- Starboard Anode Locations- Frame 21-26, 76, 216
- Port Anode Locations- Frame 21-26, 76, 216

TYPICAL
IMPRESSED
CURRENT ANODE
CONDITION

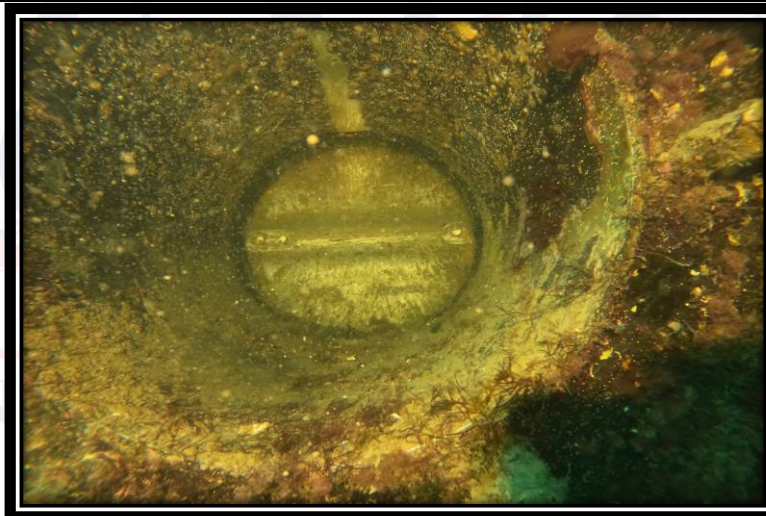
PHOTO 5:

TYPICAL
DISCHARGE
CONDITION

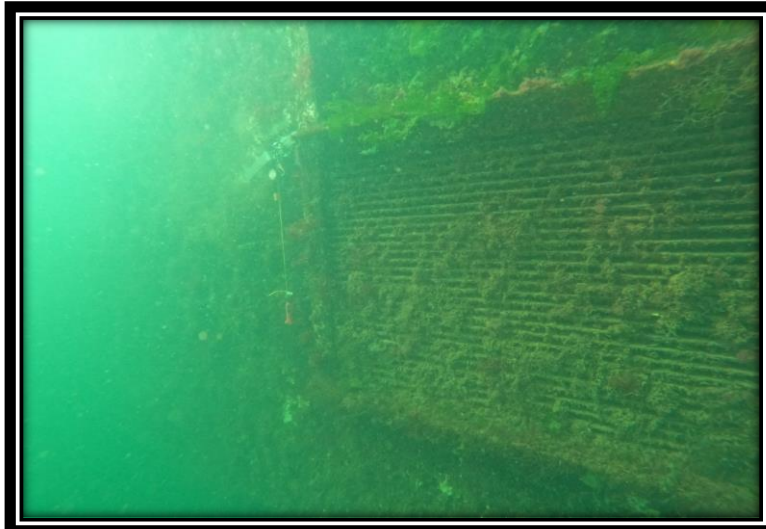
PHOTO 6:

TYPICAL SUCTION
SEA CHEST
CONDITION

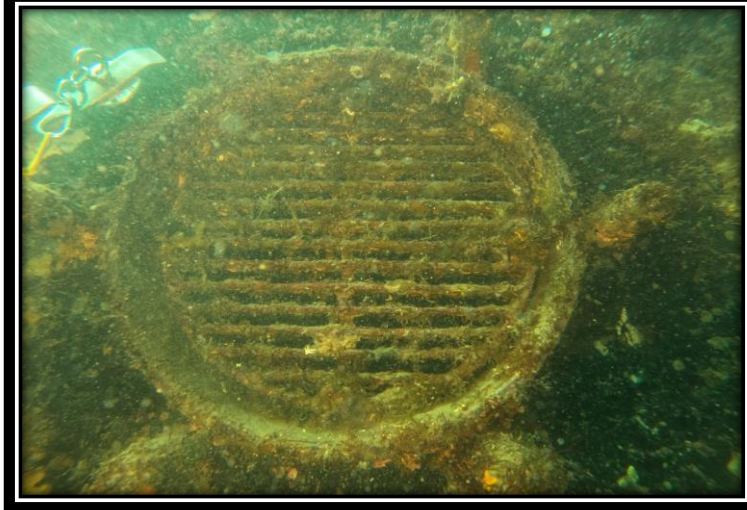
PHOTO 7:

- Starboard Frame 121: Screen and bolts holding screen in place appear to be in good condition. This opening does not have a flapper/ check valve. Fire pump screen bars were covered in a layer of soft marine growth.
- Port Frame 121: Screen and bolts holding screen in place appear to be in good condition. This opening does not have a flapper/ check valve. Fire pump screen bars were covered in a layer of soft marine growth.

TYPICAL FIRE PUMP
CONDITION

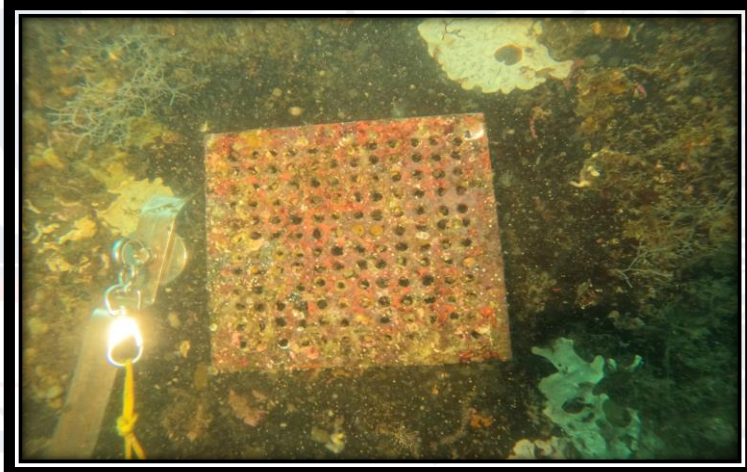
PHOTO 8:

TYPICAL PRIME PUMP
CONDITION

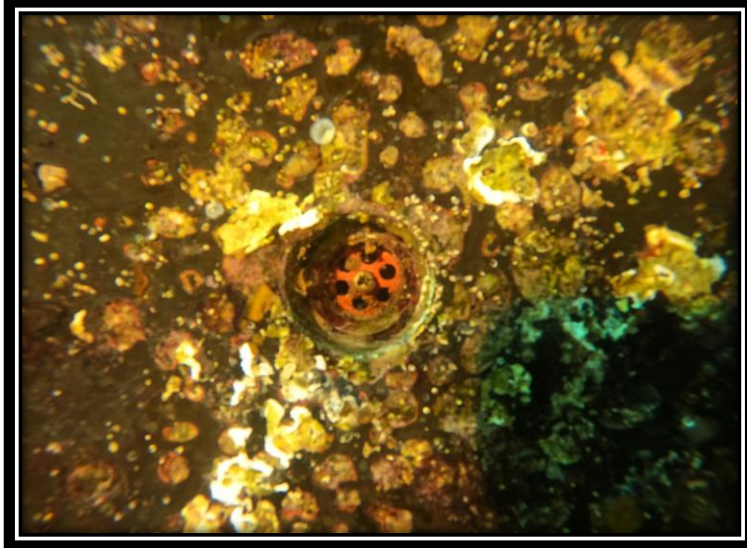
PHOTO 9:

- Starboard Side Reference Cell Frame 187: Reference cell was completely covered over in 100% marine growth. Marine growth was removed to visually inspect the reference cell. The reference cell was in good condition and free of obstructions. All 6 circular ports inside the reference cell are free of obstructions.
- Port Side Reference Cell Frame 46: Reference cell was completely covered over in 100% marine growth. Marine growth was removed to visually inspect the reference cell. The reference cell was in good condition and free of obstructions. All 6 circular ports inside the reference cell are free of obstructions.

TYPICAL REFERENCE
CELL CONDITION
