Table of Photos

Photo 1 – NASSCO “BUILDER”

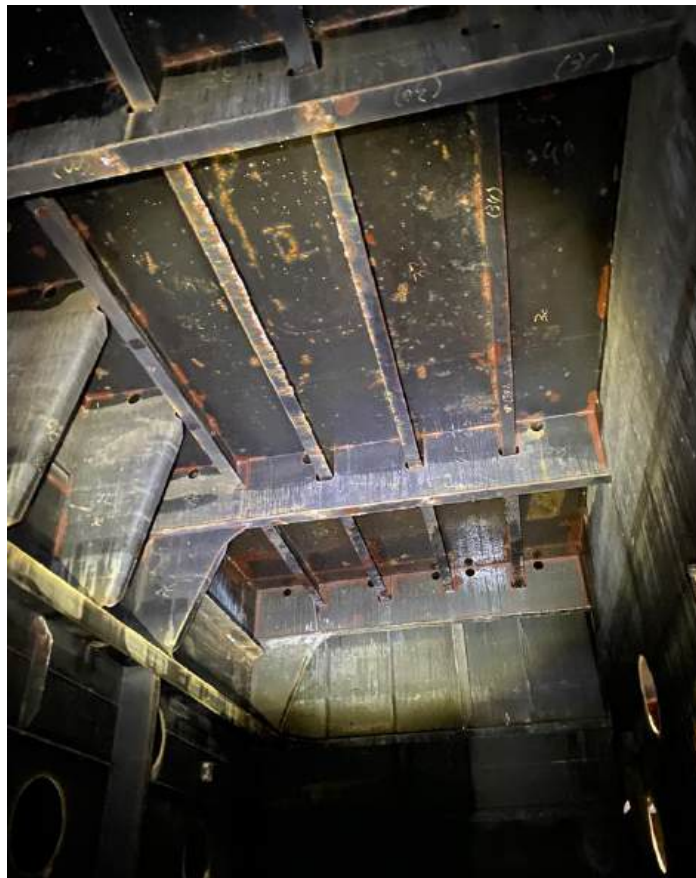
Photo 2 - Typical Condition of Center Ballast Tank

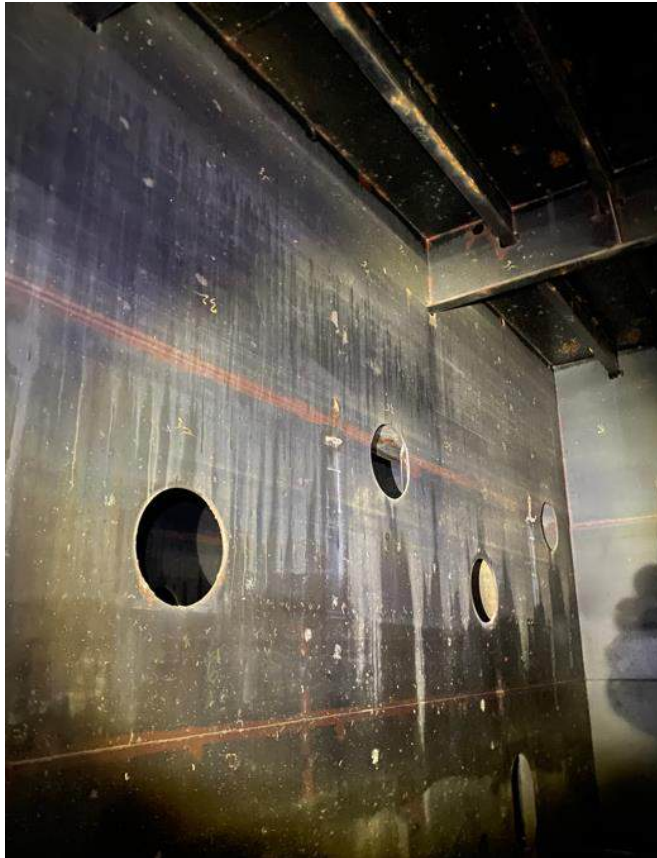
Photo 3 - Typical Condition of Center Ballast Tank

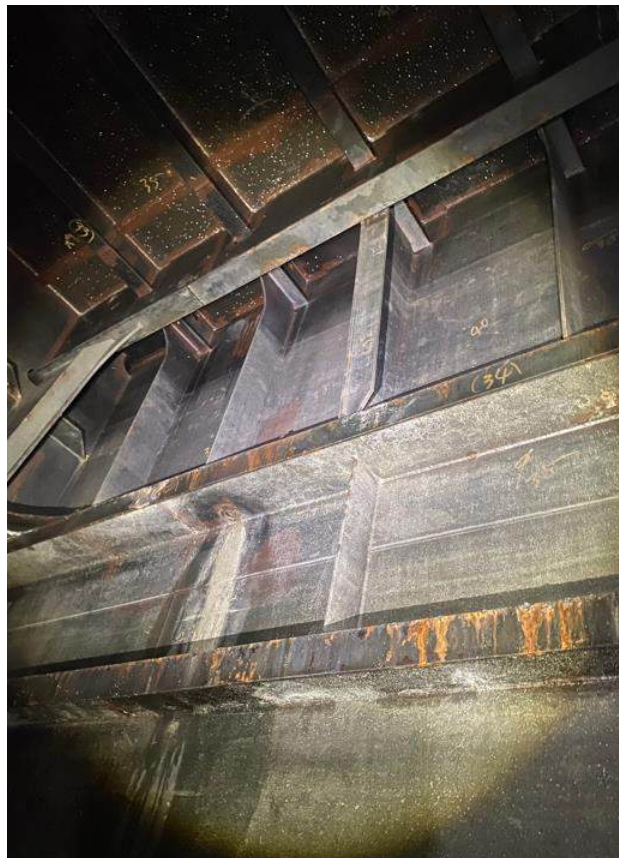
Photo 4 - Typical Condition of Center Ballast Tank

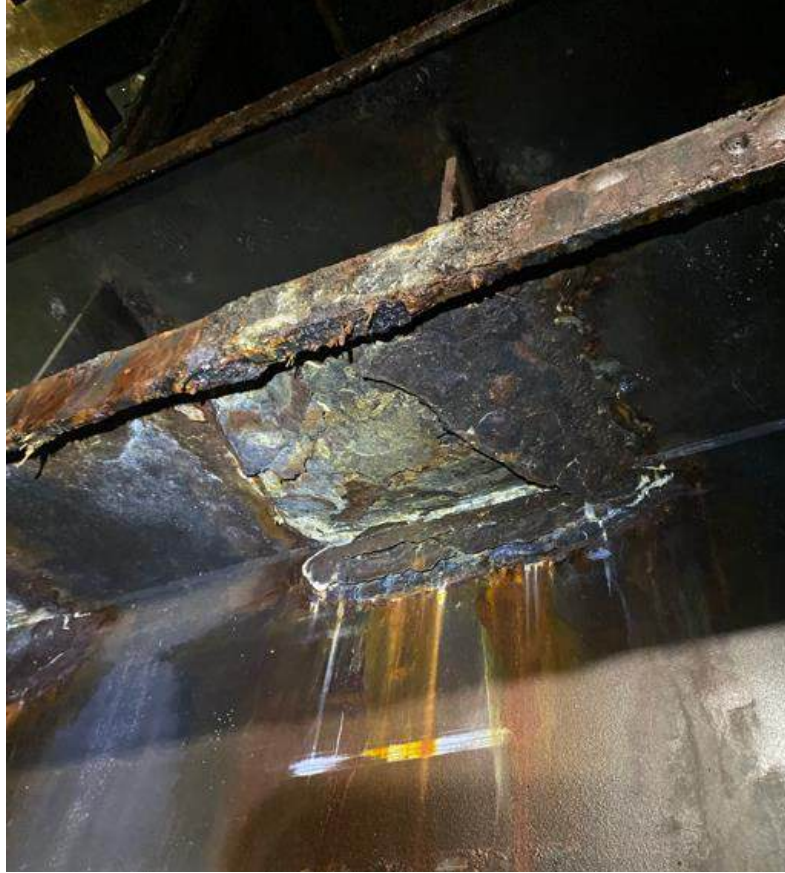
Photo 5 - Scale on BHD Stiffener Webs IWO FBs

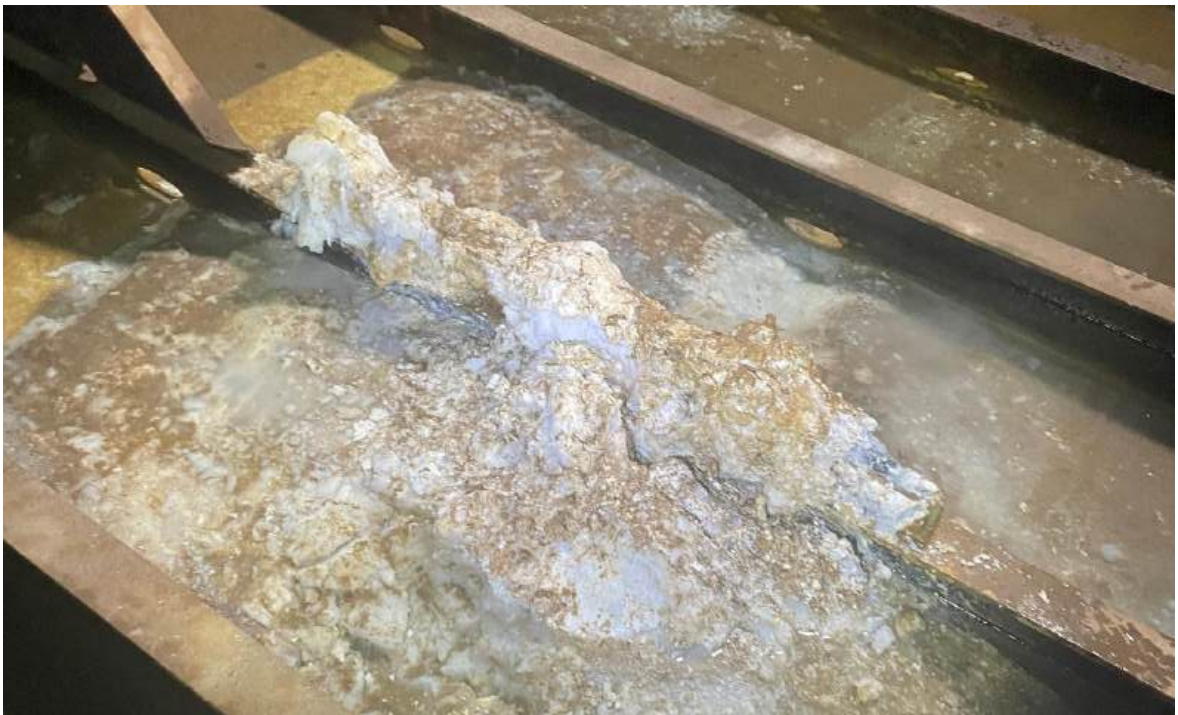
Photo 6 – Typical wasted anode in need of replacement

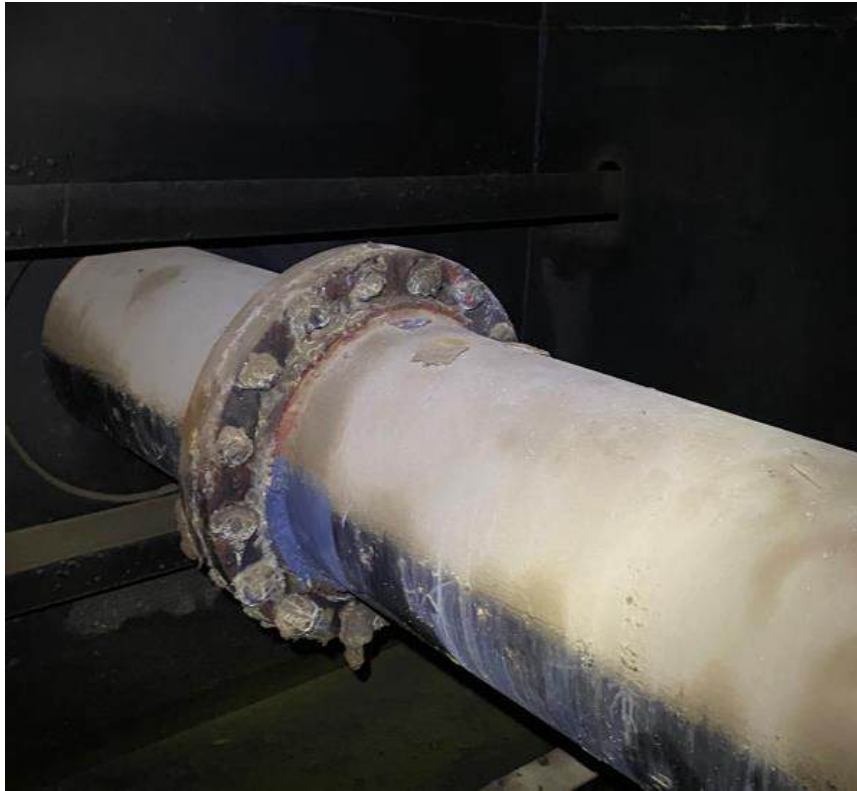
Photo 7 - Typical Condition of Ballast Flanged Connection

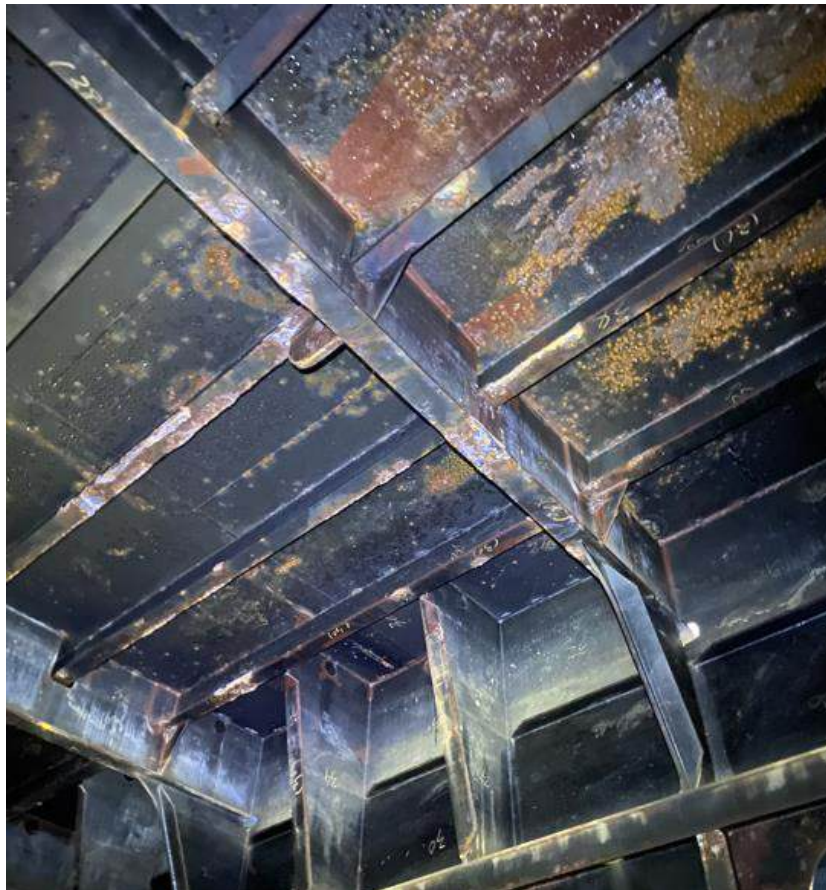
Photo 8 - Typical Condition of Wing Ballast Tank

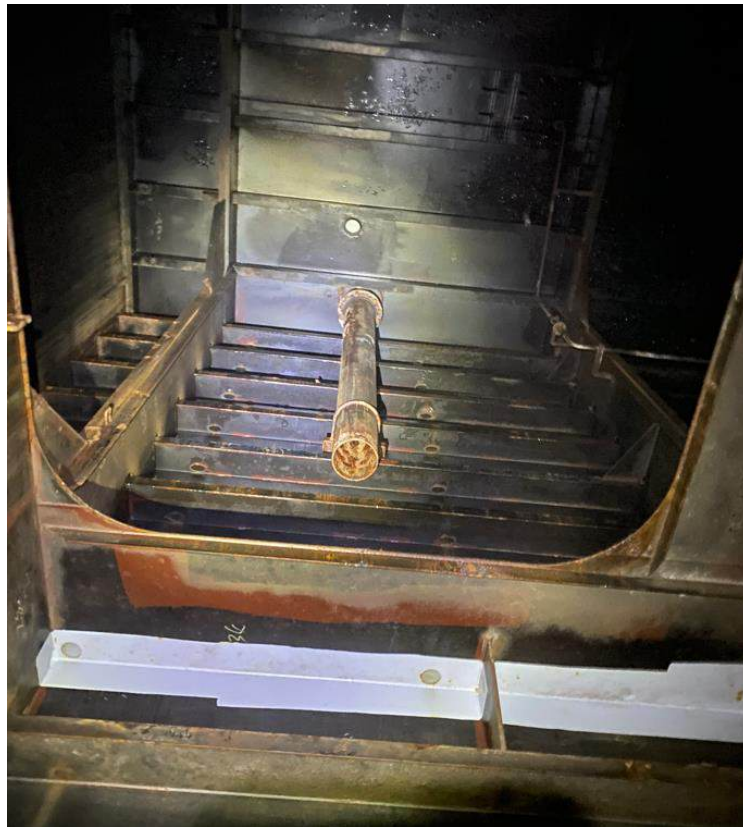
Photo 9 - Typical Condition of Wing Ballast Tank

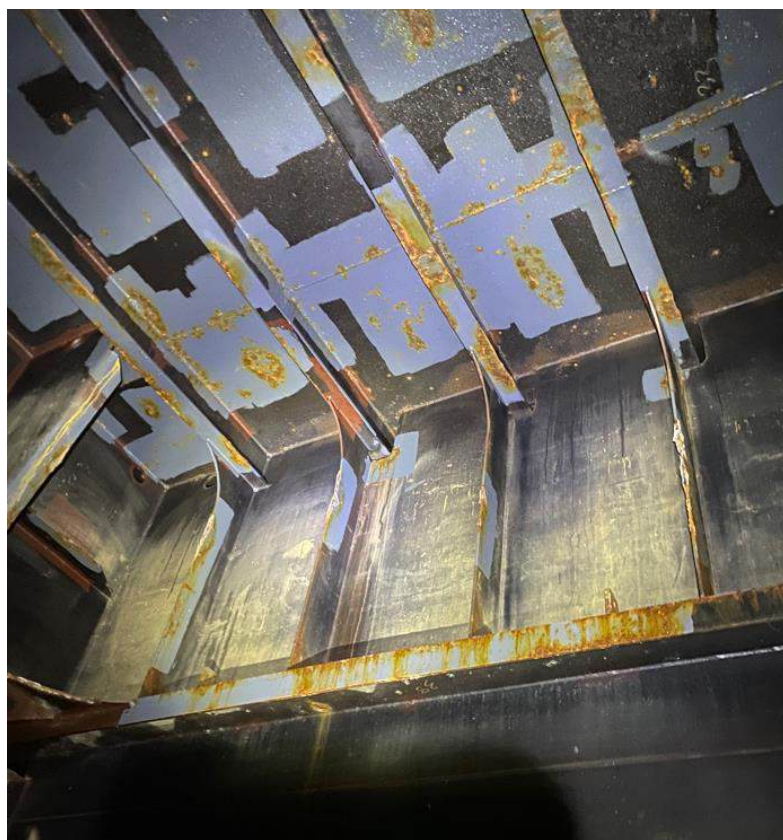
Photo 10 - Typical Condition of Wing Ballast Tank

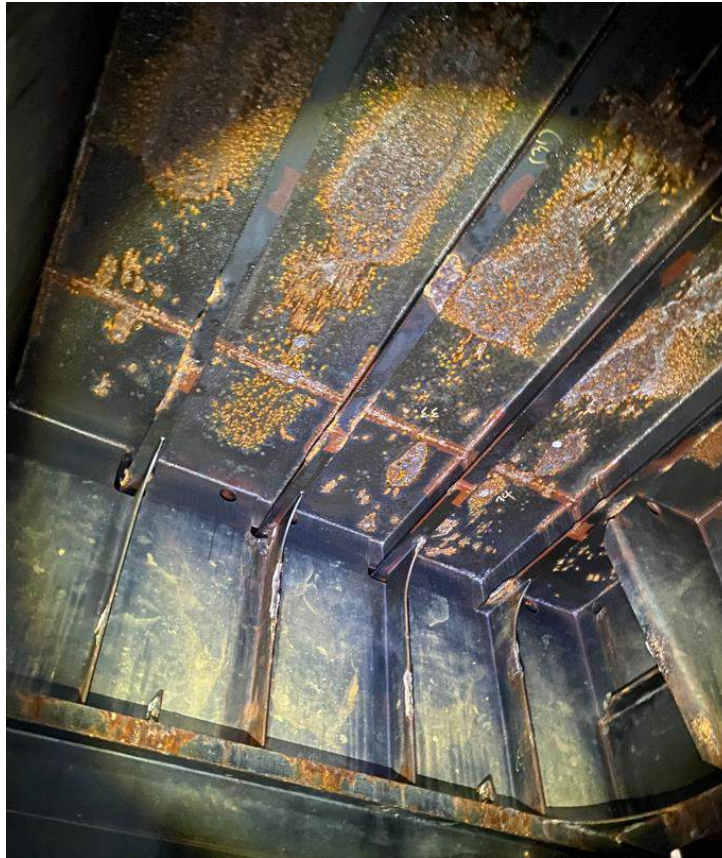
Photo 11 - Condition of Underside of Pontoon Deck

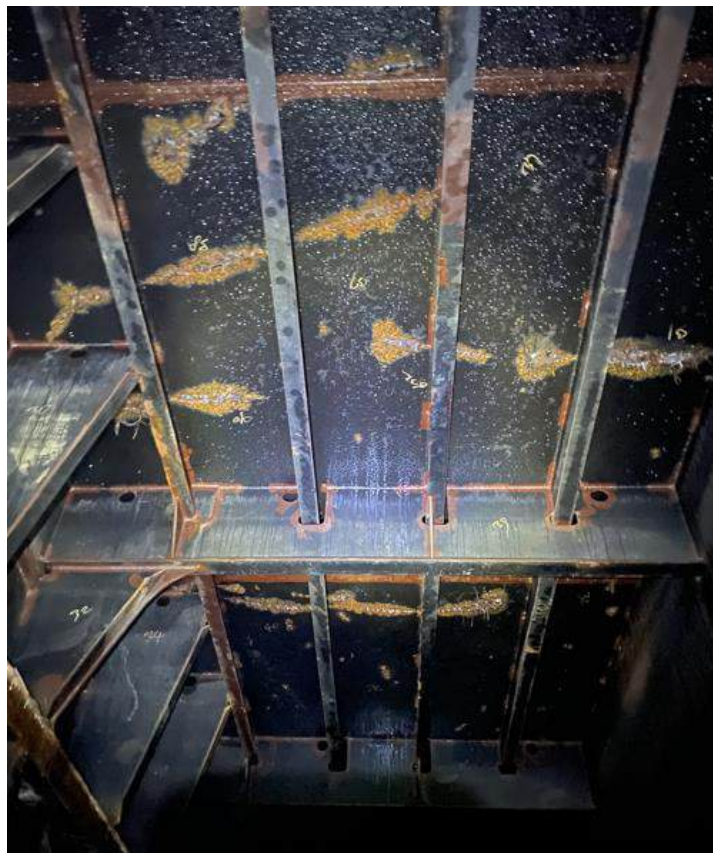
Photo 12 - Condition of Underside of Pontoon Deck

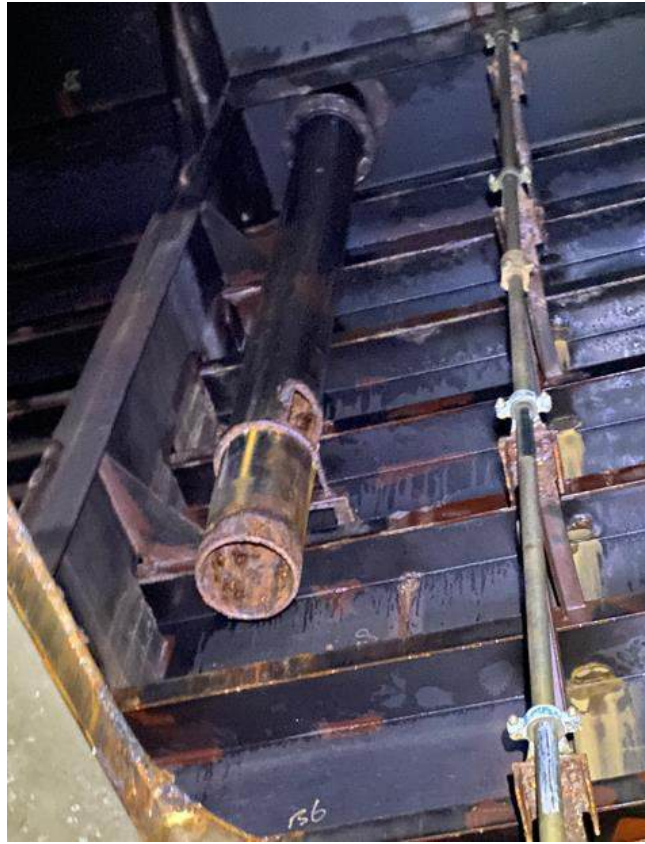
Photo 13 - Condition of Vent Pipe

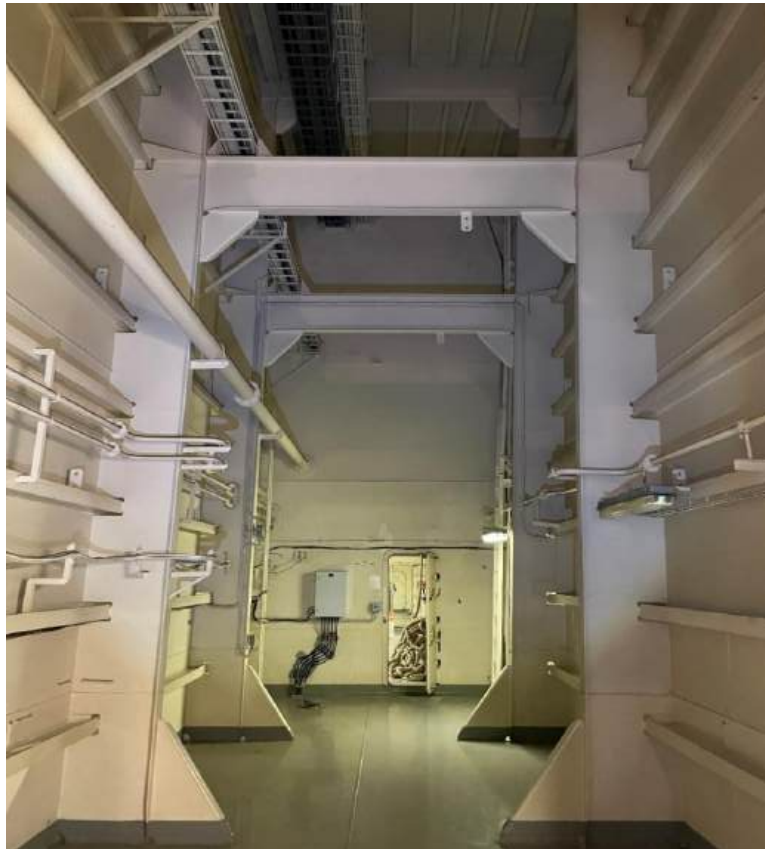
Photo 14 – Typical condition of safety deck (Port shown)

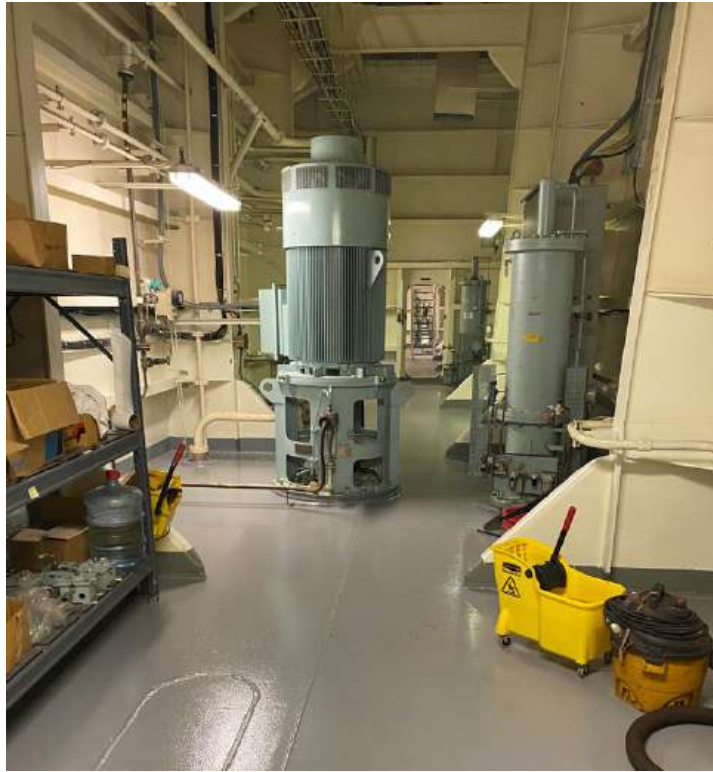
Photo 15 - Typical Condition of Safety Deck (Stbd Shown)

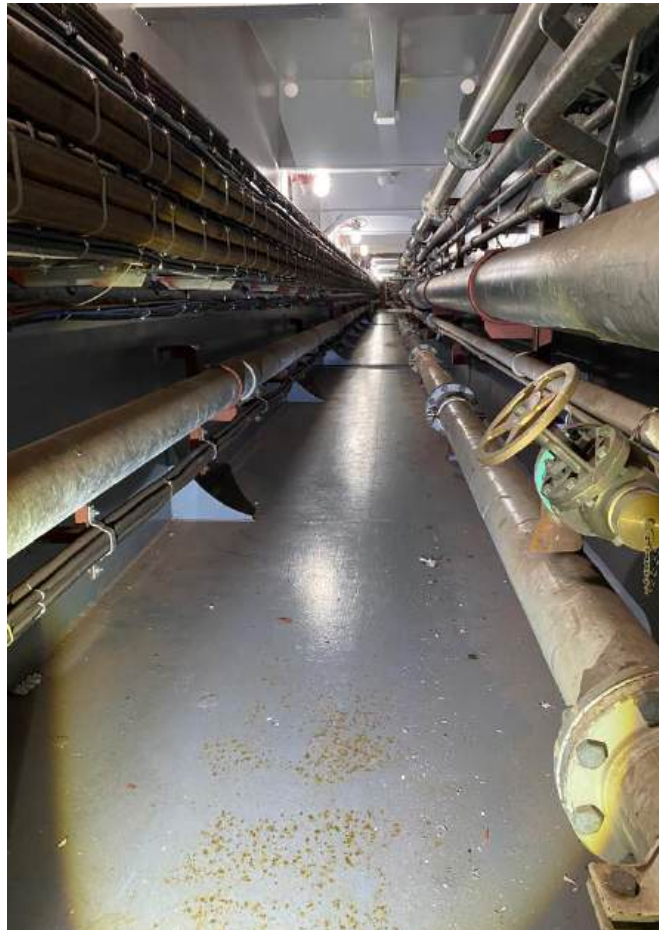
Photo 16 - Typical Condition of Crossover Tunnel

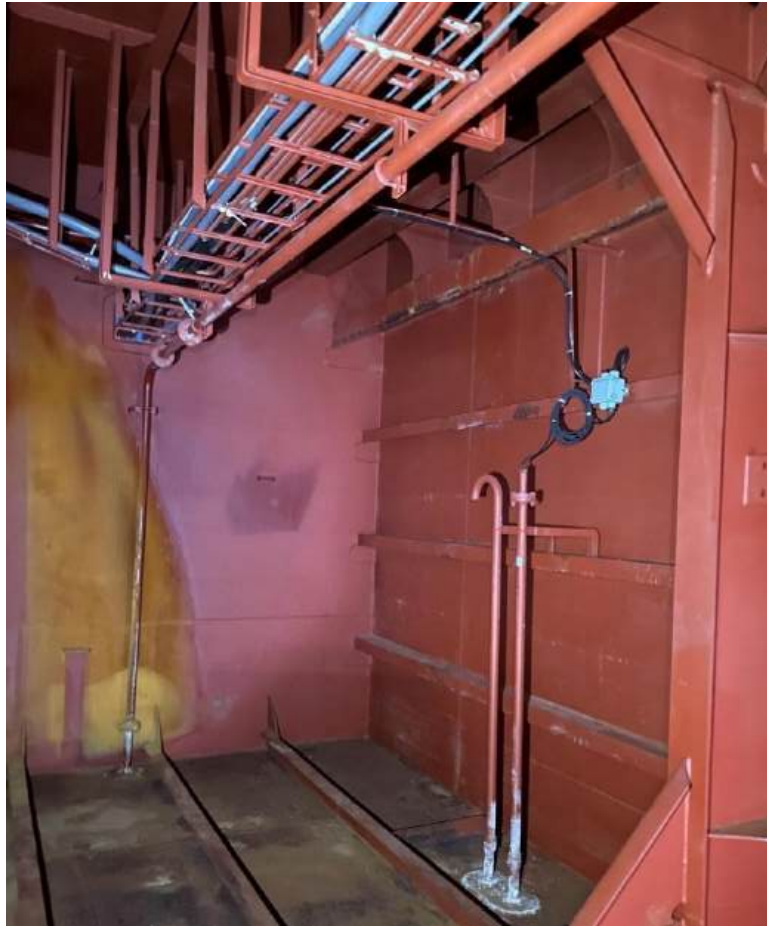
Photo 17 – Typical condition of port side void spaces

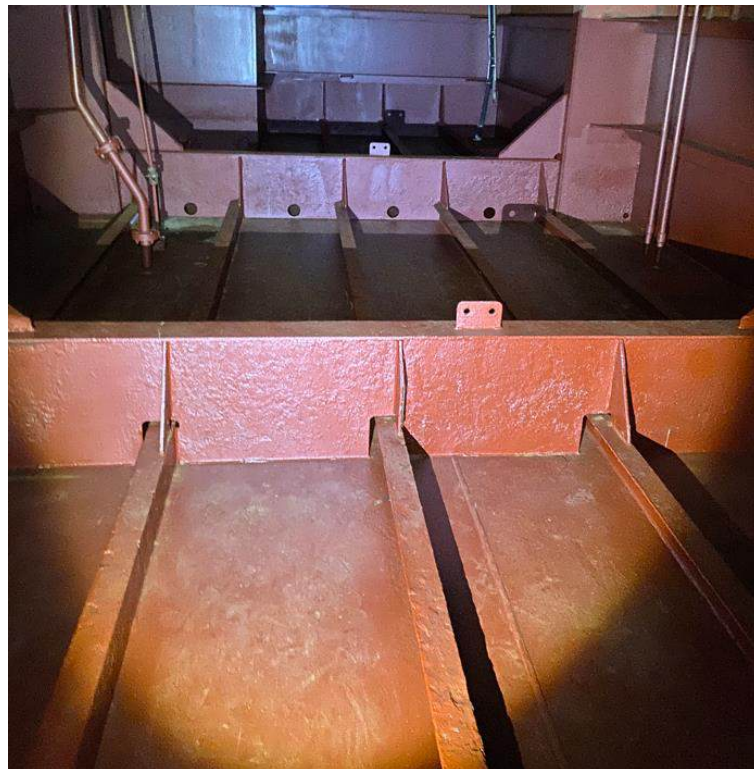
Photo 18 - Condition of Port Fwd-most Void

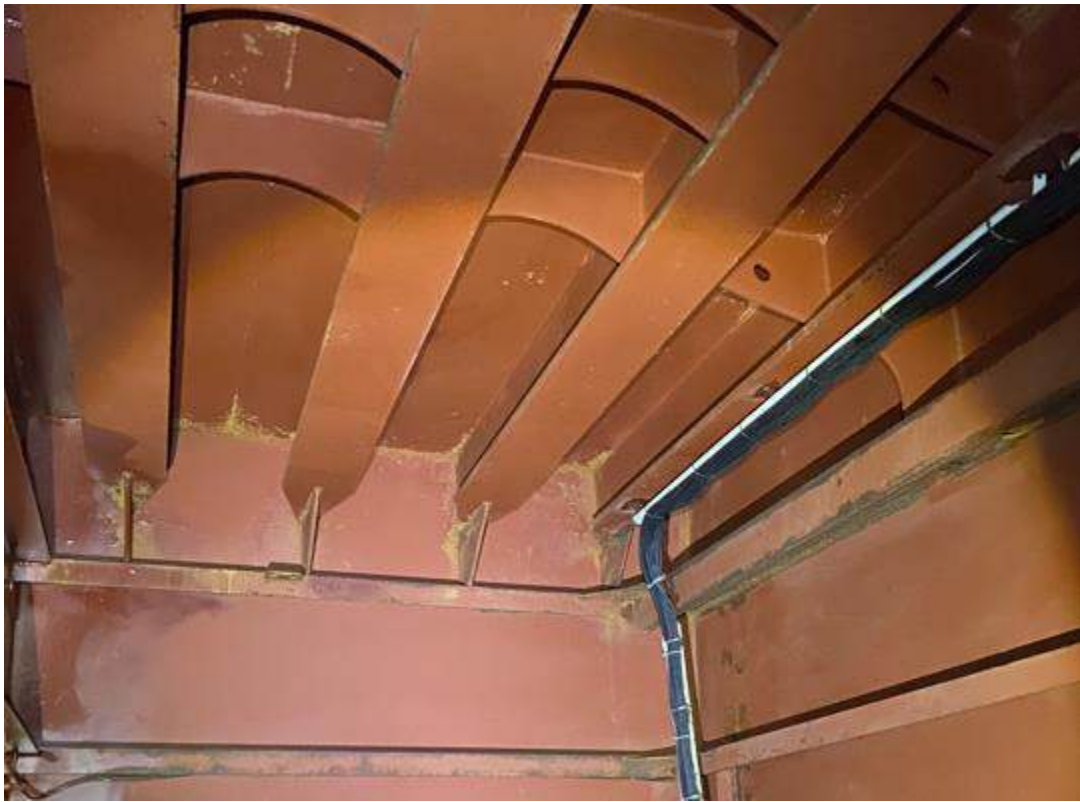
Photo 19 - Condition of Port Fwd-most Void

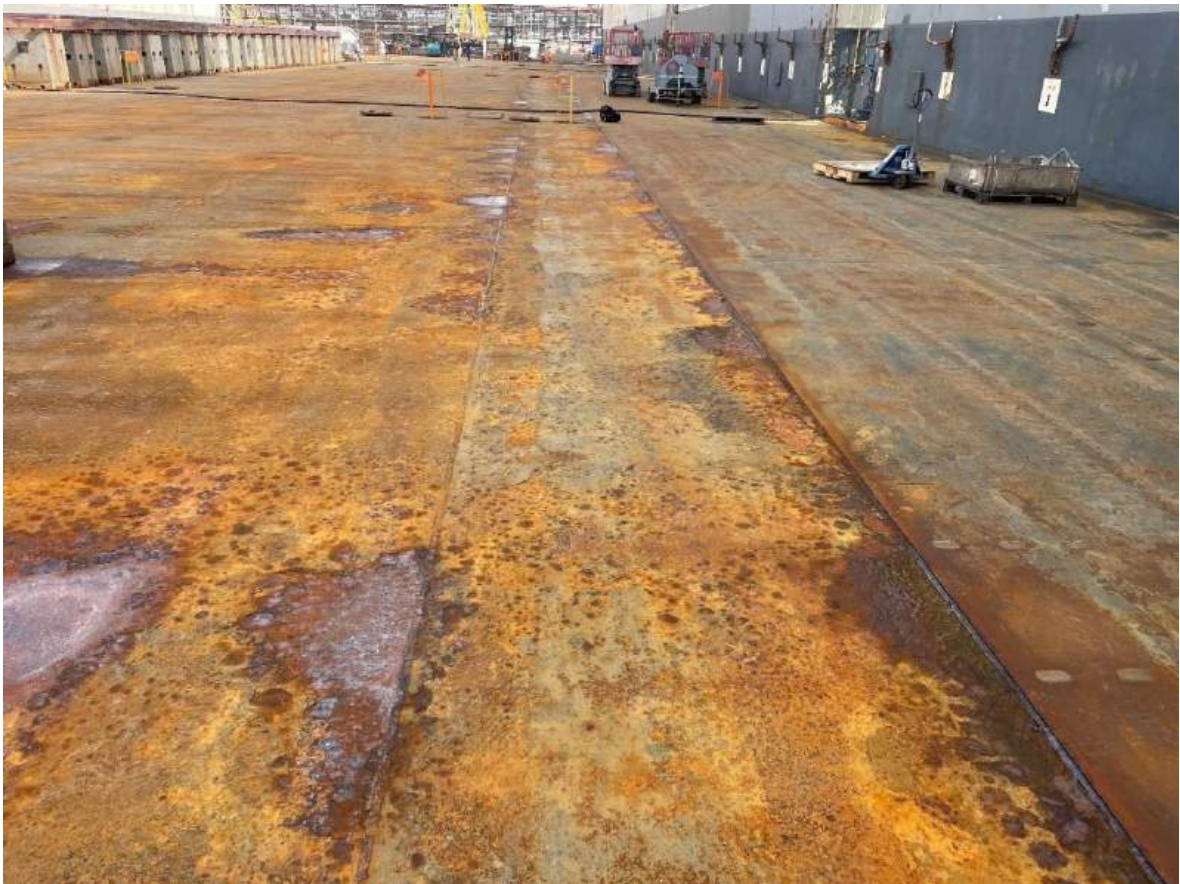
Photo 20 – Typical condition of the pontoon deck

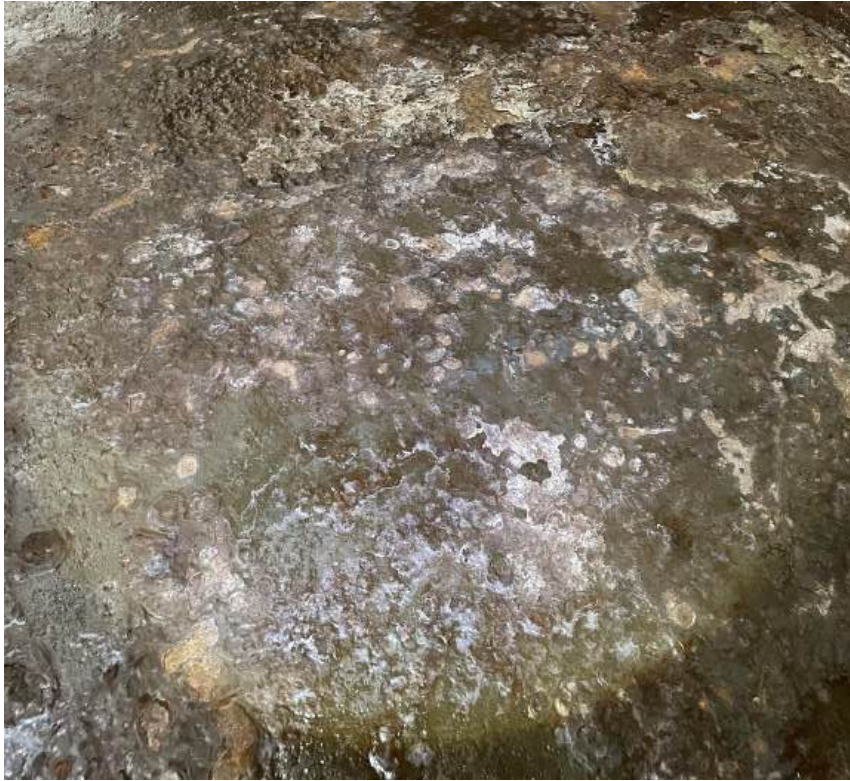
Photo 21 – Scaling and Pitting of the pontoon deck plate

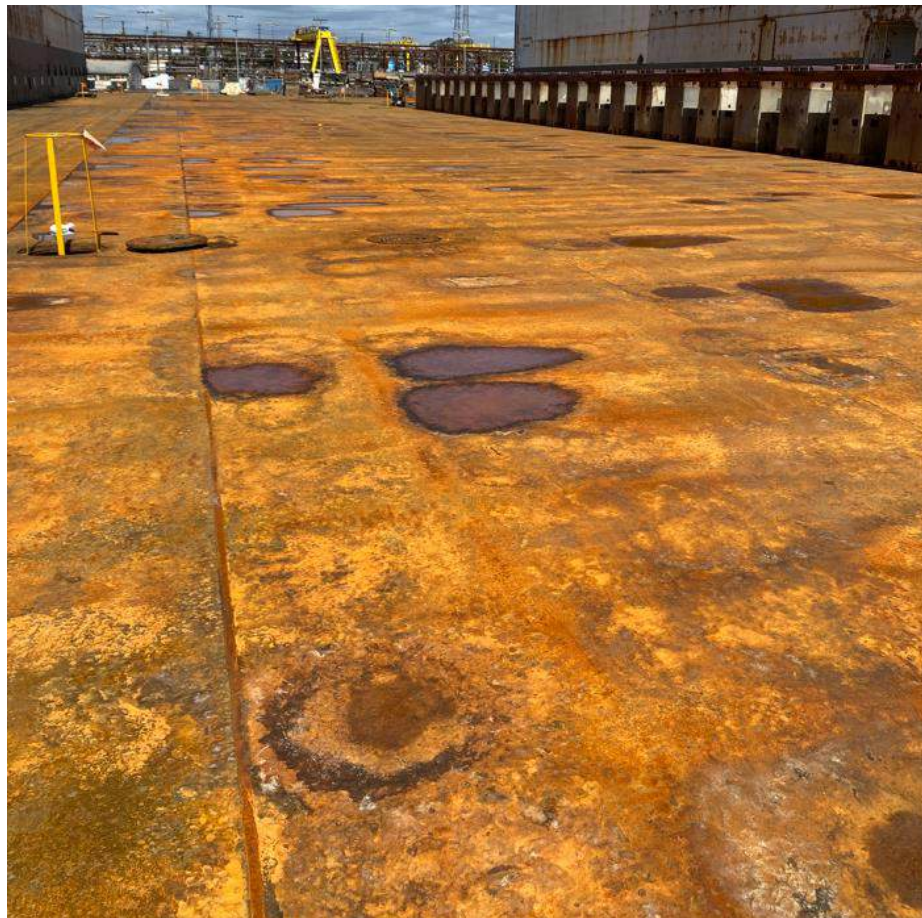
Photo 22 - Typical Condition of the Pontoon Deck

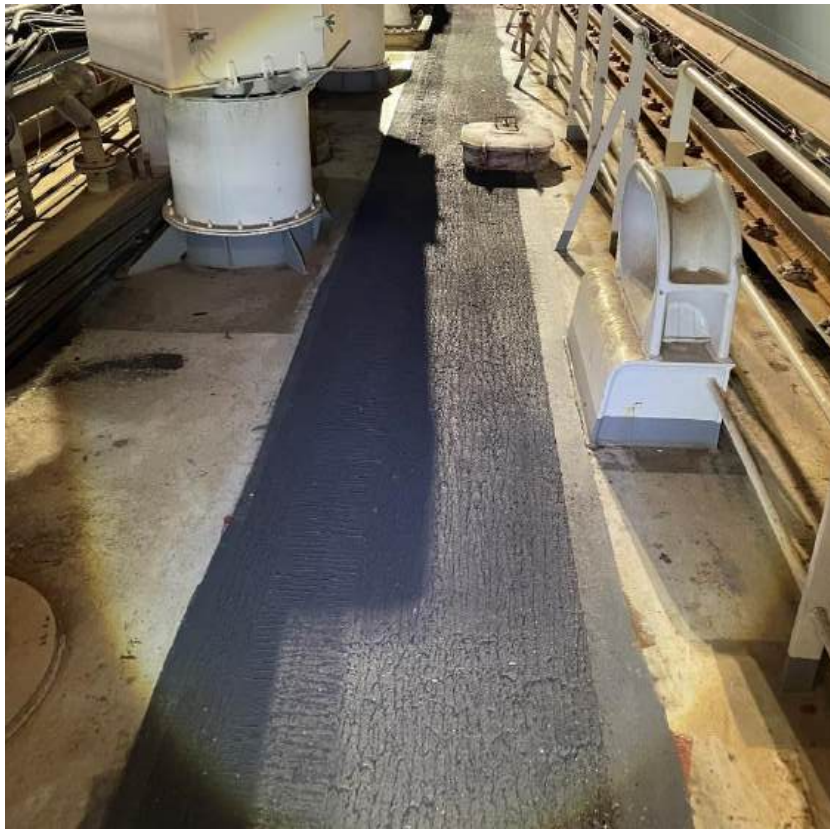
Photo 23 – Condition of STBD Wing Deck

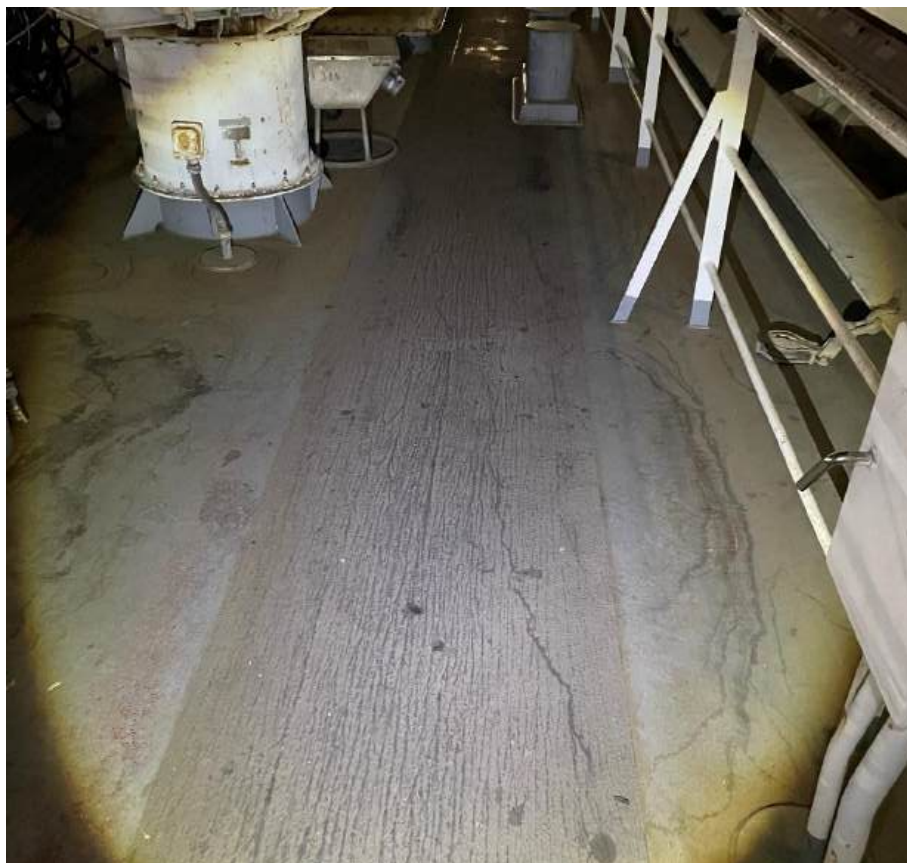
Photo 24 – Condition of PORT Wing Deck

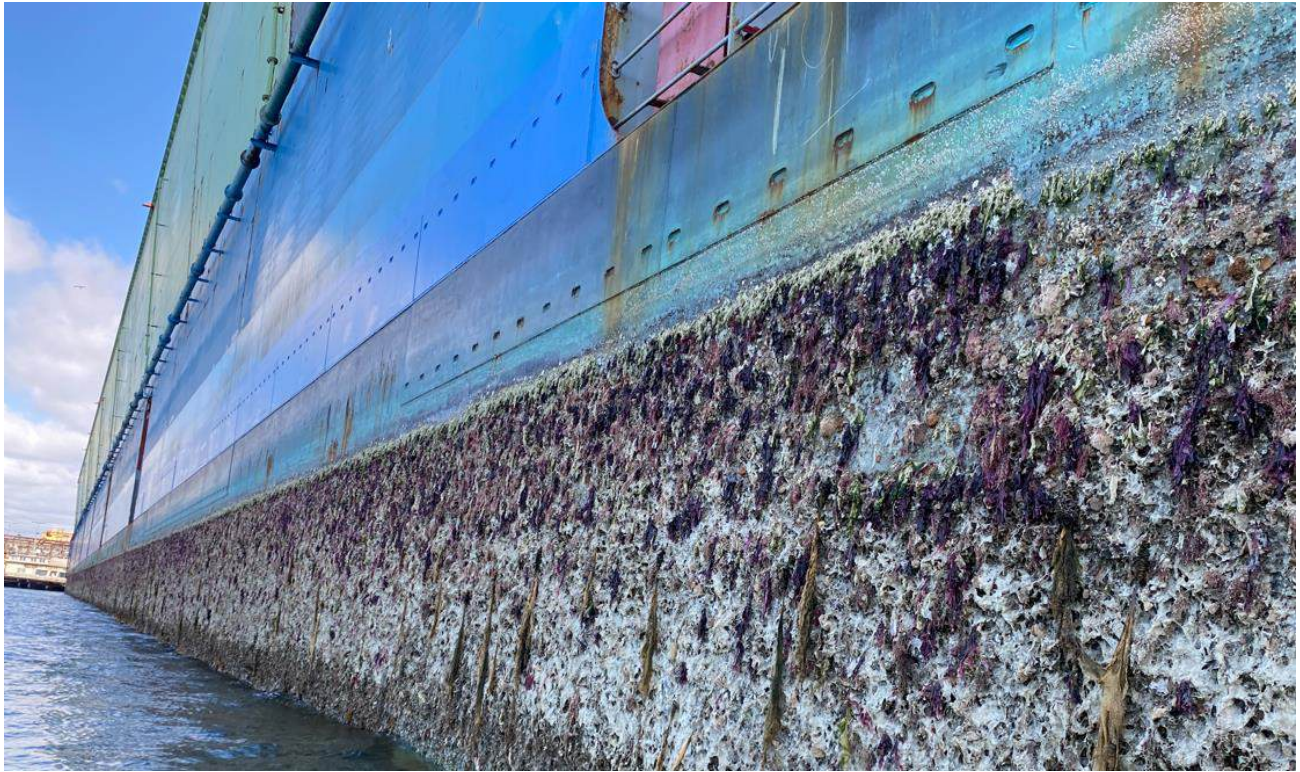
Photo 25 - Pontoon Shell Typical Condition

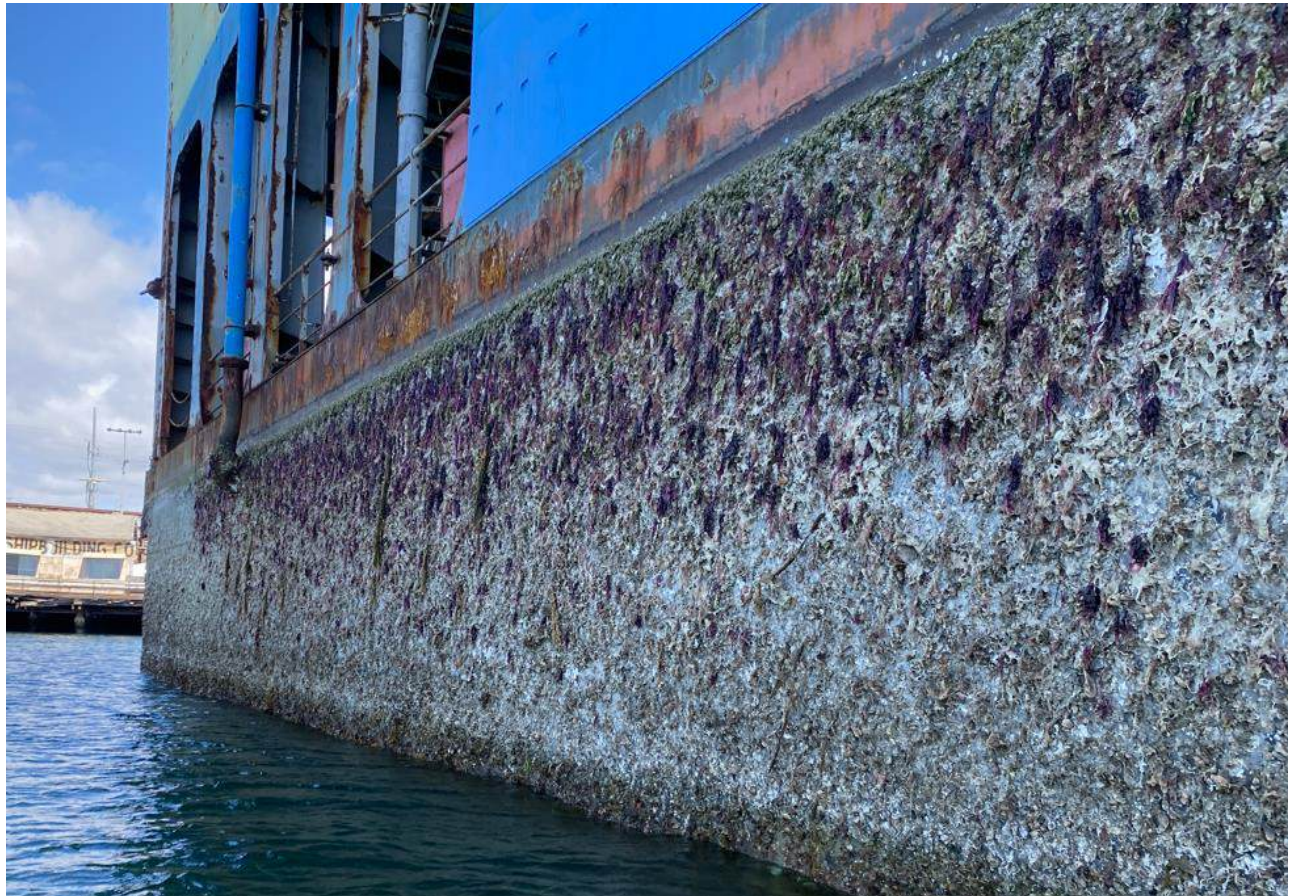
Photo 26 - Typical Condition Pontoon Shell

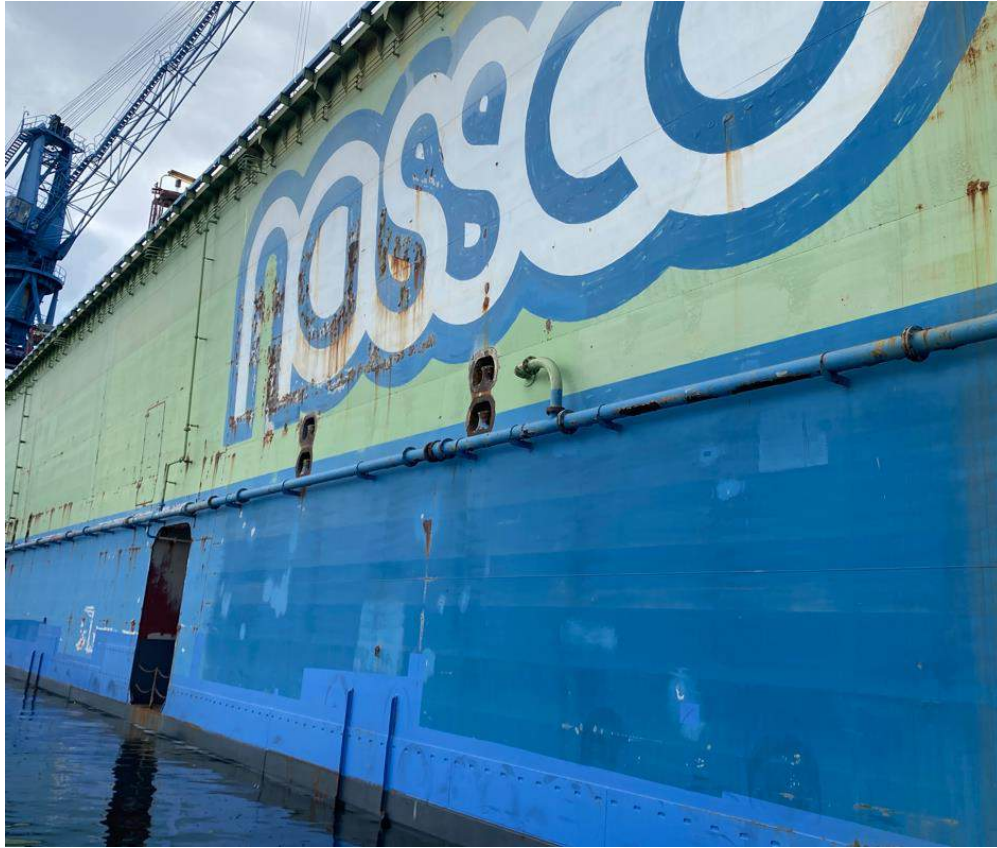
Photo 27 - Typical Condition of OTBD Shell (STBD)

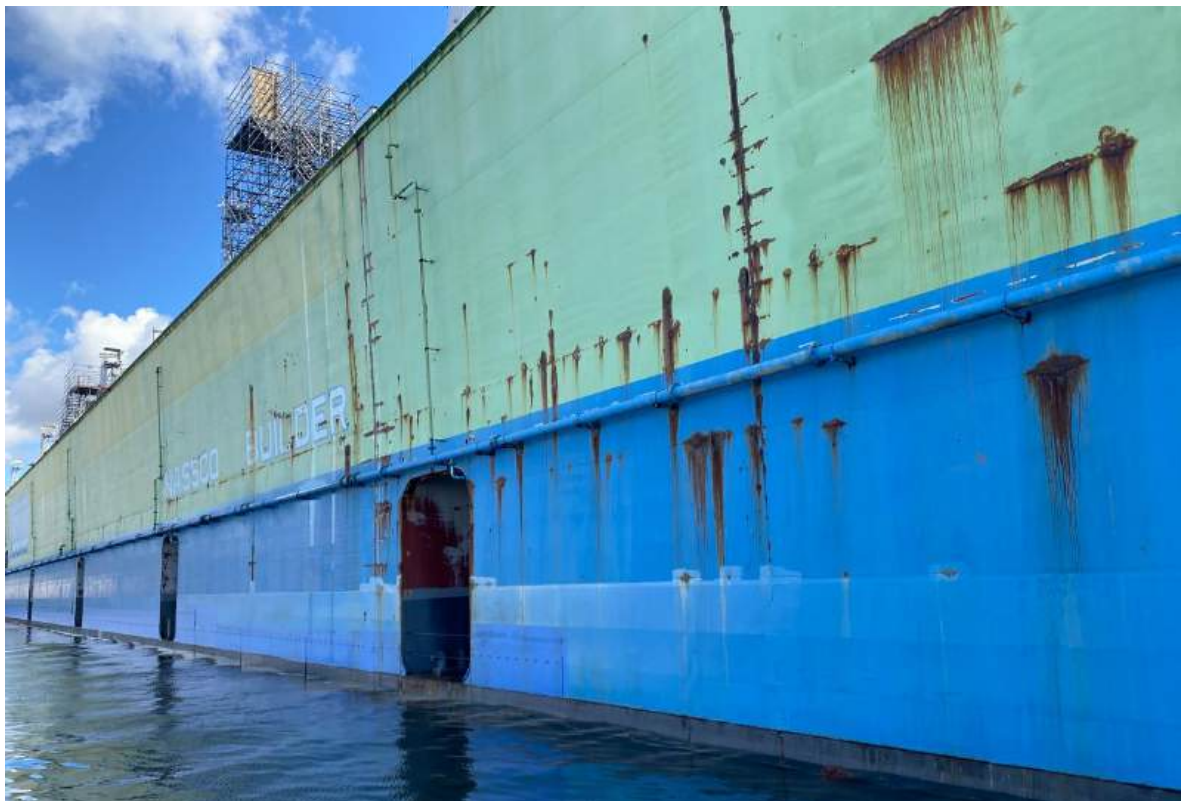
Photo 28 - Typical Condition of OTBD Shell (Port)

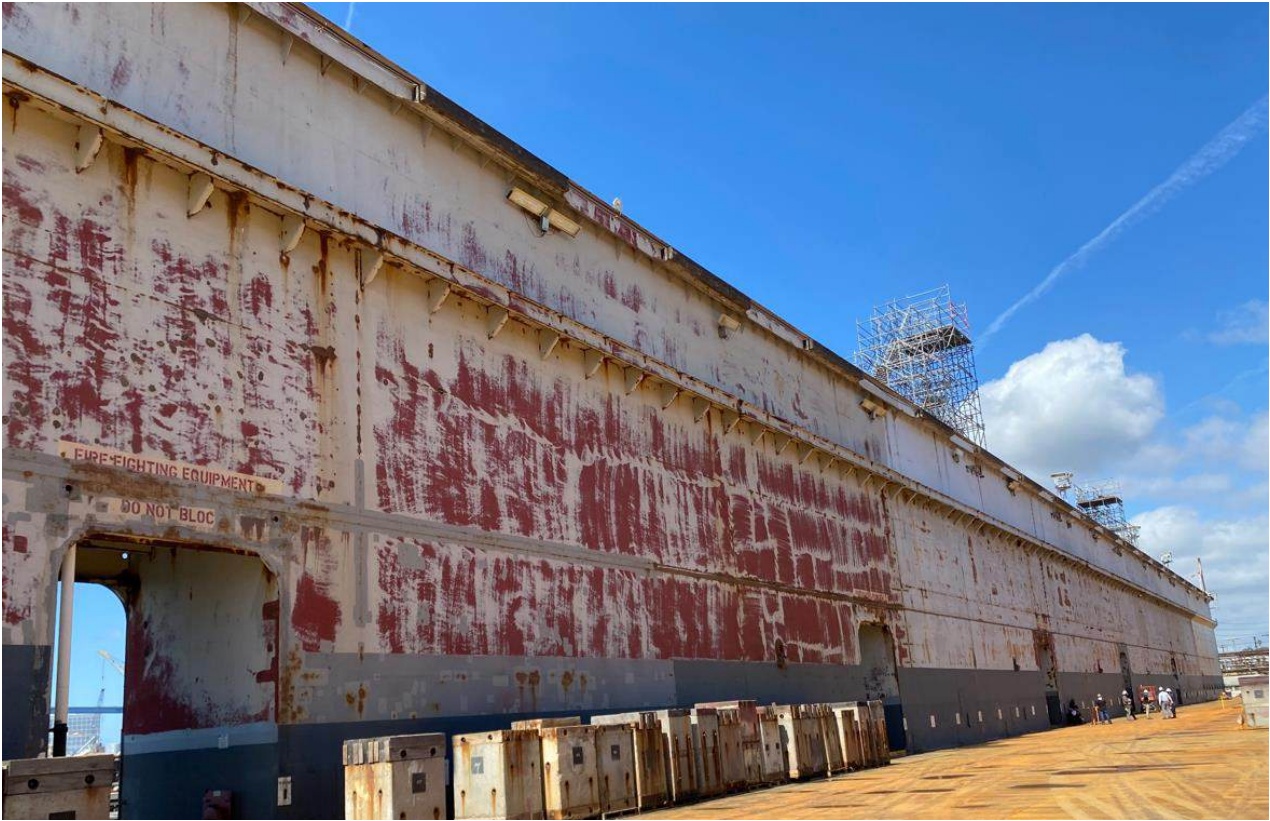
Photo 29 - Typical Condition STBD INBD Wing Shell

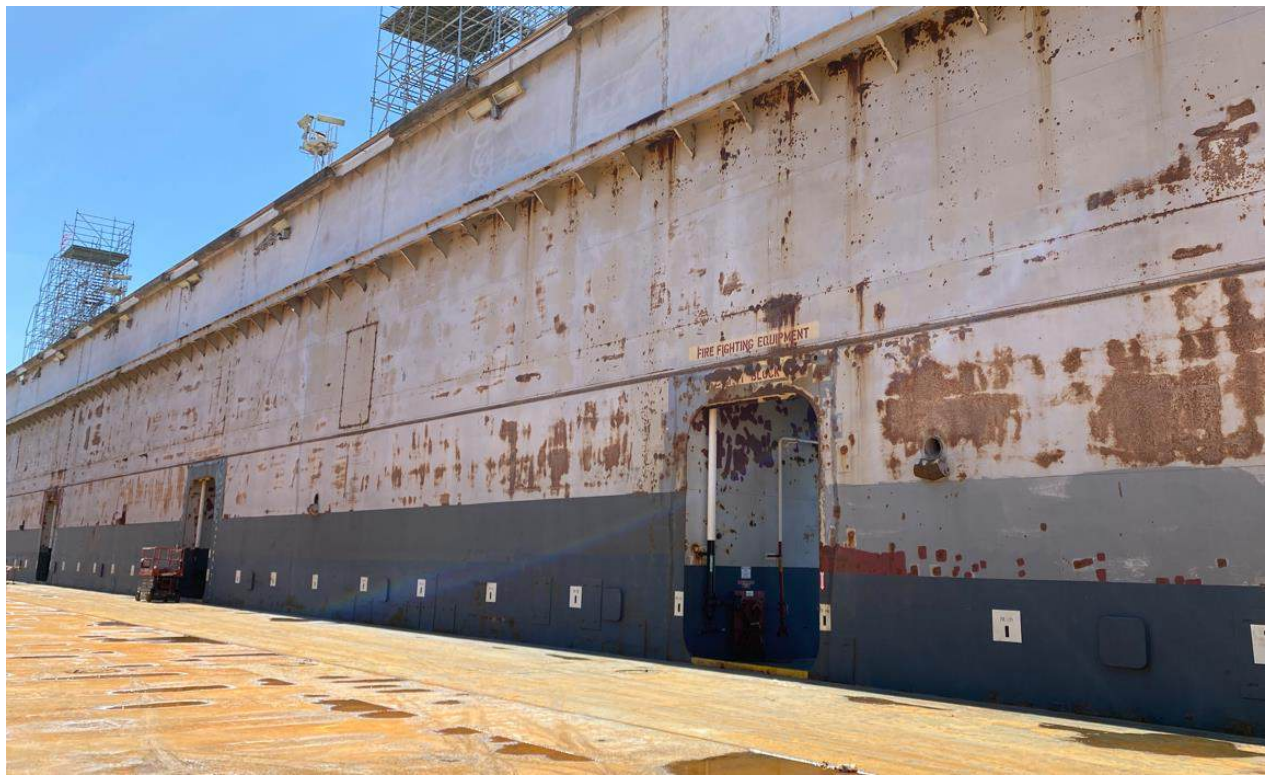
Photo 30 - Typical Condition Port INBD Wing Shell

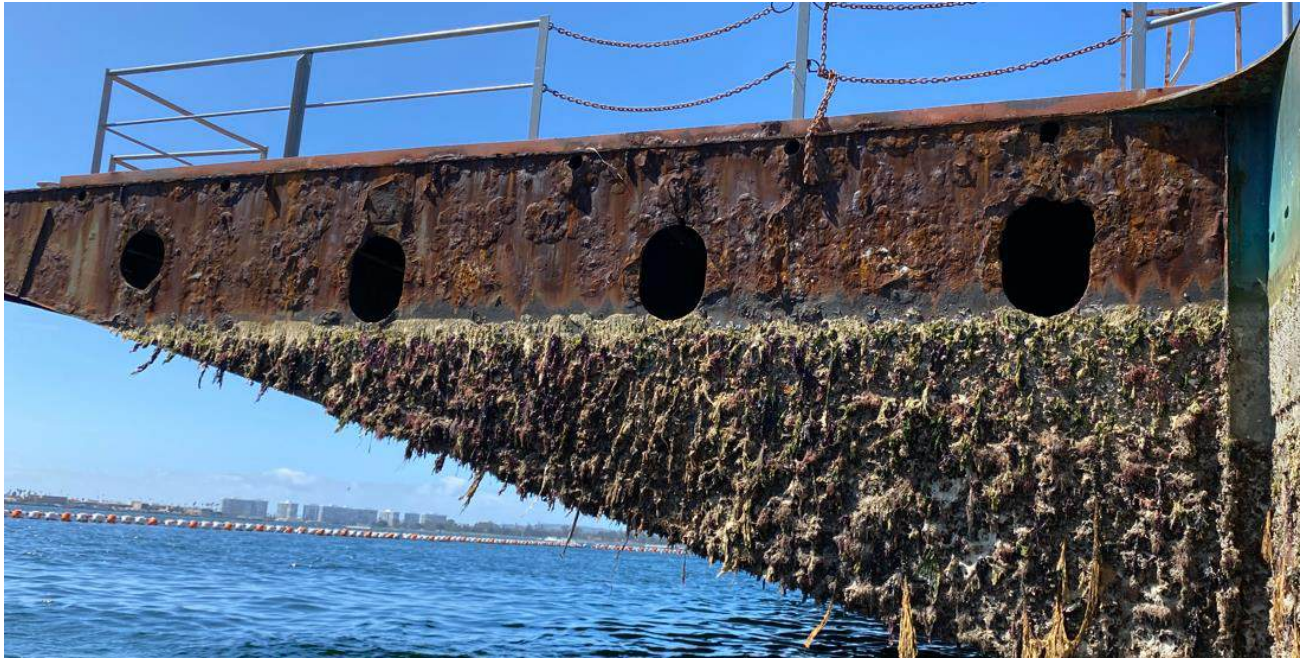
Photo 31 - Condition of Apron (Port/Stbd Most Frames)
