Table of Photos

Photo 1 – NASSCO “BUILDER”

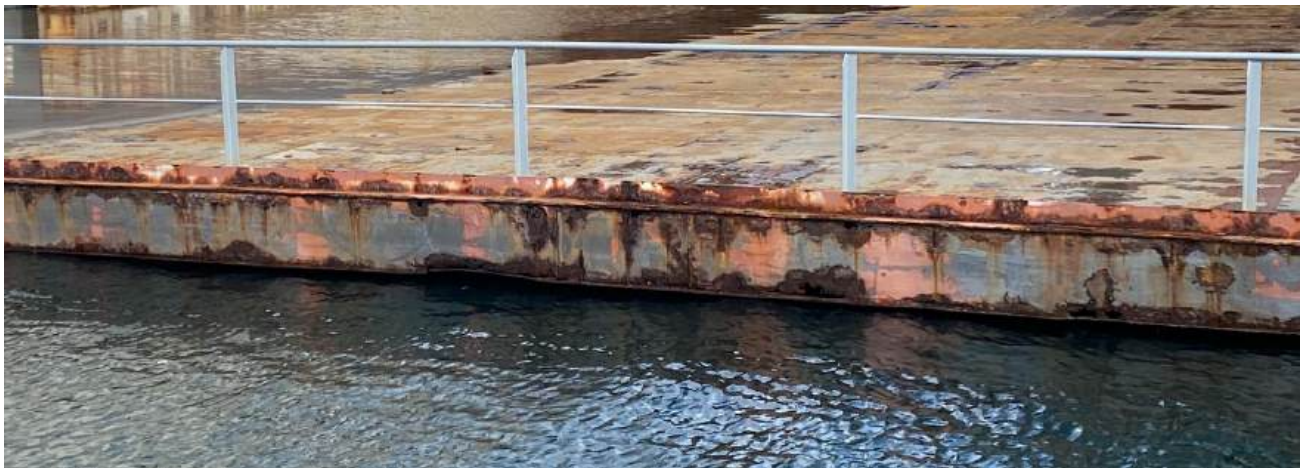
Photo 32 - Condition of Apron Coaming

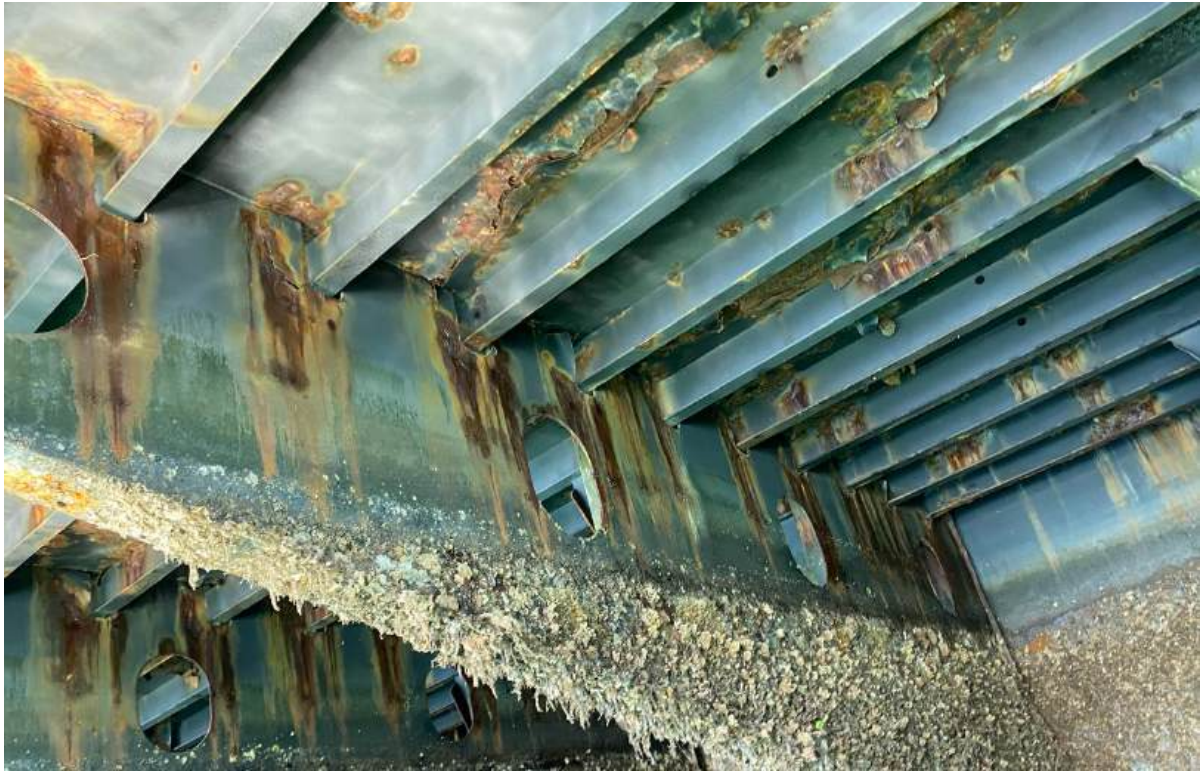
Photo 33 - Condition on Underside of Apron

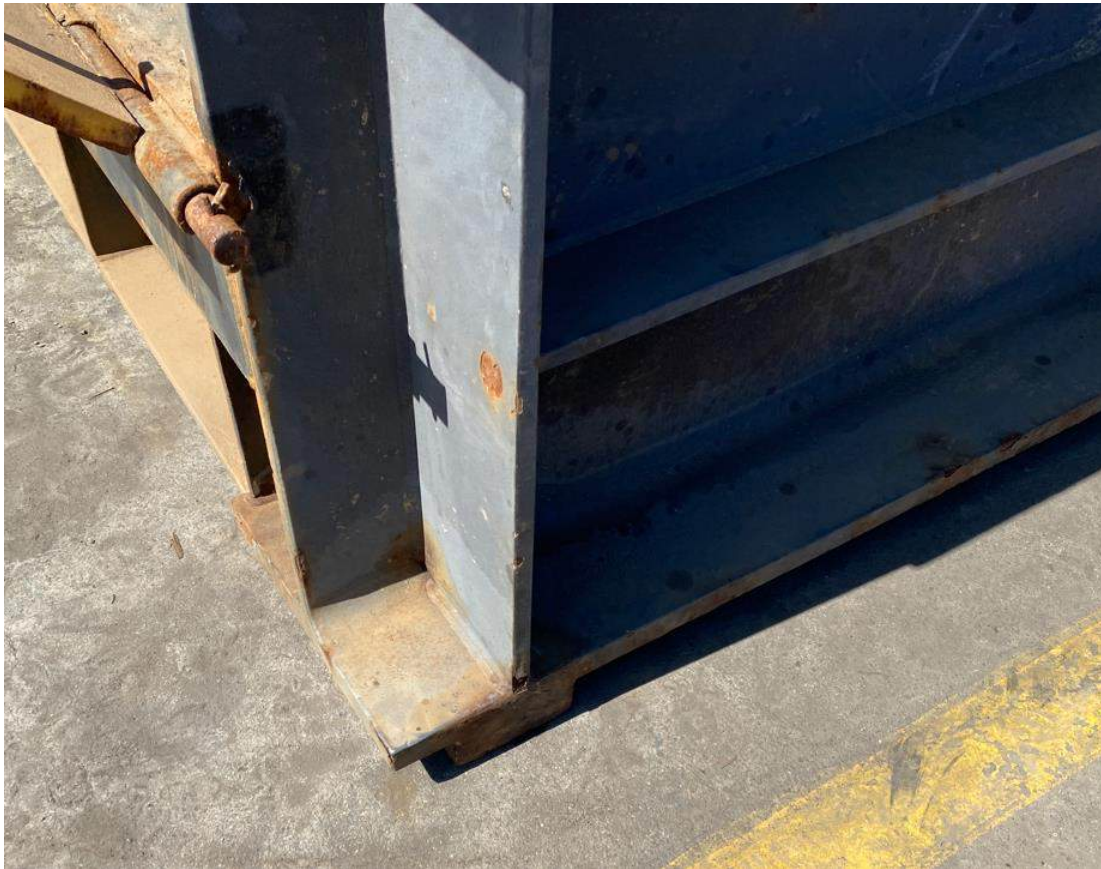
Photo 34 - Condition of Vehicle Ramp Structure and Bearing Pads

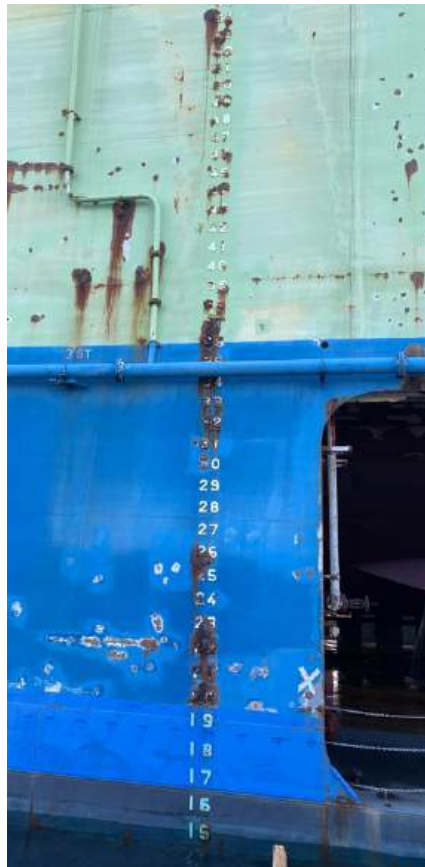
Photo 35 - Condition of Draft Boards OTBD

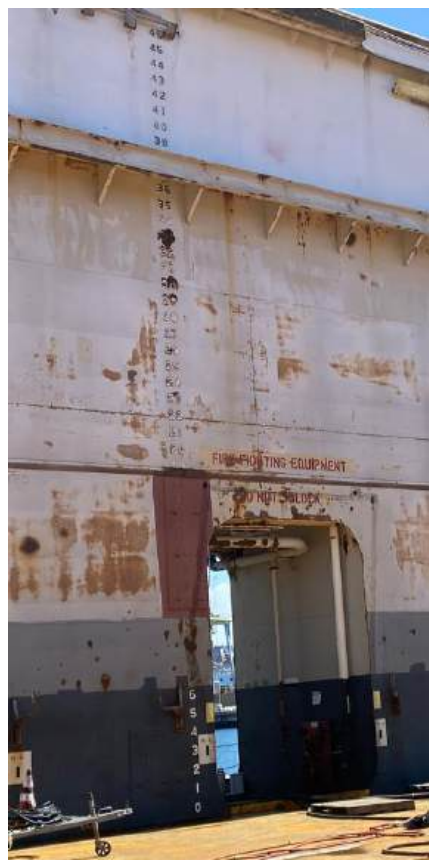
Photo 36 - Condition of Draft Boards Internal

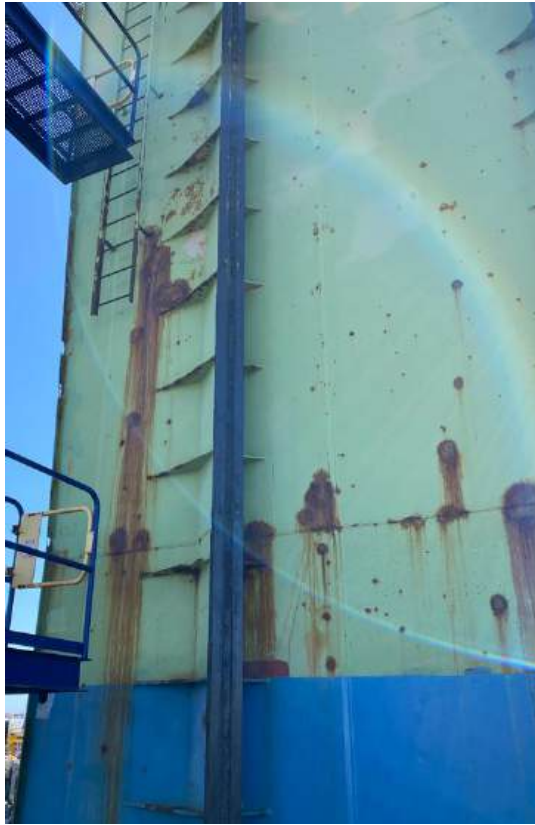
Photo 37 - Condition of 45 deg. Mooring Tee

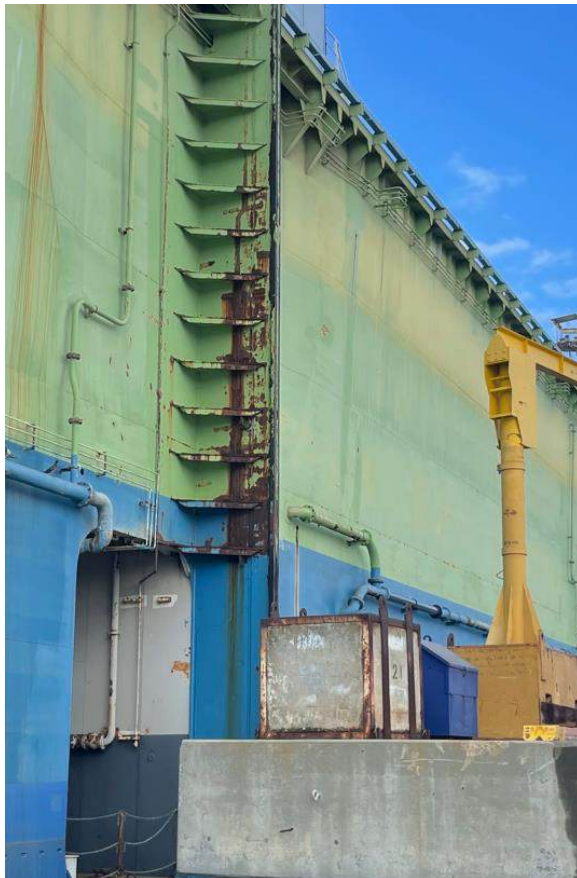
Photo 38 - Condition of Frame 121 90 deg. Mooring Tee

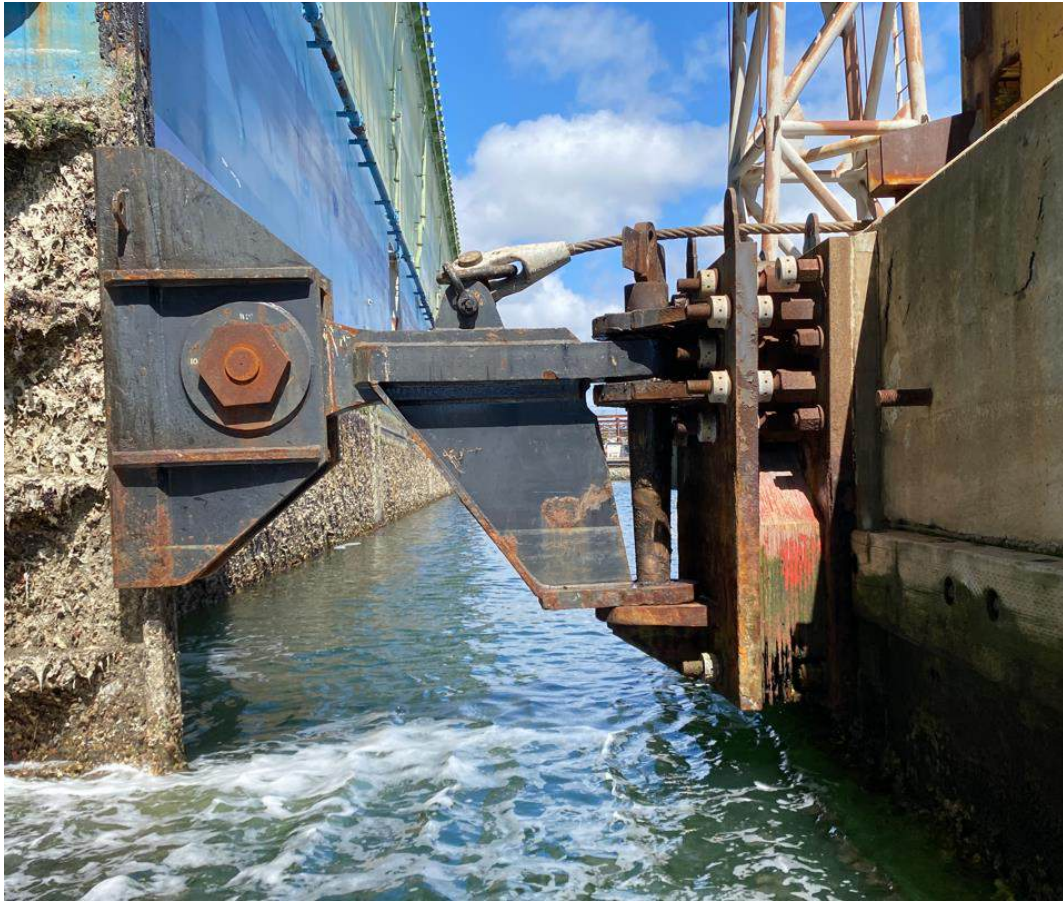
Photo 39 - Condition of Frame 121 Gripper

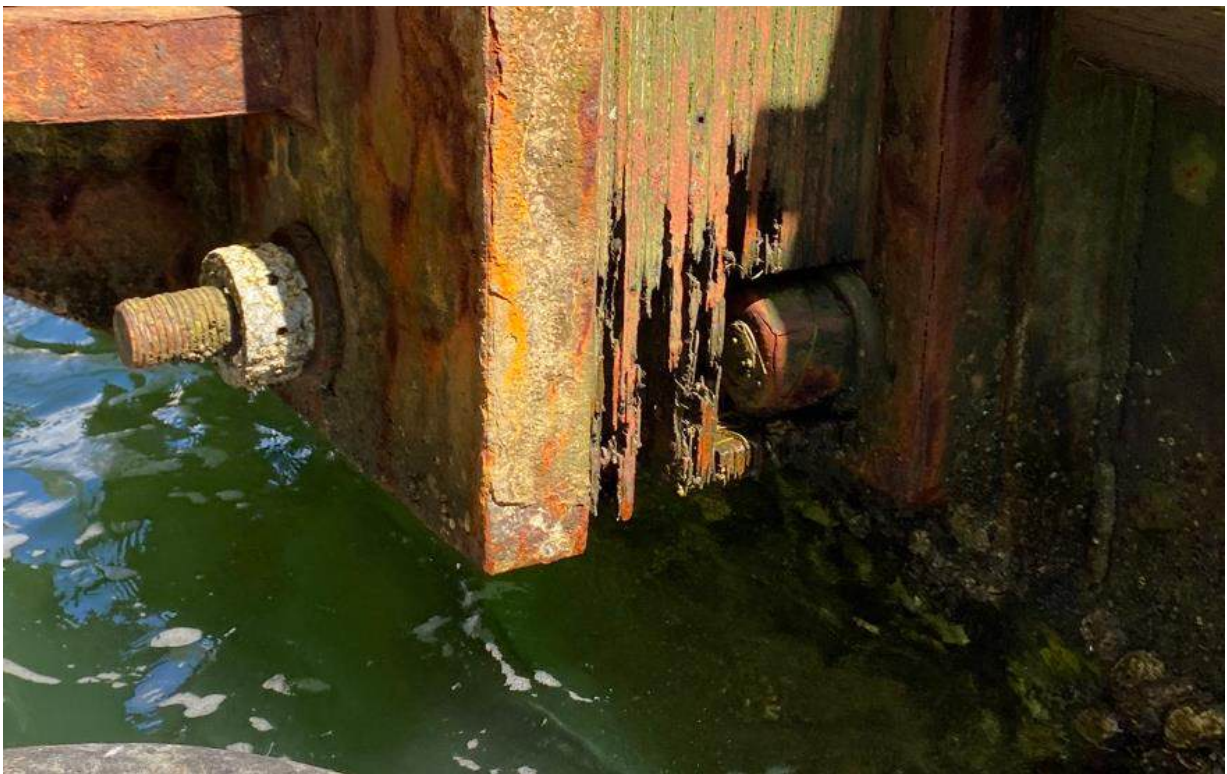
Photo 40 - Condition of Lower Anchor Bolt, Nut, and Timber Frame 121

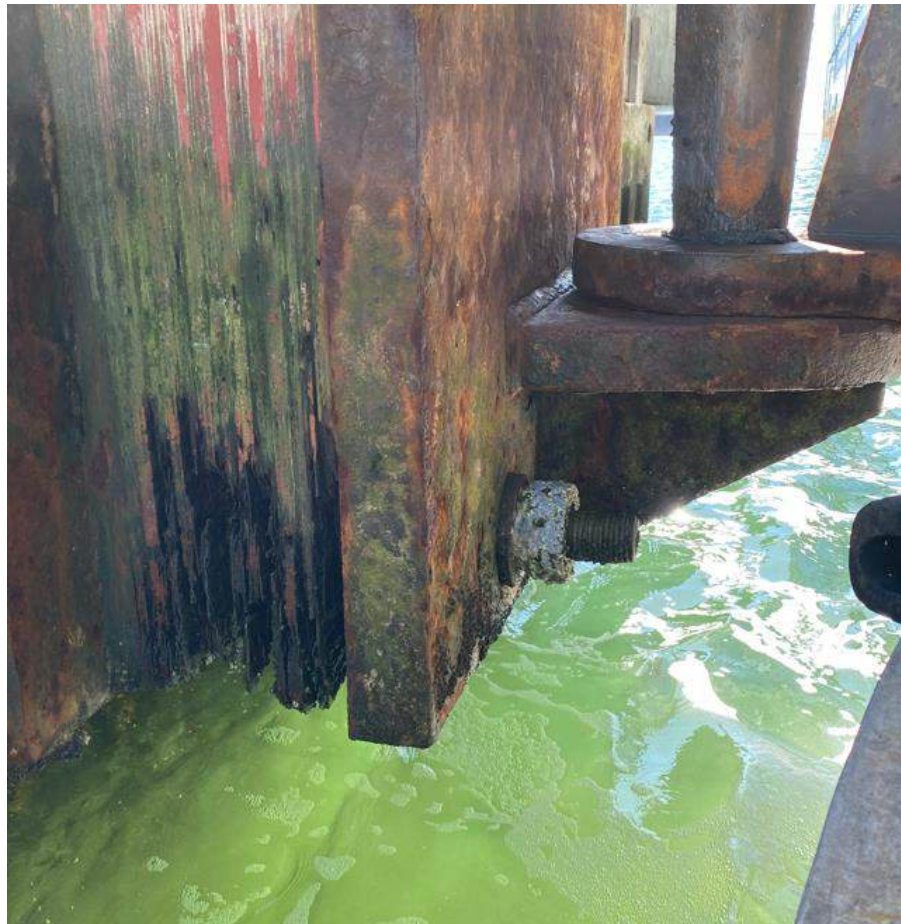
Photo 41 - Condition of Lower Anchor Bolt, Nut, and Timber Frame 121

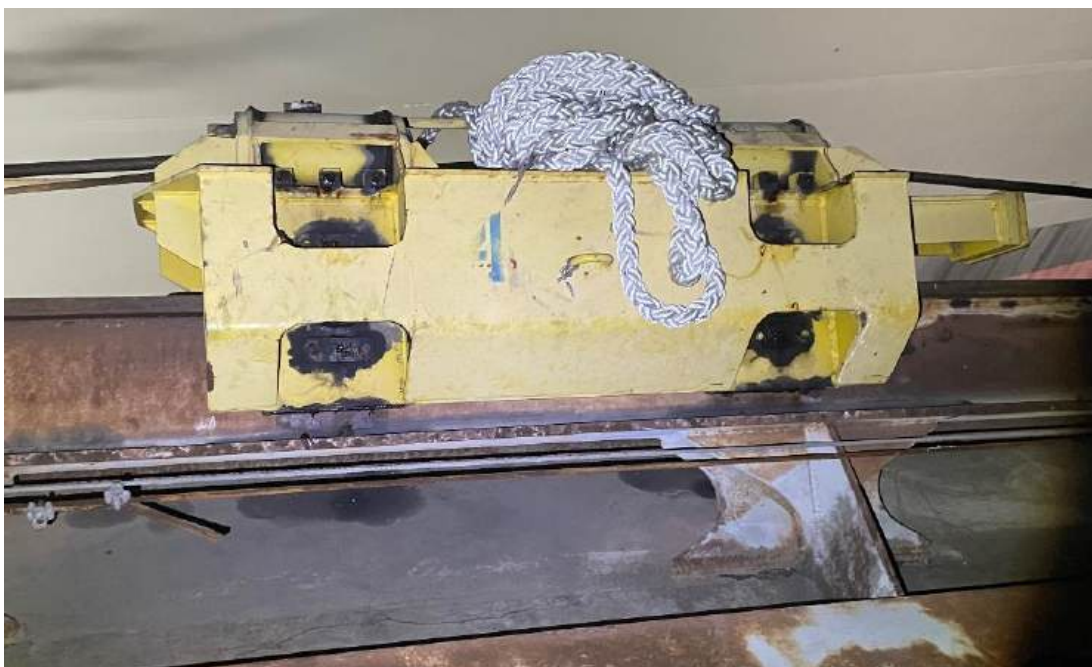
Photo 42 – Typical condition of vessel handling trolley

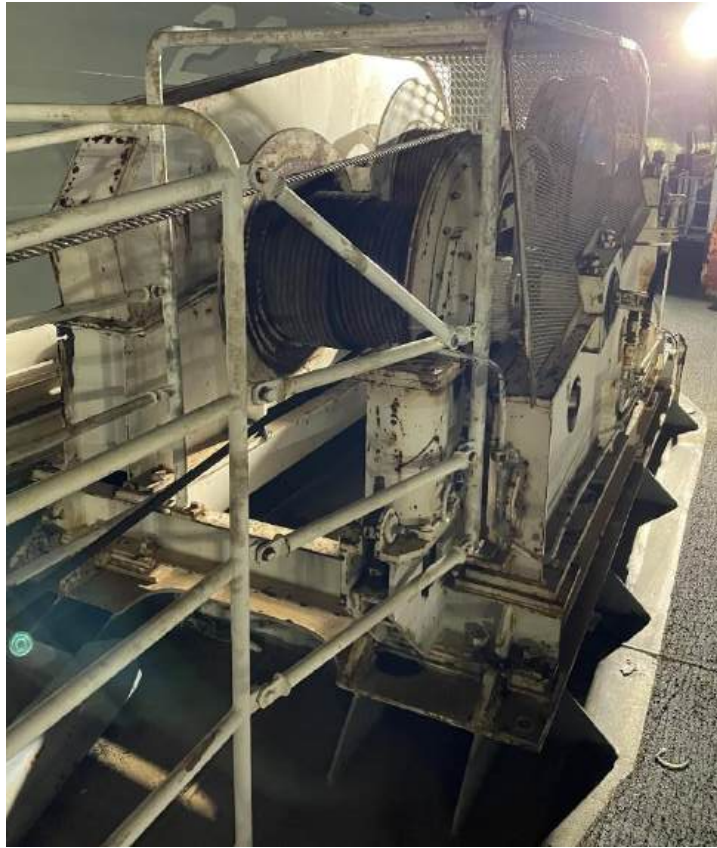
Photo 43 – Typical condition of vessel handling winch

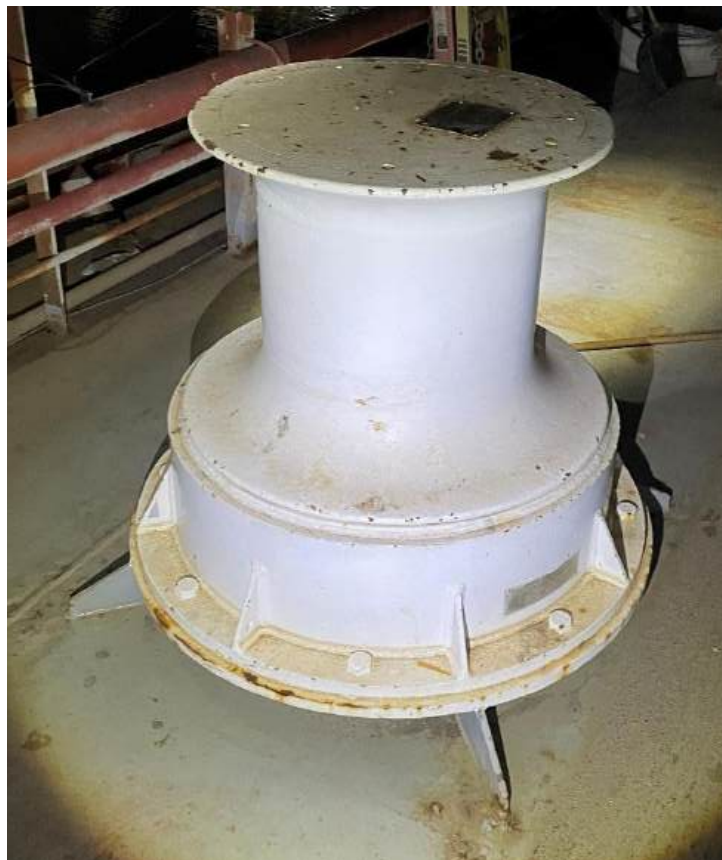
Photo 44 – Typical condition of capstan

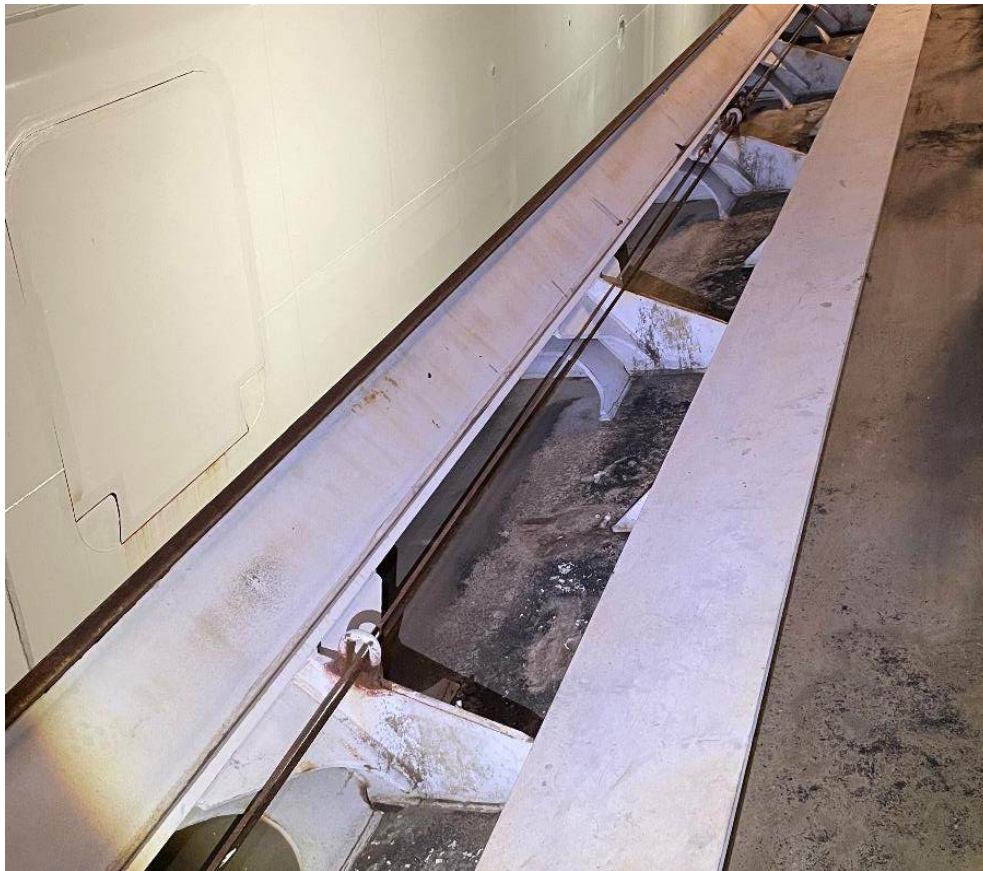
Photo 45 – Typical condition of trolley track

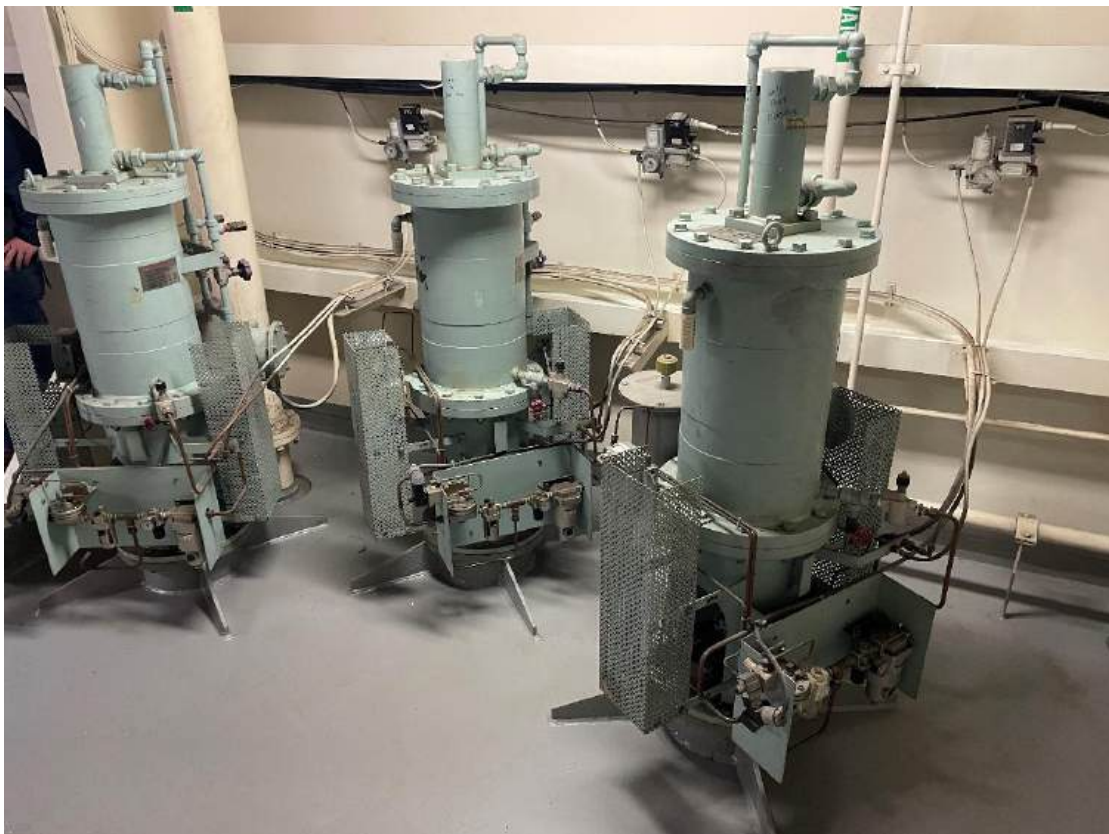
Photo 46 – Typical condition of valve actuators on the starboard safety deck

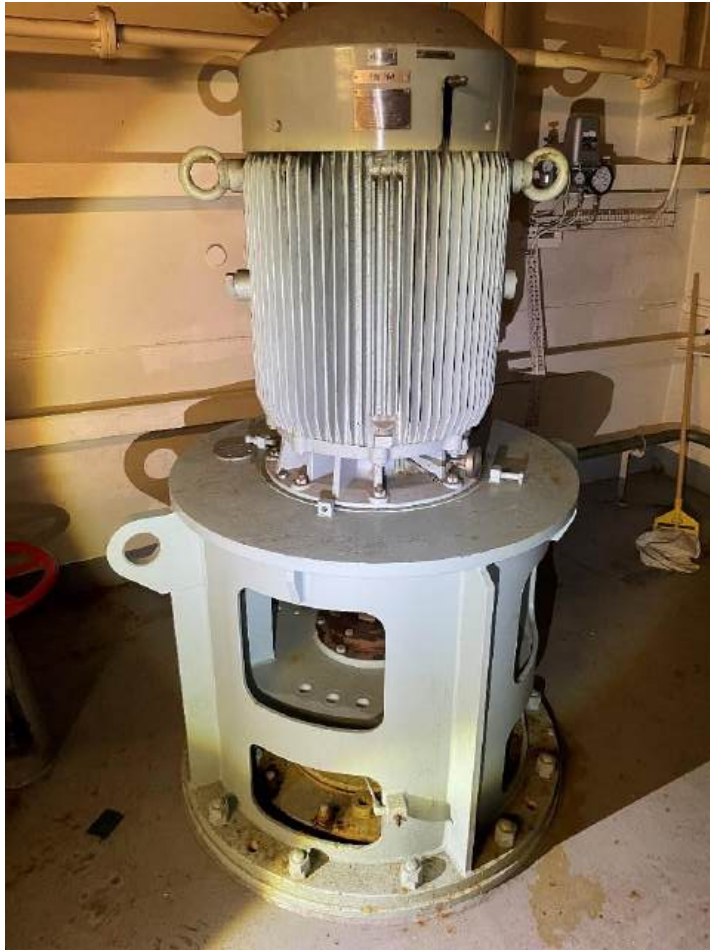
Photo 47 – Typical condition of fire pump (Port shown)

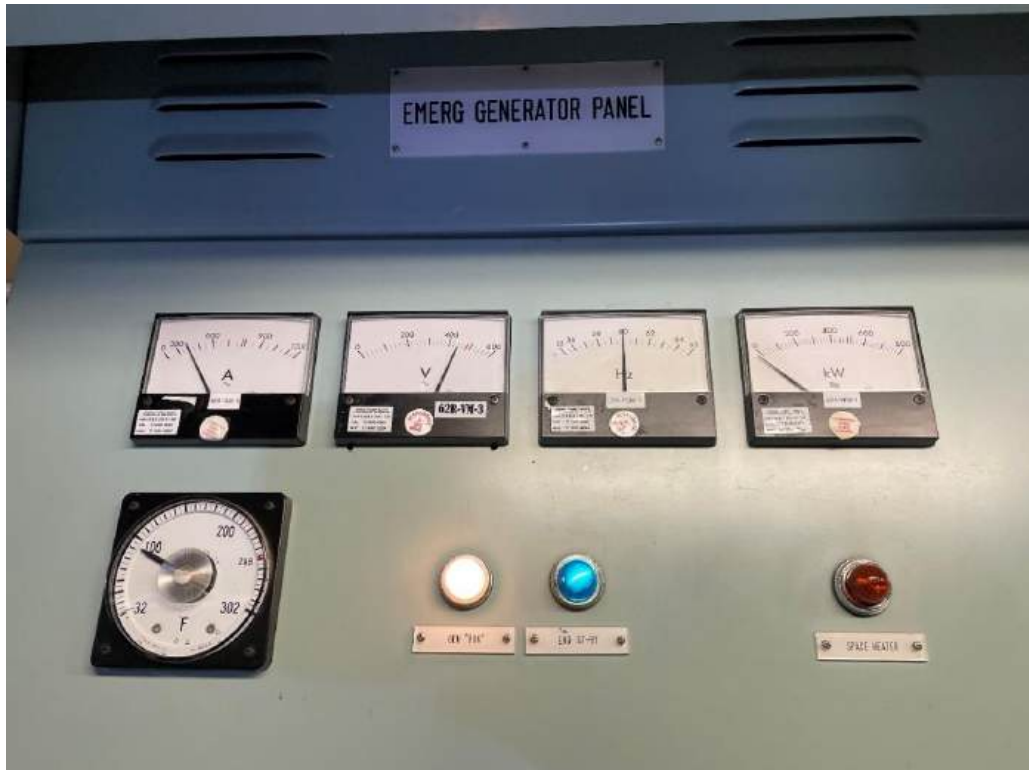
Photo 48 – Emergency generator panel (Powering 2 ballast pumps)

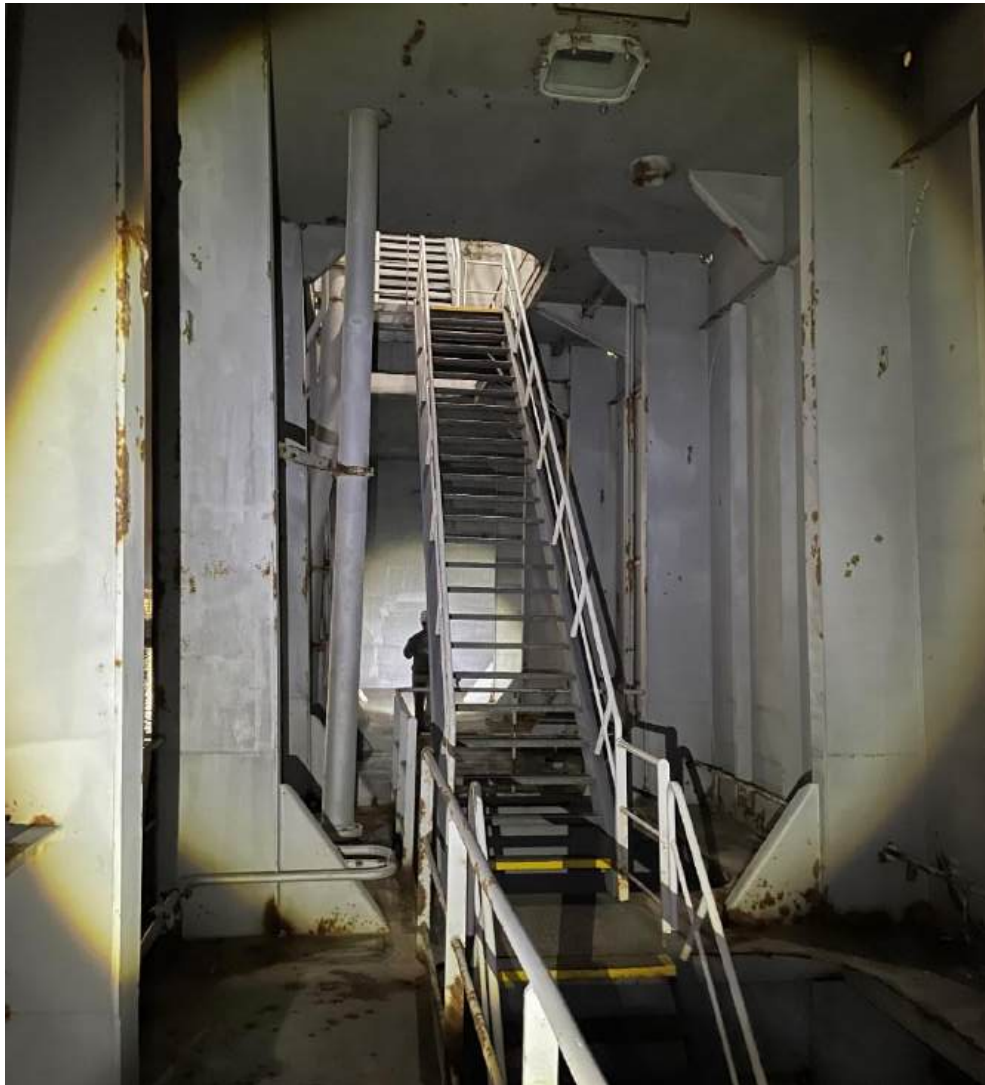
Photo 49 – Typical condition of open portal structure and stairwell (Port Aft shown)

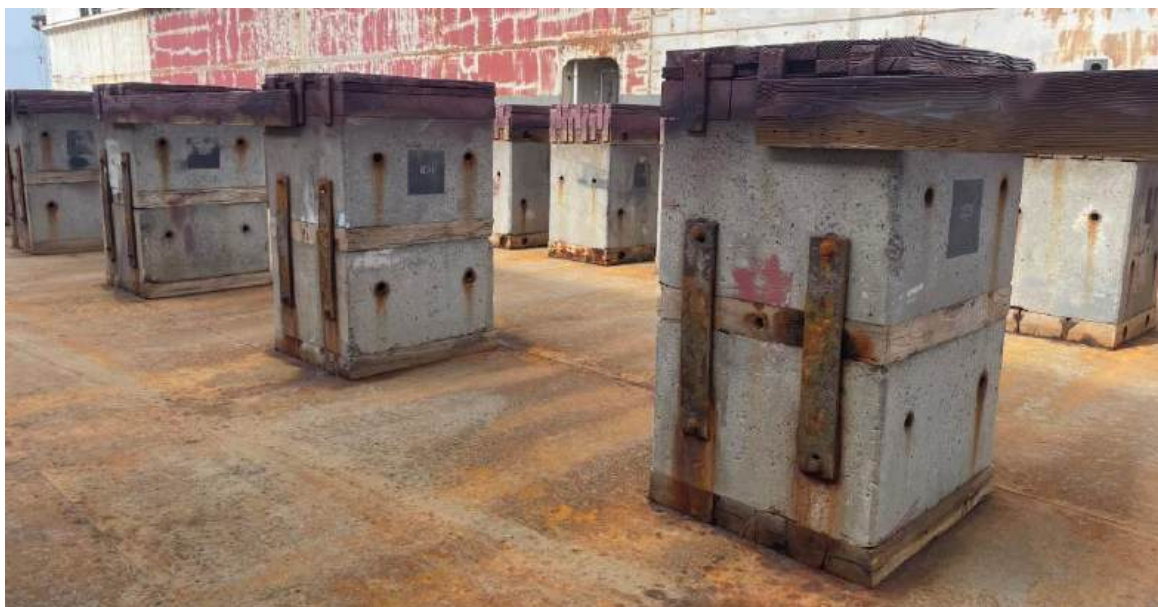
Photo 50 – Typical condition of keel and side blocks

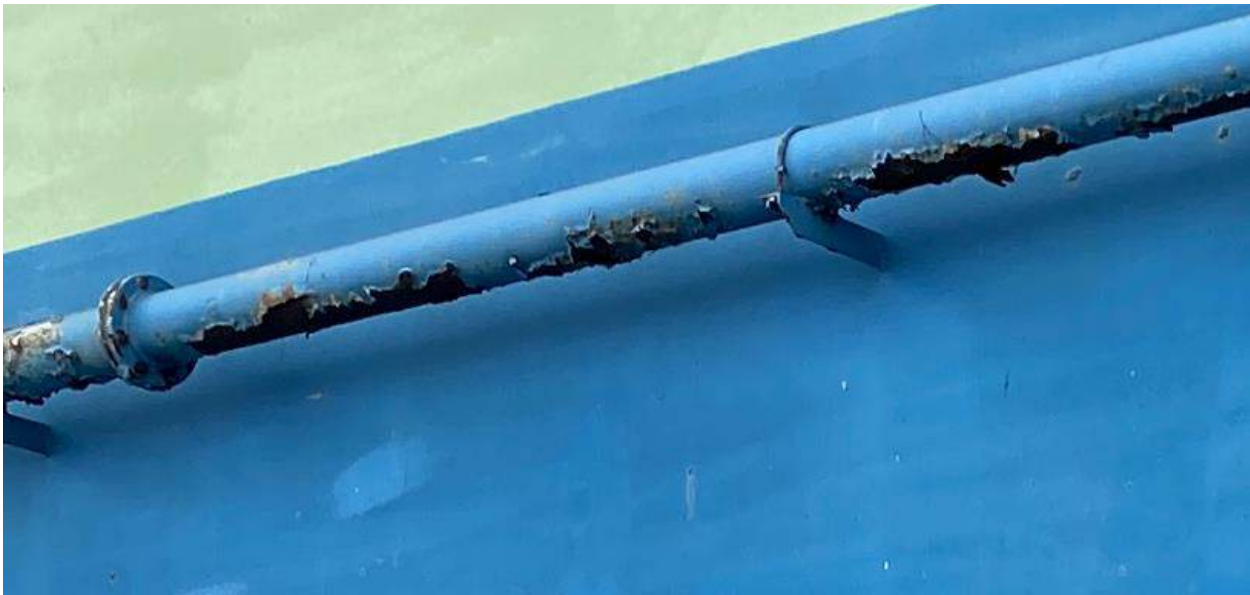
Photo 51 - Exterior Fire Main Pipe

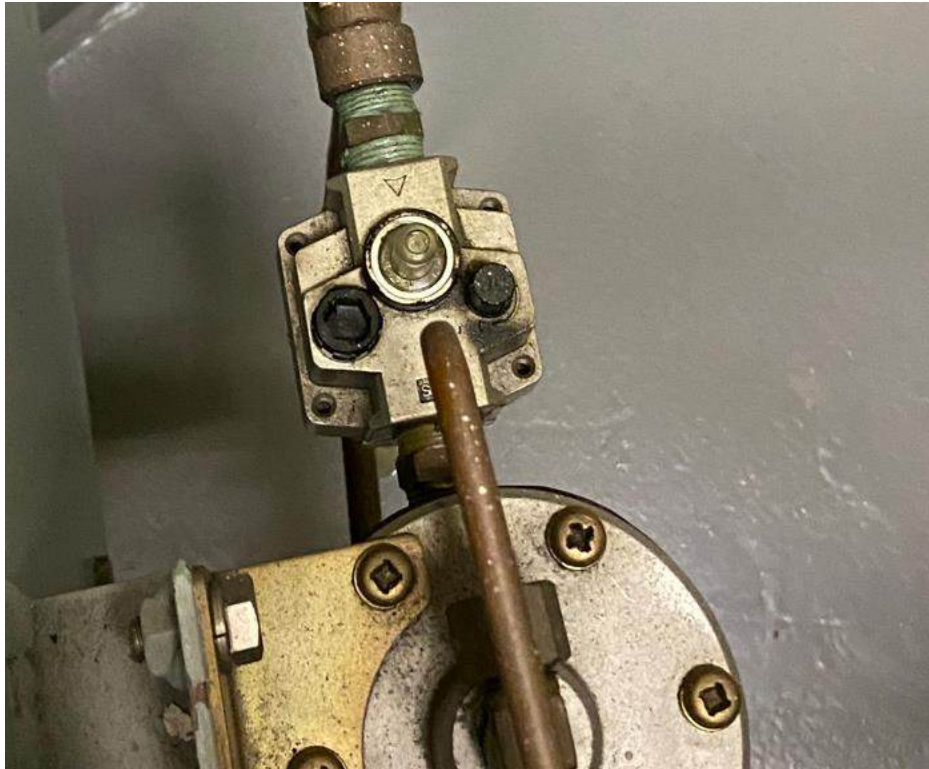
Photo 52 - Missing Cap on Air Line Filter

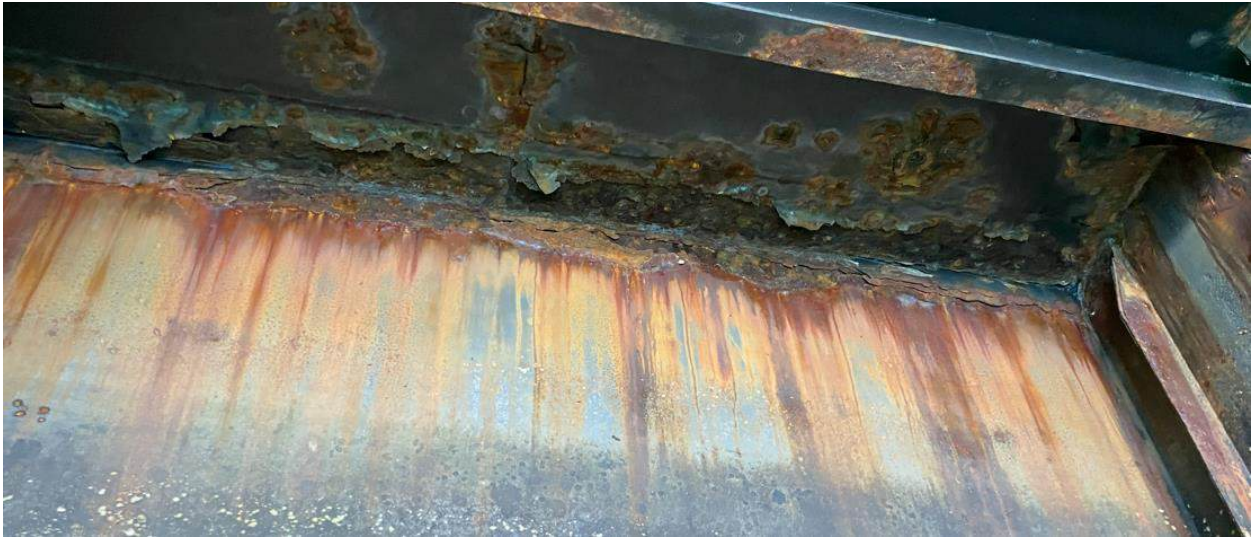
Photo 53 - Apron Deck/PD/End BHD Seam Scale

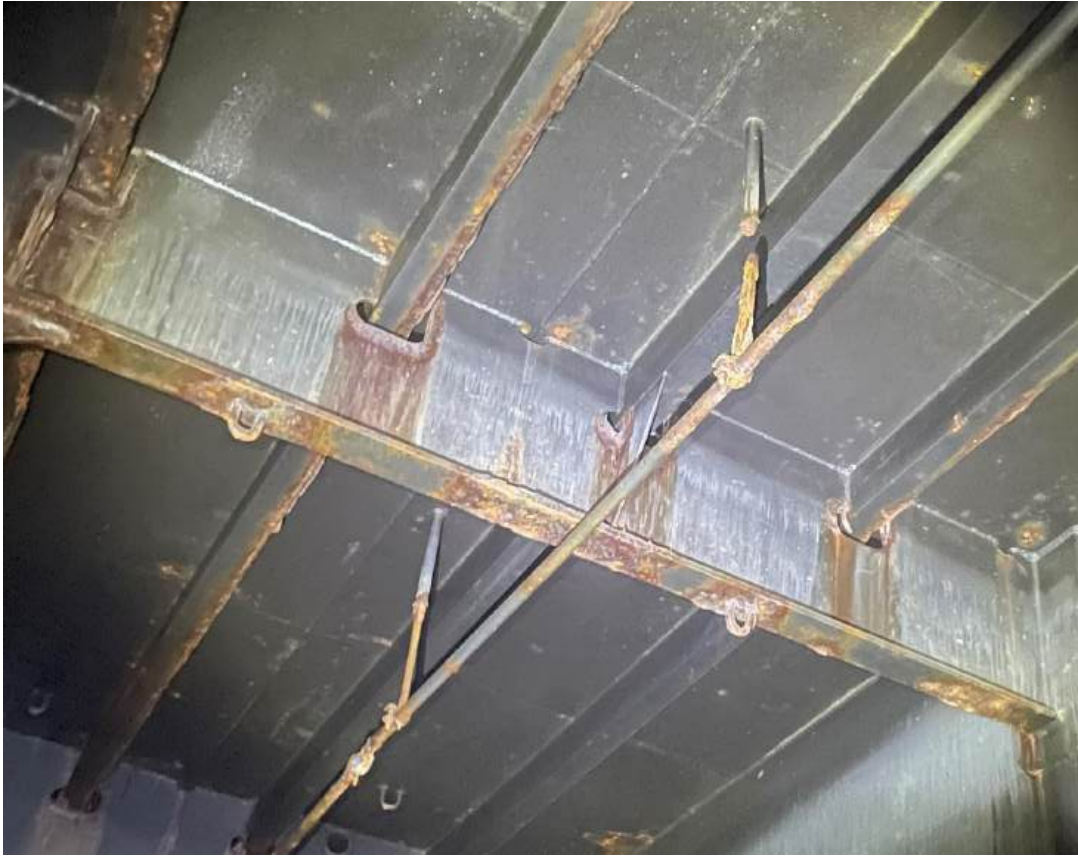
Photo 55 – Typical abandoned overhead piping with wasted hangers

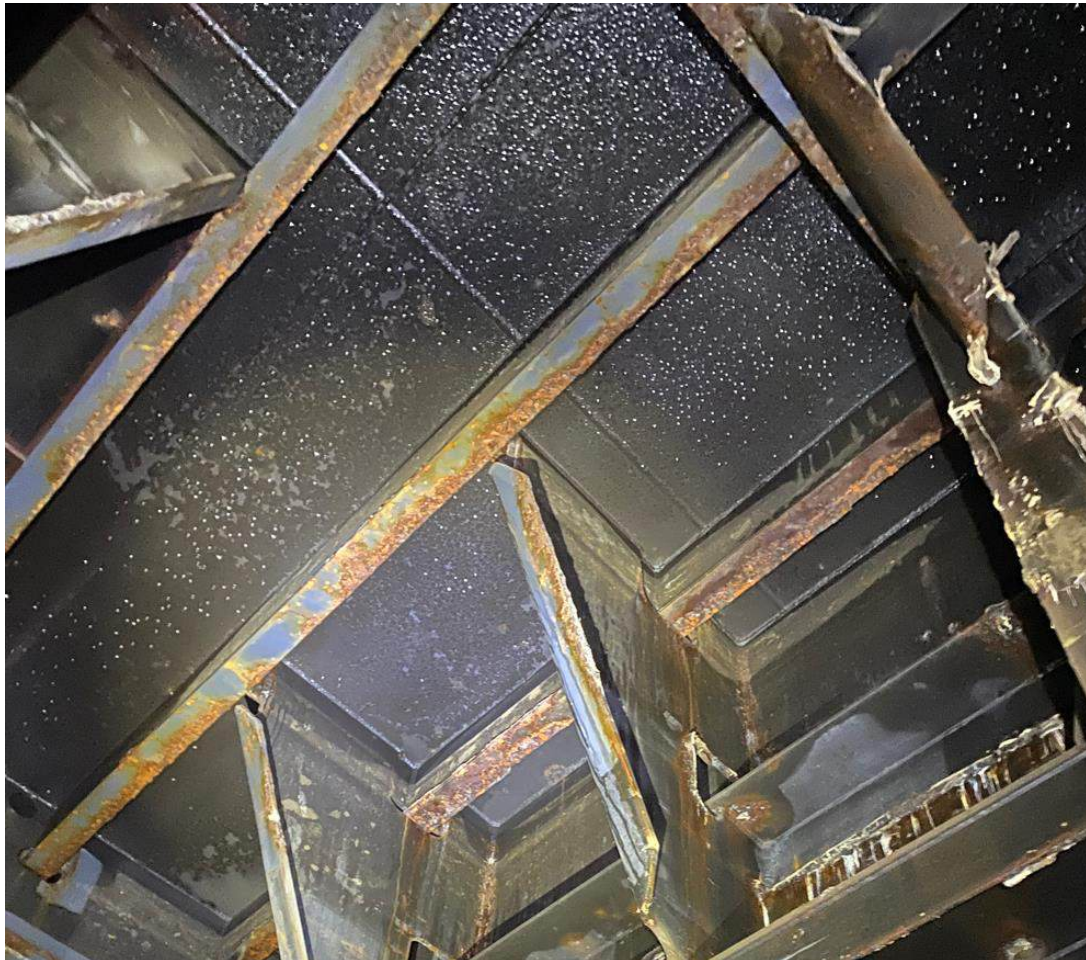
Photo 58 - Tank 1 FWD – SC: PD Stiffeners Iso KE of FLG

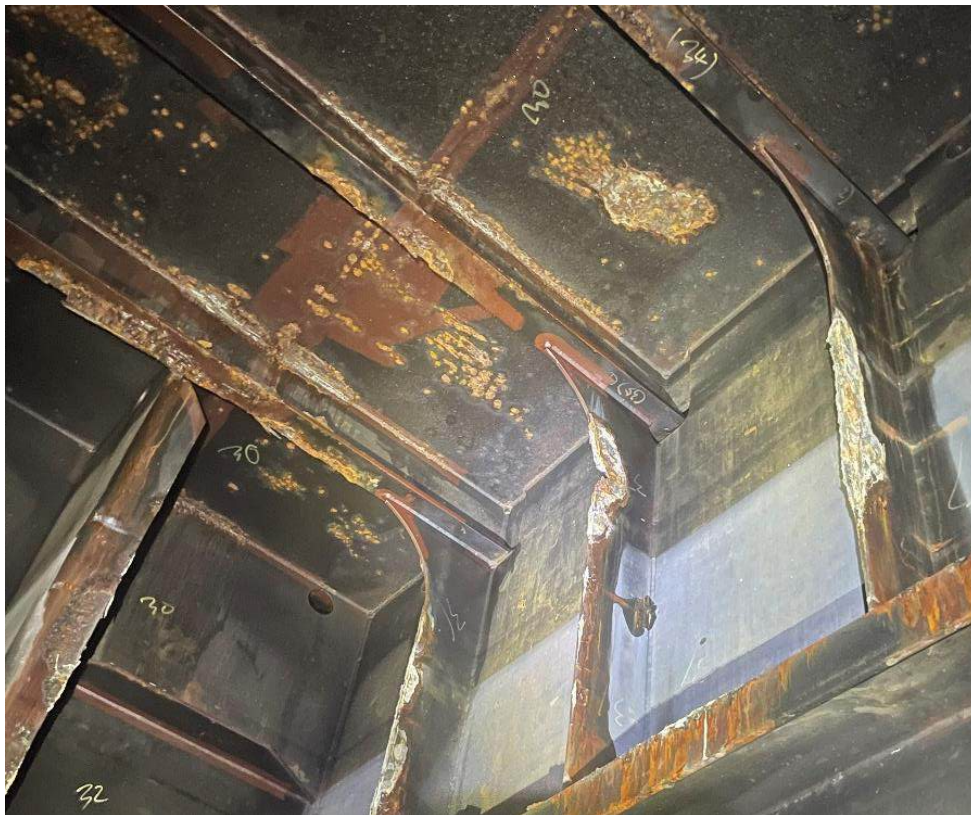
Photo 60 – Tank 1 AFT-P (FR 204): Vertical flat bar at the top of the off-CL longitudinal WT BHD is notched. Adjacent pontoon deck stiffeners in this area have rust scale

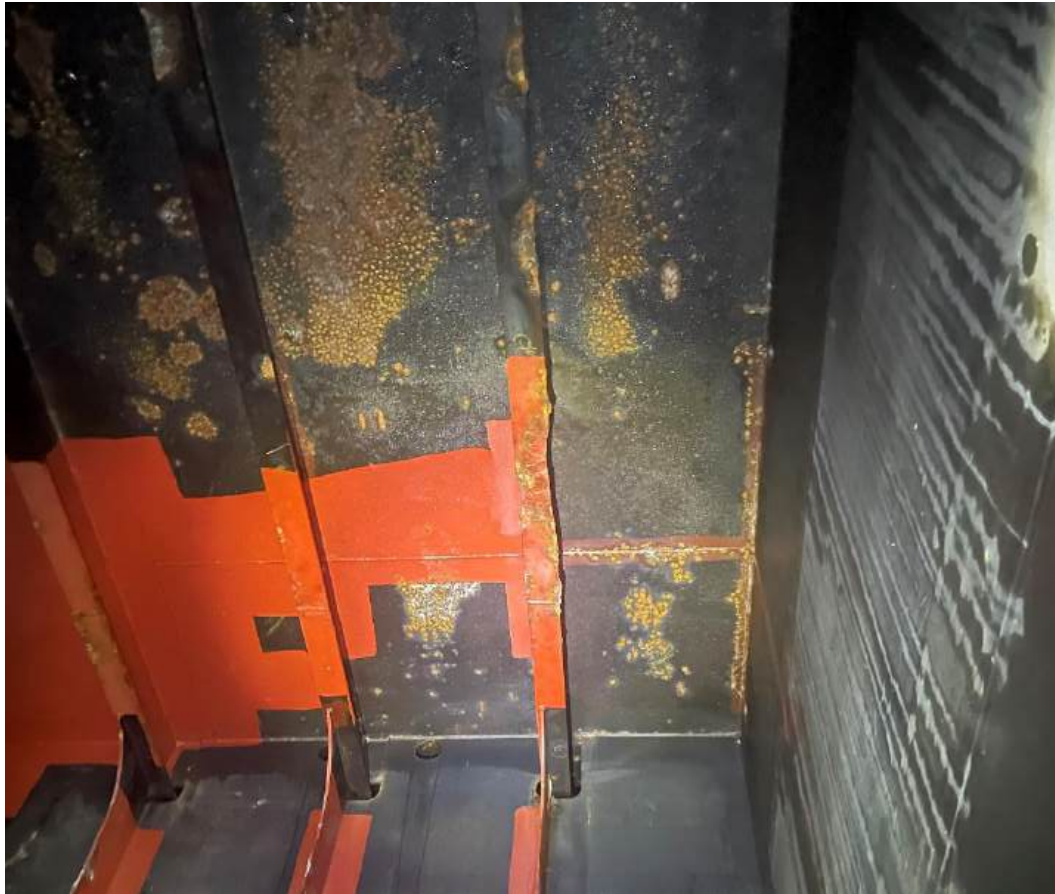
Photo 61 – Tank 1 AFT-P (FR 207): Pontoon deck stiffener notched midspan between off-CL BHD and 1st longitudinal OTBD

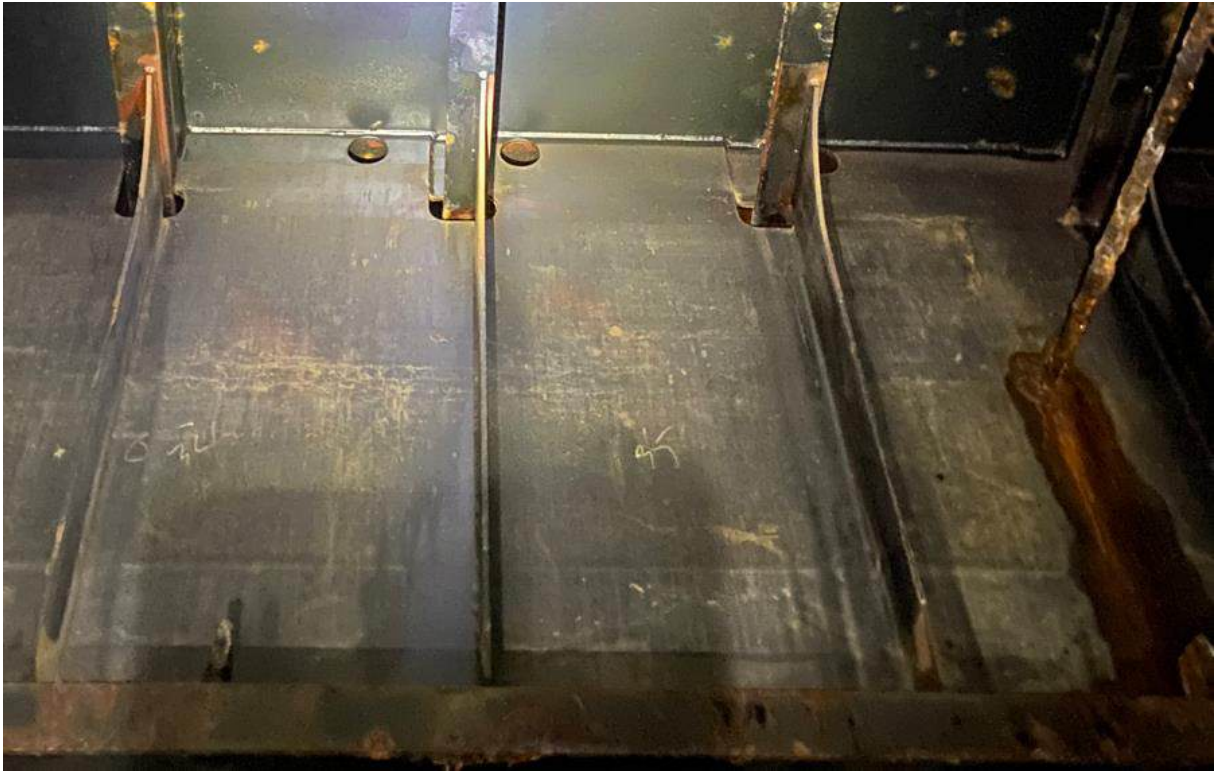
Photo 67 - Tank 1 AFT – S: OVHD FBs on OCL WT BHD Thinning

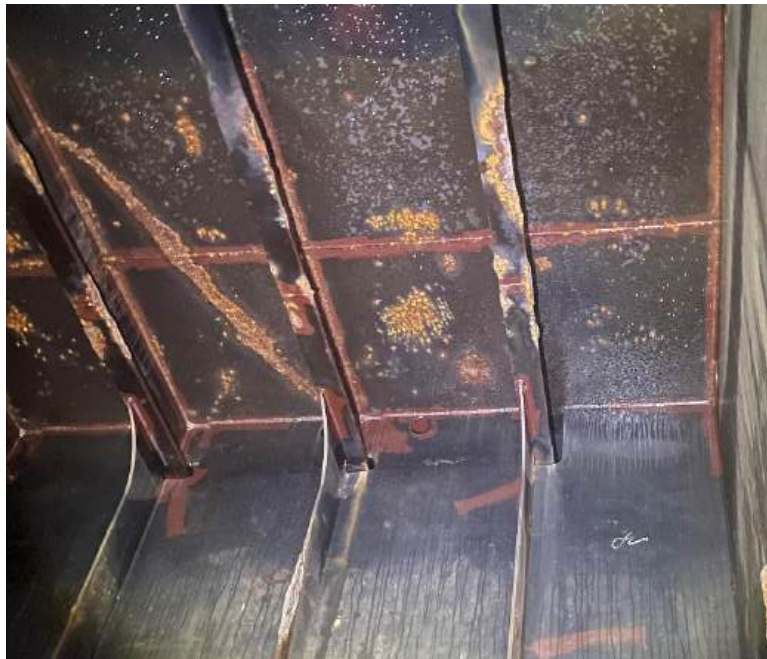
Photo 82 – Tank 4-P (FR 92): Pontoon deck stiffener notching 4-ft form off-CL longitudinal WT BHD. Others have rust scale in this bay.

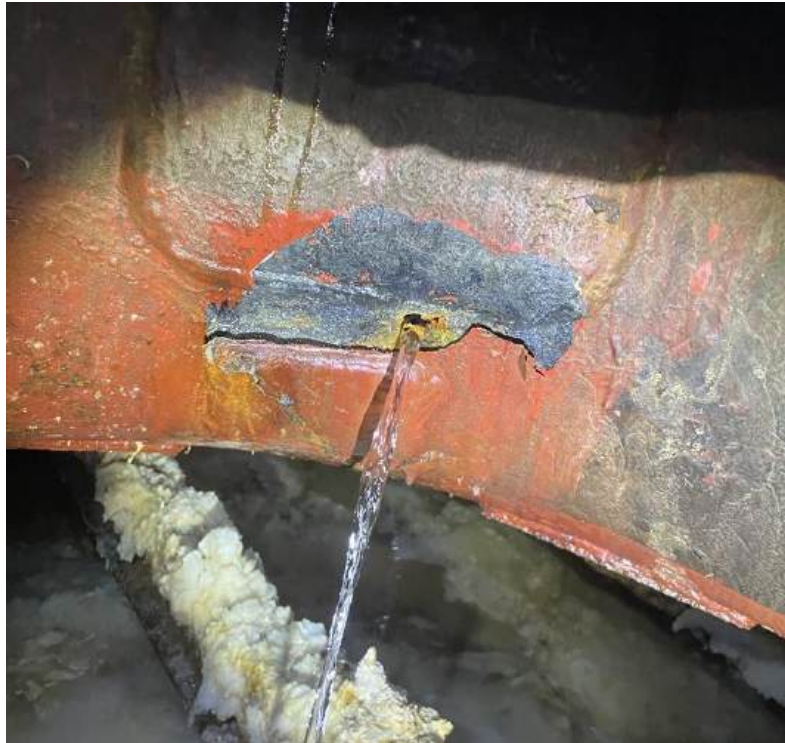
Photo 83 – Tank 4-S (FR 81): Discharge pipe has 1/2" diameter hole in doubler plate.

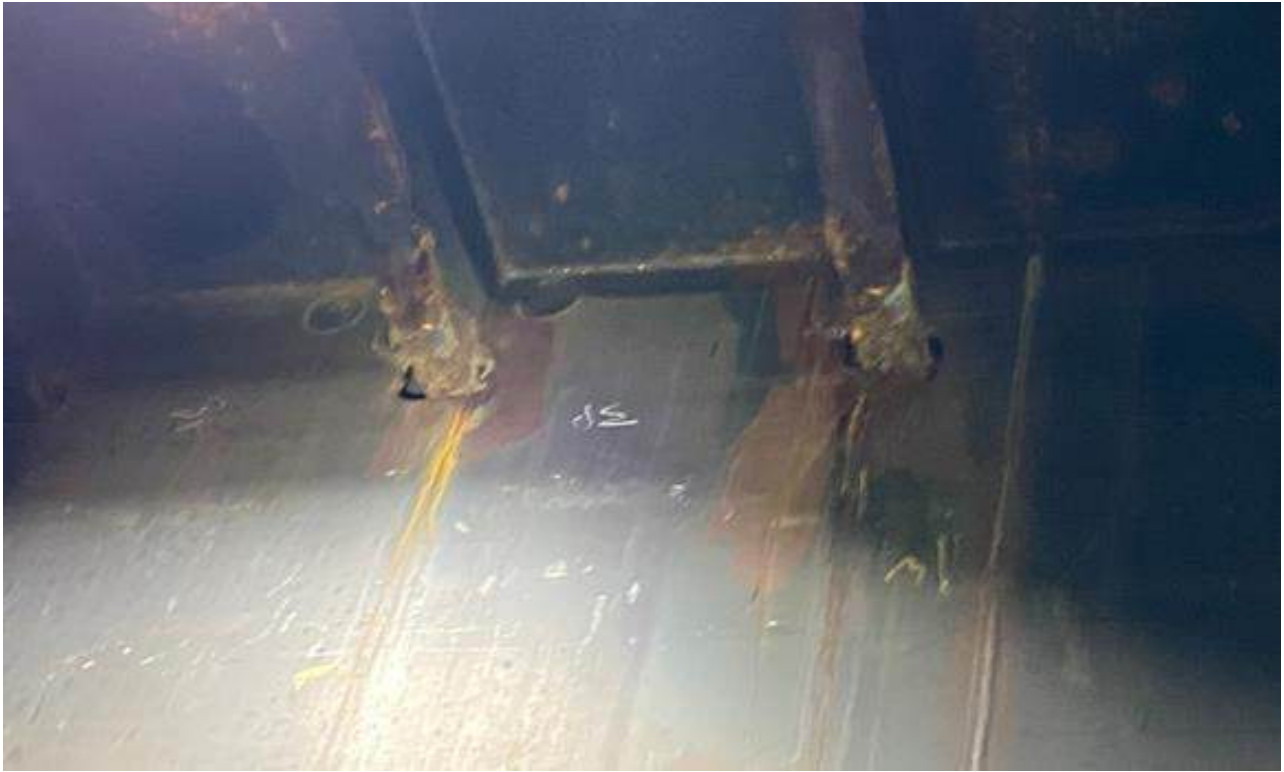
Photo 96 - Tank 6 FWD – PC (Fr 38 & 39): PD Stiffeners Necking IWO OCL WT BHD Pass-thru
