Table of Photos

Photo 1 – NASSCO “BUILDER”

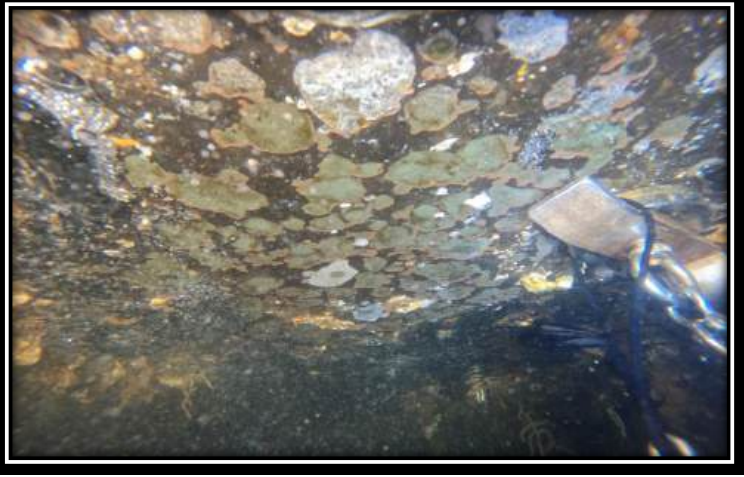
<p>PHOTO 2:</p> <p>TYPICAL TRANSECT WELD CONDITION WHERE BARE METAL IS EXPOSED</p>

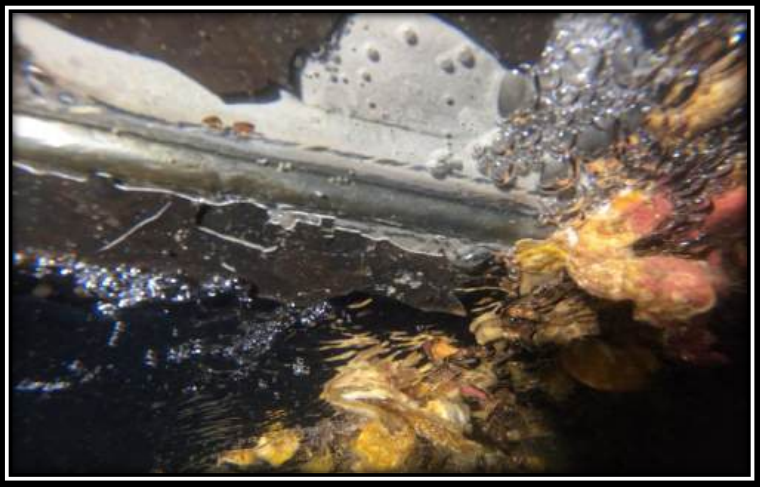
<p>PHOTO 3:</p> <p>TYPICAL MARINE GROWTH ON TRANSECTS</p>

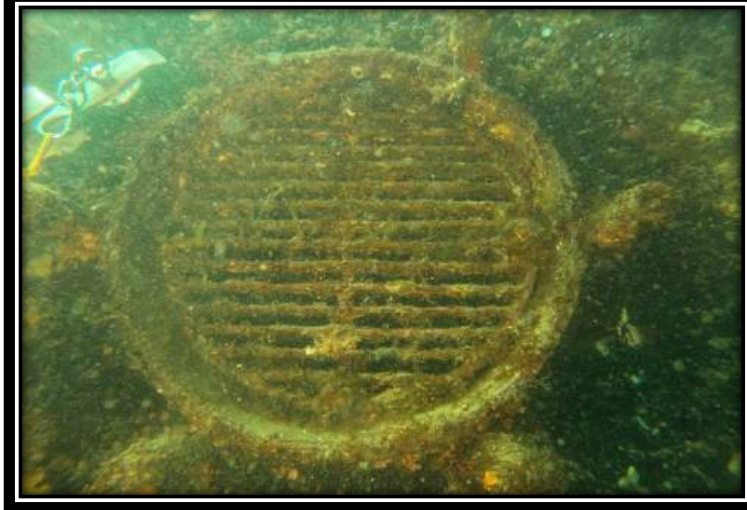
PHOTO 8:

TYPICAL PRIME PUMP
CONDITION

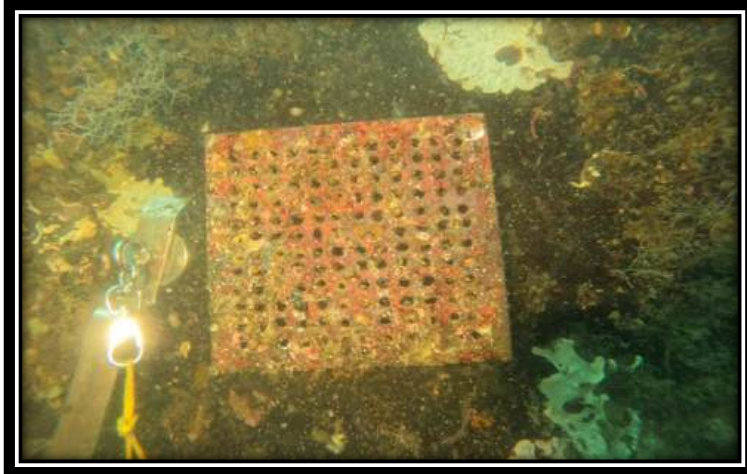
PHOTO 9:

TYPICAL REFERENCE
CELL CONDITION
