Table of Photos

Photo 1 – NASSCO “BUILDER”

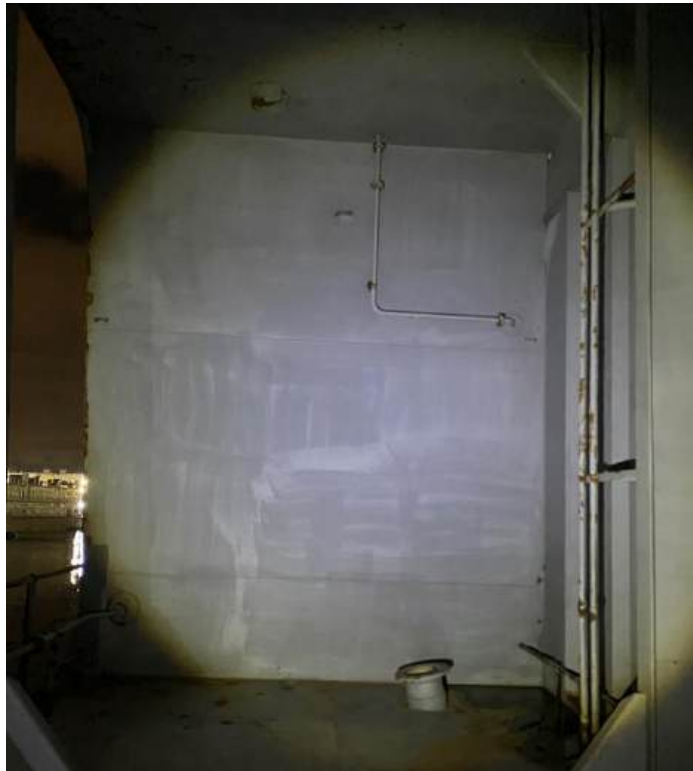
Photo 53 - Apron Deck/PD/End BHD Seam Scale

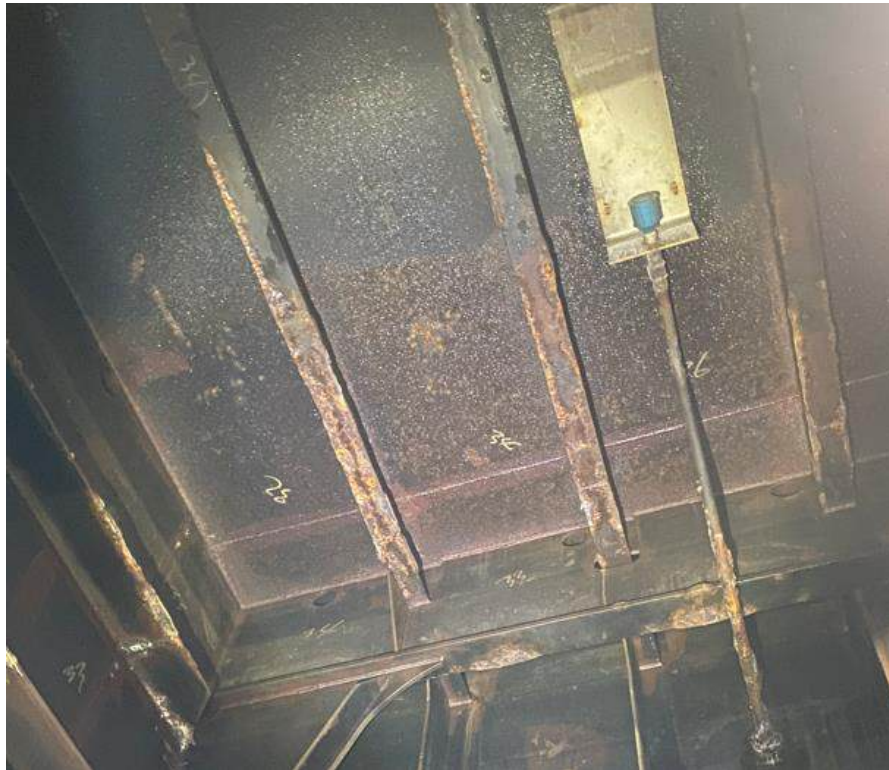
Photo 55 – Typical abandoned overhead piping with wasted hangers

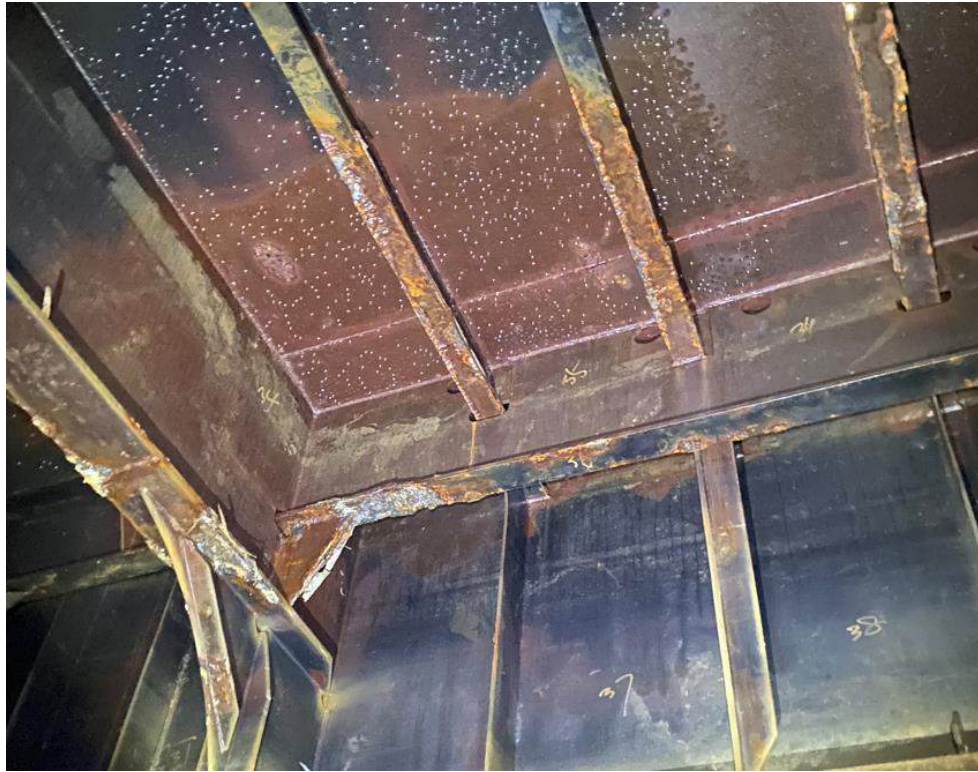
Photo 56 - Tank 1 FWD – PC: PD Stiffeners KE & Neck

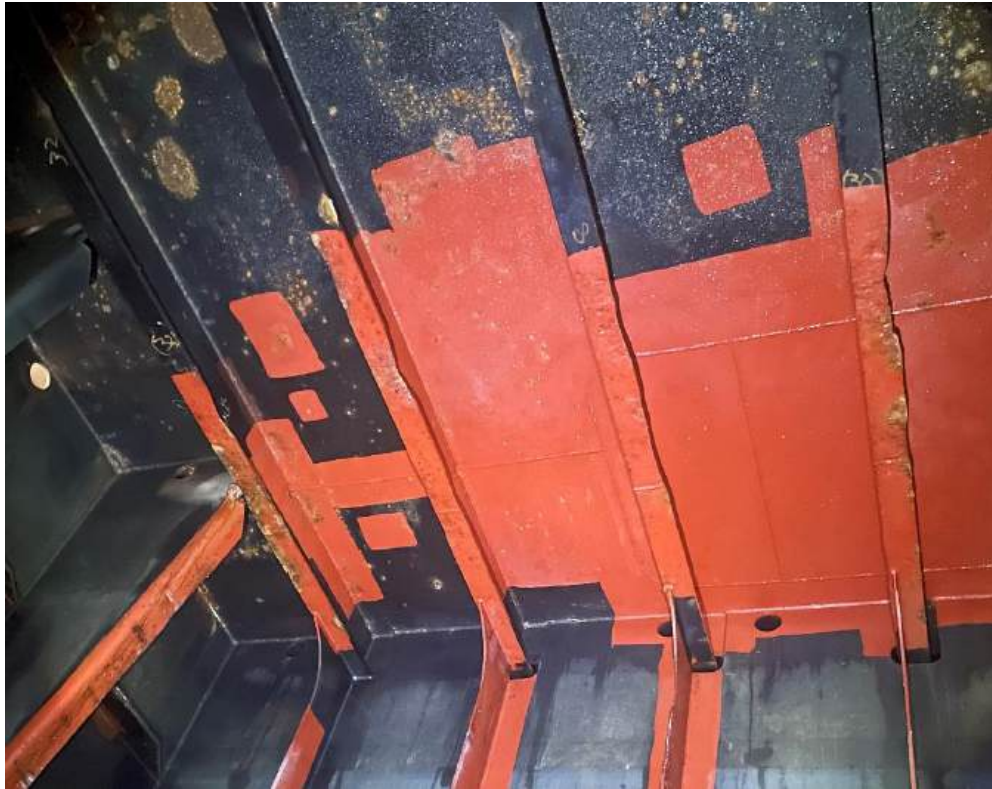
Photo 62 – Tank 1 AFT-P (FR 212-215): These pontoon deck stiffeners are notching from the off-CL longitudinal WT BHD to the 1st longitudinal OTBD.

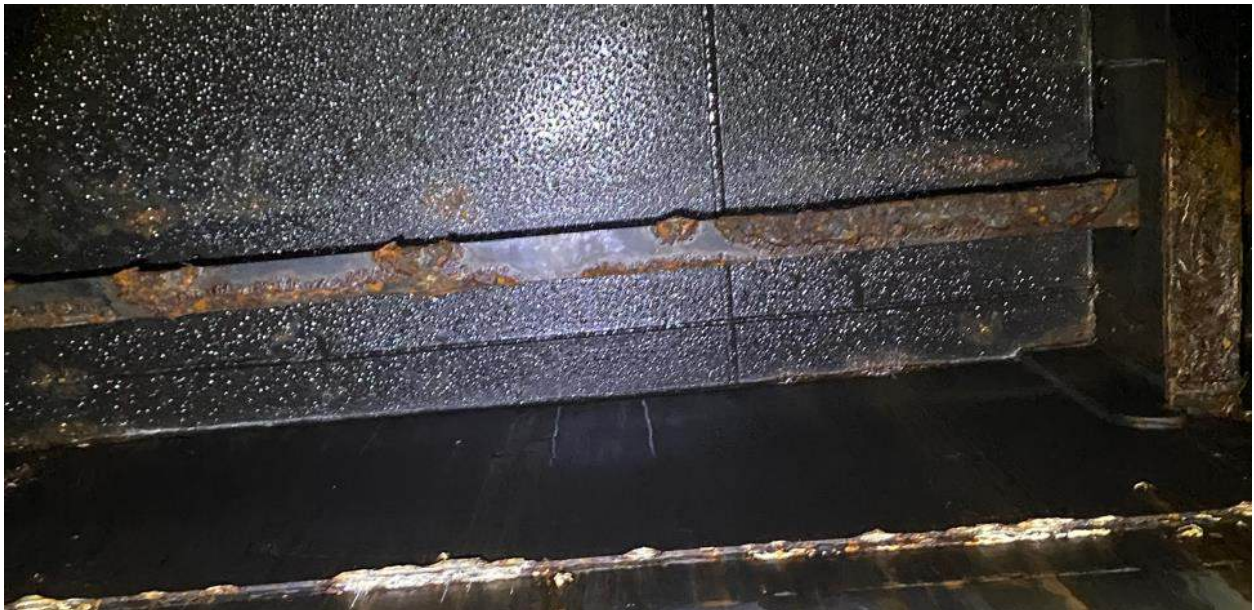
Photo 63 – Tank 1 AFT-P (FR 219-220): These pontoon deck stiffeners are notching from the off-CL longitudinal WT BHD to the 1st longitudinal OTBD.

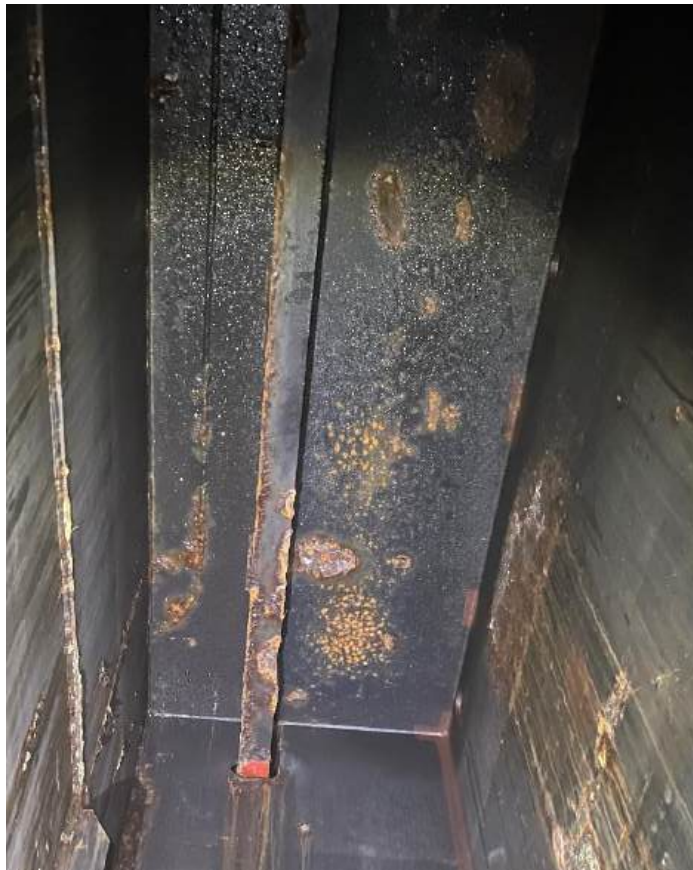
Photo 65 - Tank 1 AFT - PC: PD Stiffeners in Bay 4 Iso Flange Notching (x13)

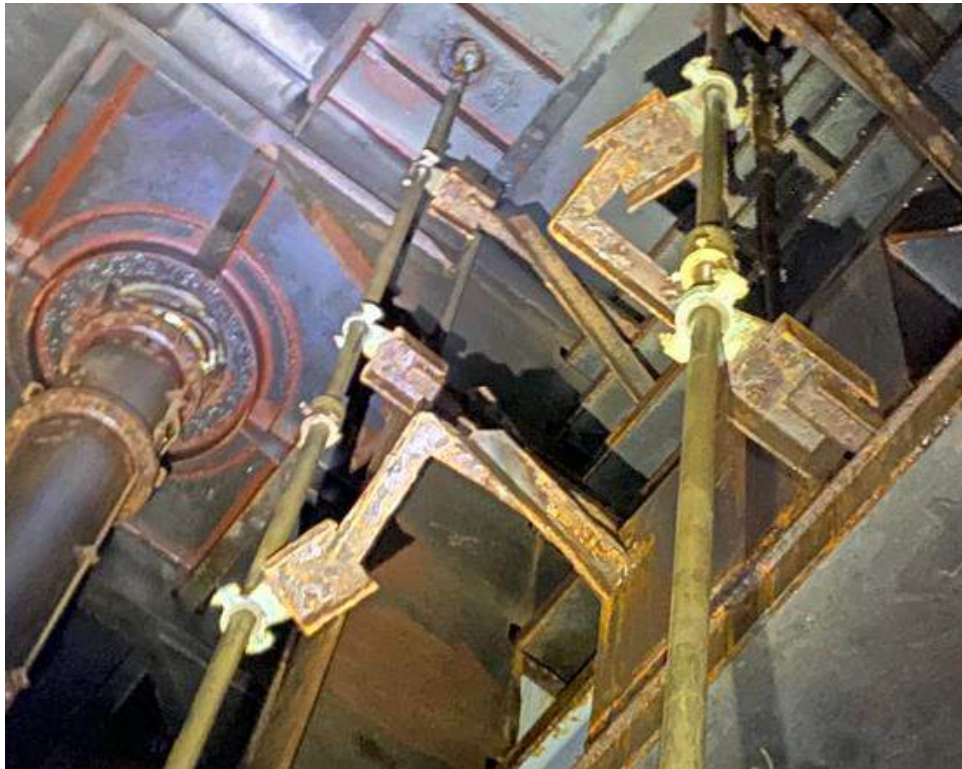
Photo 67 - Tank 1 AFT – S: OVHD FBs on OCL WT BHD Thinning

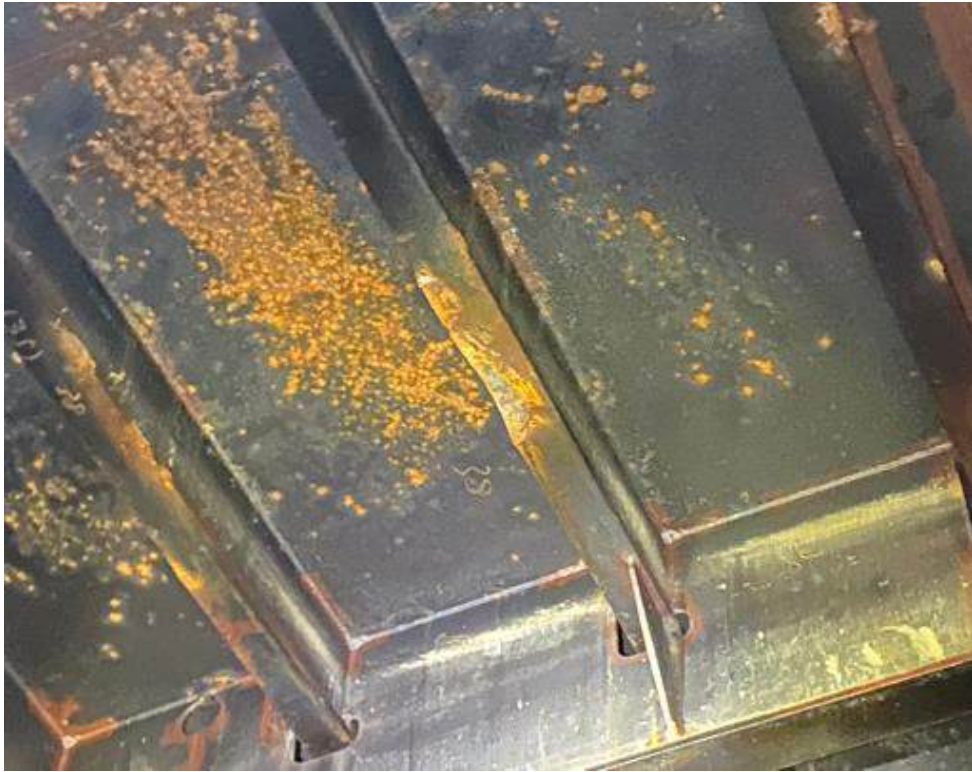
Photo 70 - Tank 1 AFT - S: PD Stiffeners in Bay 1 Iso Flange Thinning/Notching

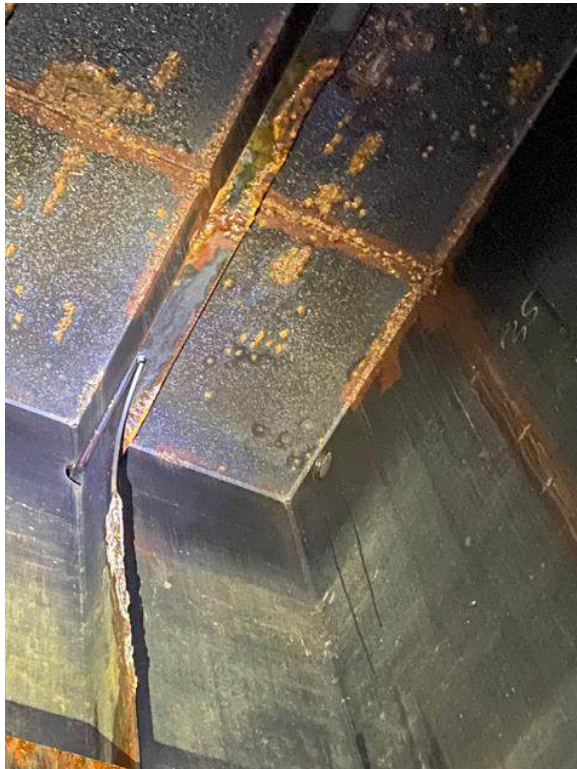
Photo 71 - Tank 2 FWD – P (Fr 204): PD Stiffener in Bay 2 Iso Flg Notch

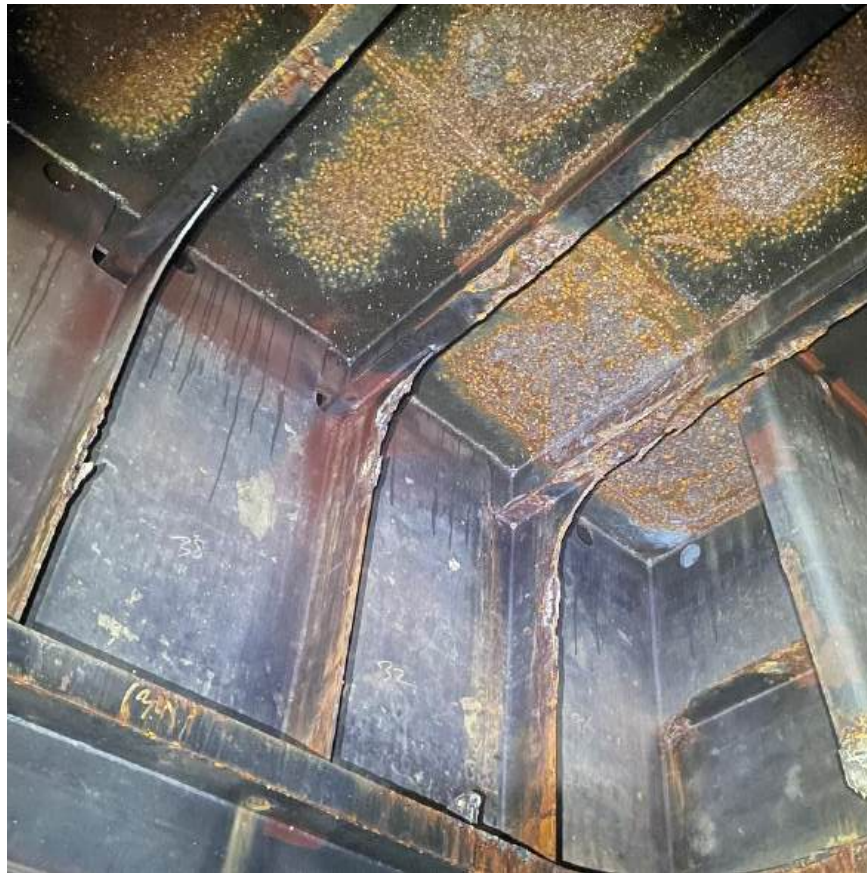
Photo 78 - Tank 2 AFT - P (Fr 173-175): PD Stiffeners Iso Flange Notching

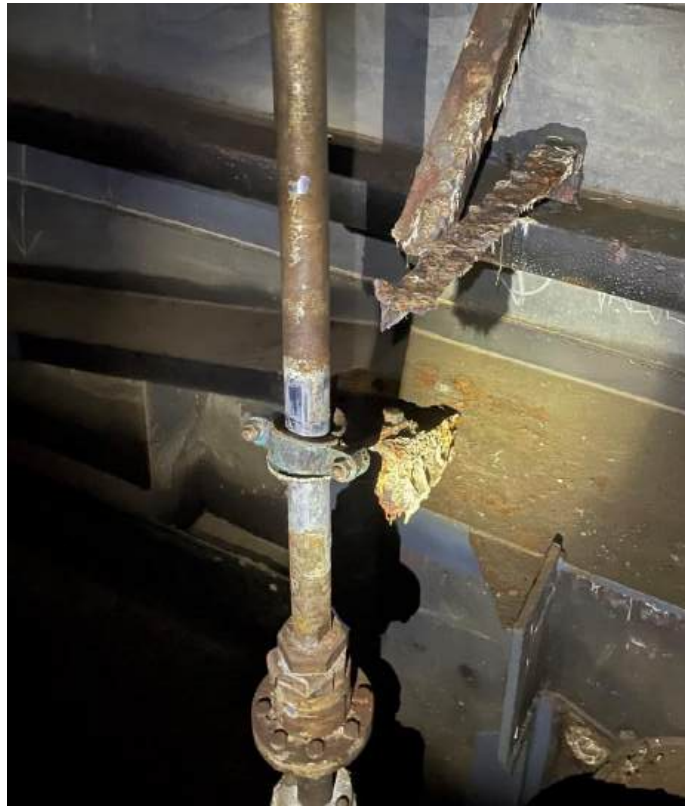
Photo 80 - Tank 3-P: U-Joint Taped and Scaling Wasting RR Connection

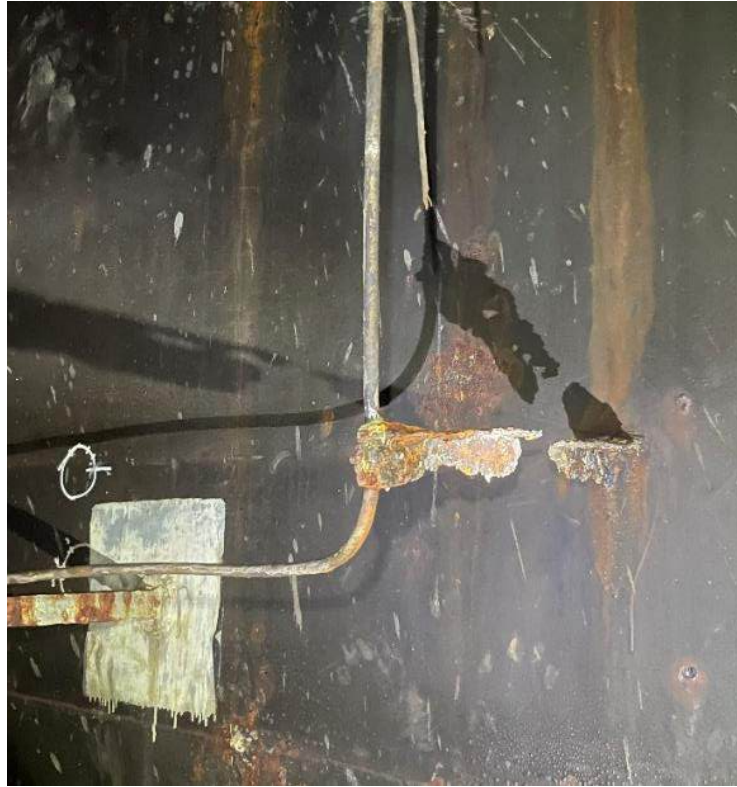
Photo 84 – Tank 5S (FR 45): Piping Sensor has wasted support bracket

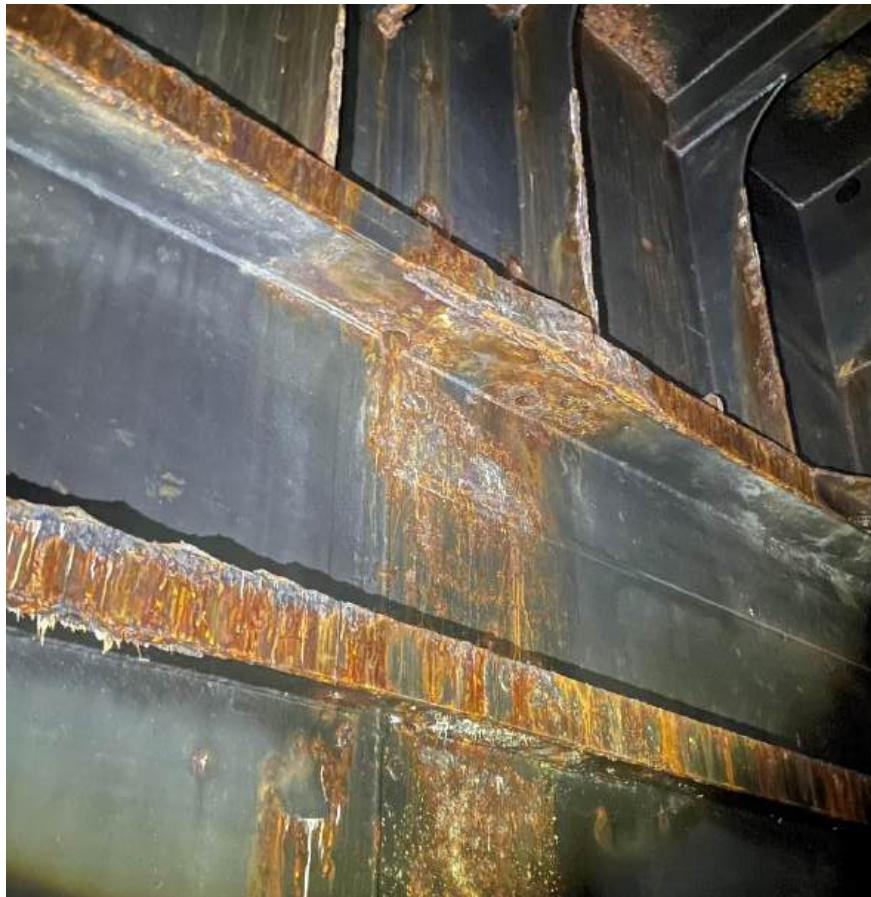
Photo 85 – Tank 5S (FR 41): On the off-CL longitudinal WT BHD, stiffeners 4 & 5 are scaling.

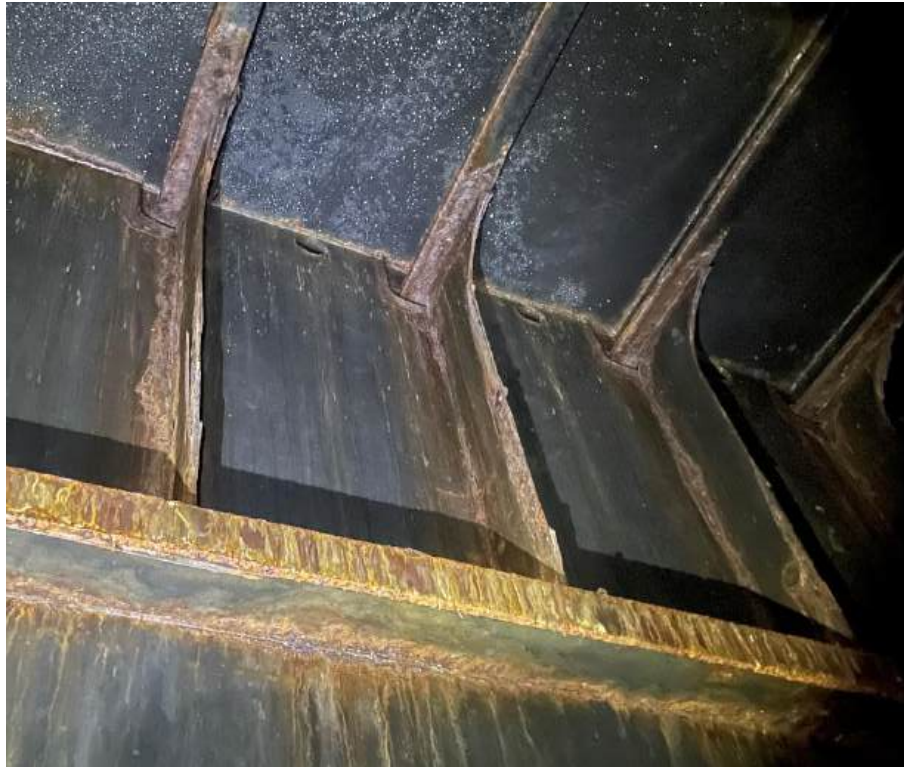
Photo 86 – Tank 5A - S (FR 41 (63, 64)): On the off-CL longitudinal WT BHD, the vertical flat bars have MRS with connection to pontoon deck stiffeners

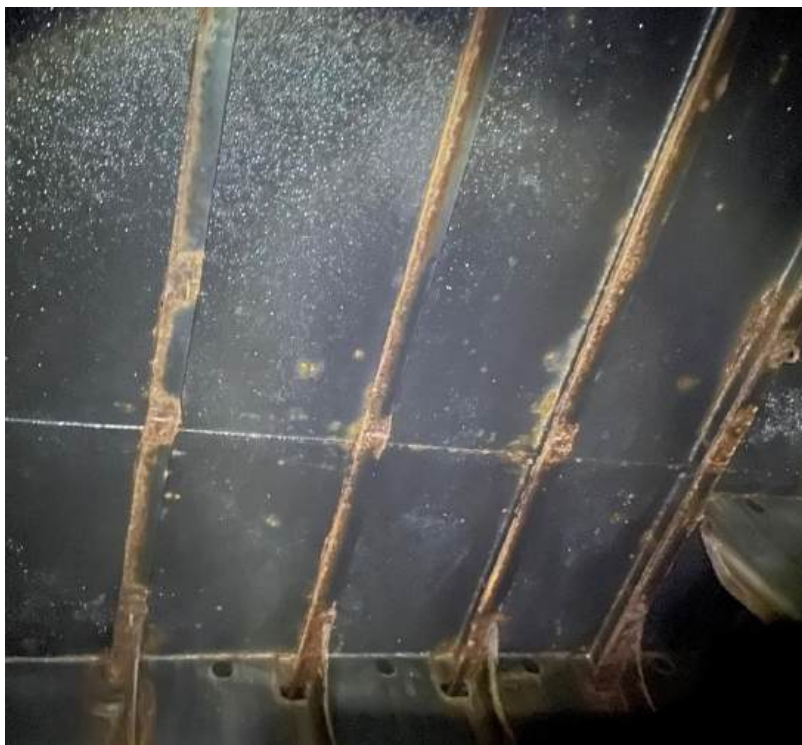
Photo 87 – Tank 5A - S (FR 41 (50-55)): Pontoon deck stiffeners in this bay have MRS on the flanges

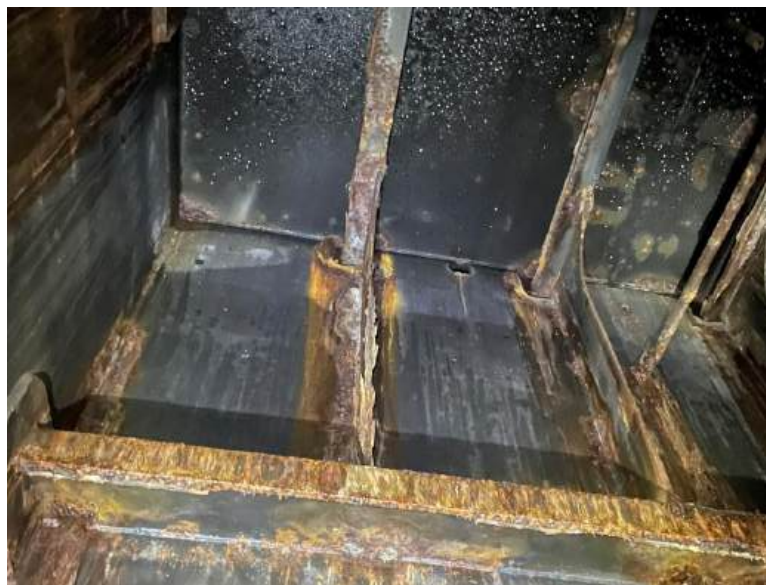
Photo 89 – Tank 5B FWD-S (FR 41(30-35)): On the off-CL longitudinal WT BHD, the upper vertical flat bars have M-HRS along with their adjacent pontoon deck stiffeners

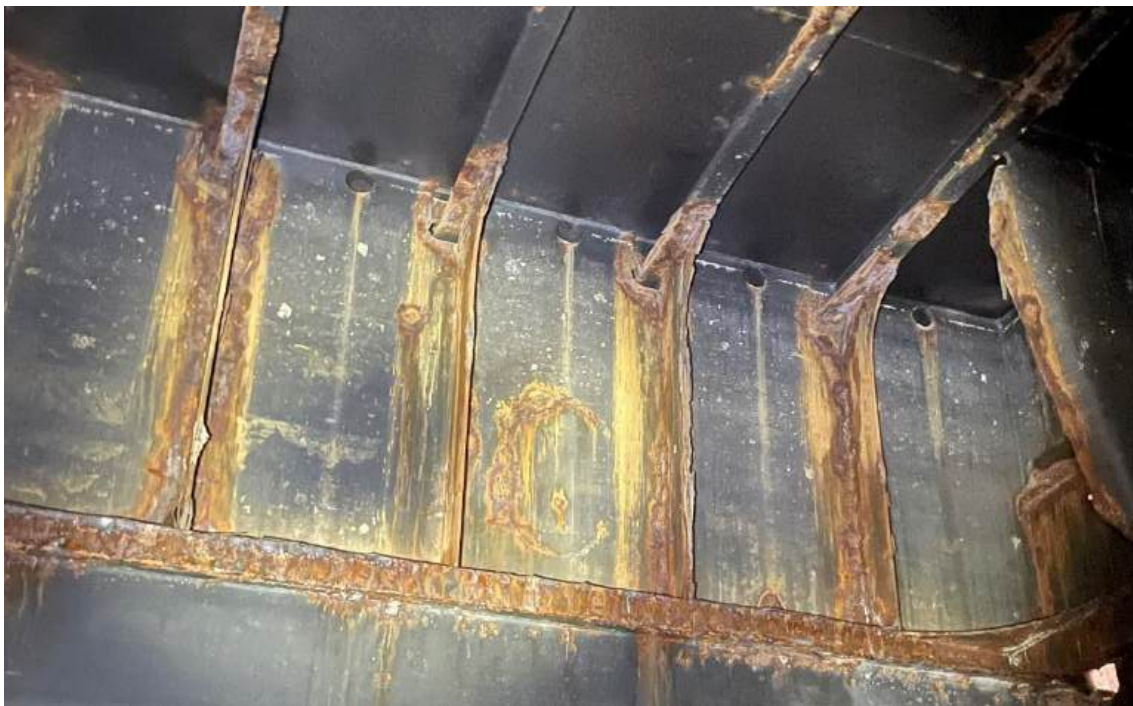
Photo 91 – Tank 5B AFT-S (FR 41(5-10)): On the off-CL longitudinal WT BHD, the upper vertical flat bars have M-HRS along with their adjacent pontoon deck stiffeners

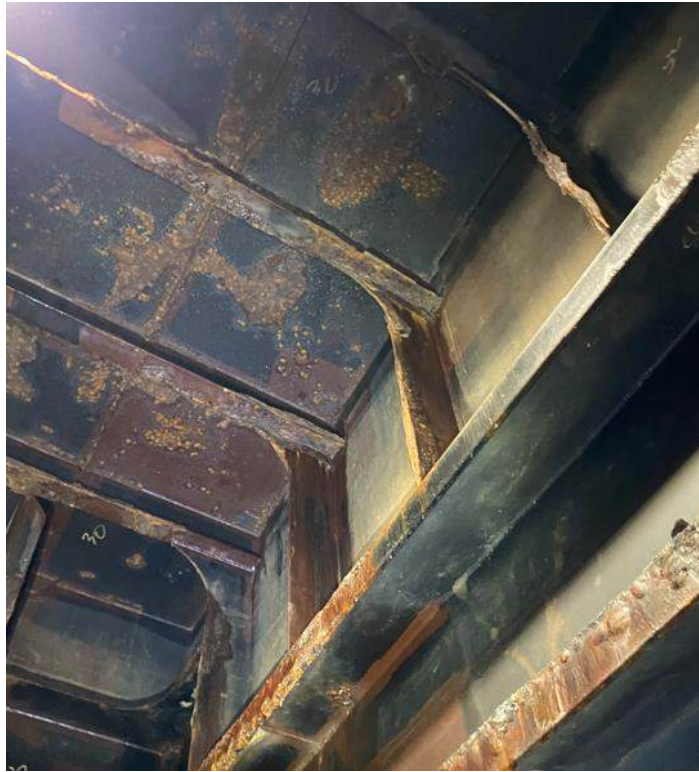
Photo 92 - Tank 6 FWD - P (Frs 37, 38, 40): OVHD FB on OCL WT BHD and PD Stiffenes Scaling/Thinning x33

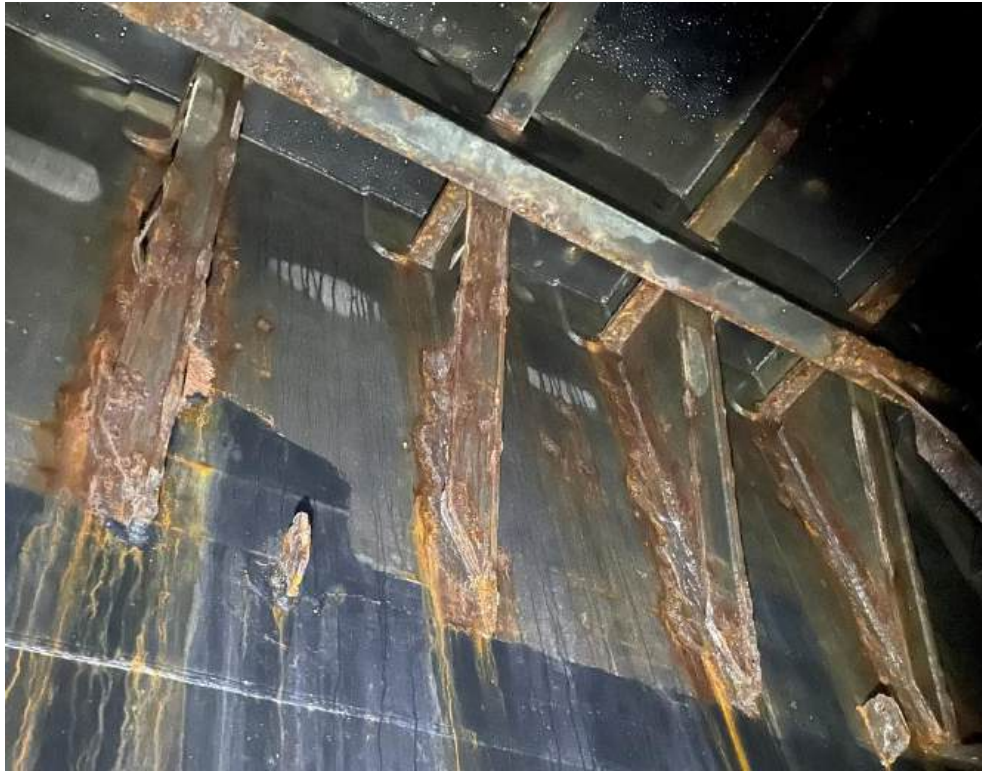
Photo 98 – Tank 6 FWD-SC (FR 36-41): Scaling of CL BHD and connection to transverse PD stiffener brackets

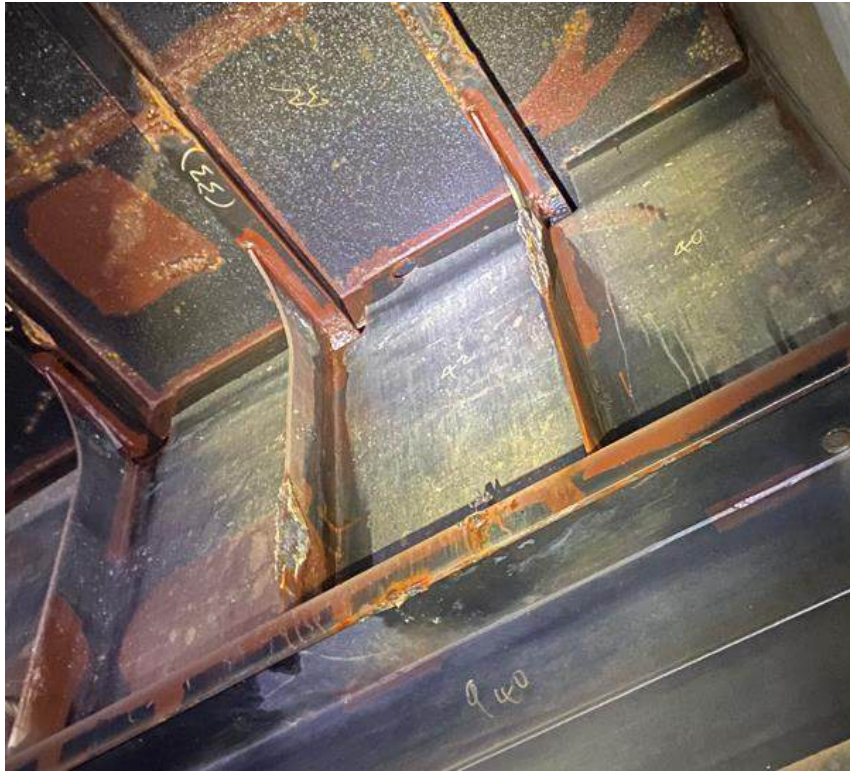
Photo 100 - Tank 6 AFT- P (Fr 10, 12, 13): OVHD FBs on OCL WT BHD Notching/Scaling
