Table of Photos

Photo 1 – NASSCO “BUILDER”

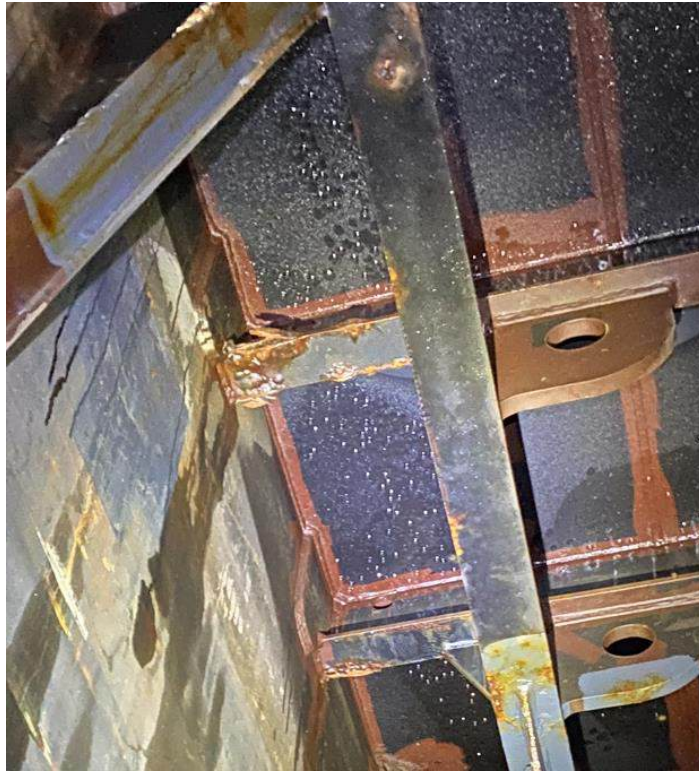
Photo 58 - Tank 1 FWD – SC: PD Stiffeners Iso KE of FLG

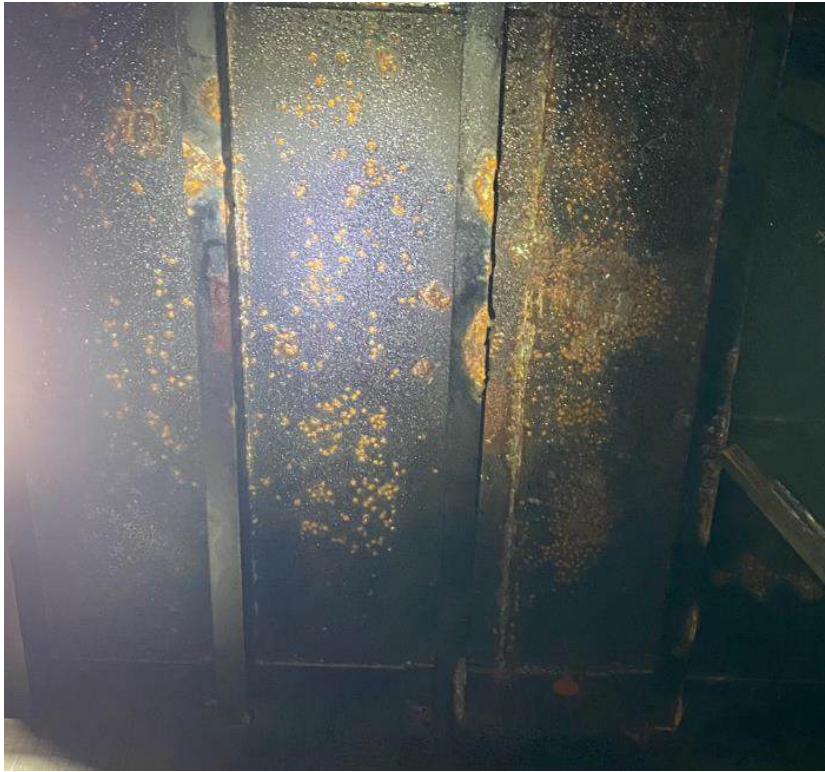
Photo 64 - Tank 1 AFT - PC (Fr 222): PD Stiffener KE and Notch Iso Areas (x12)

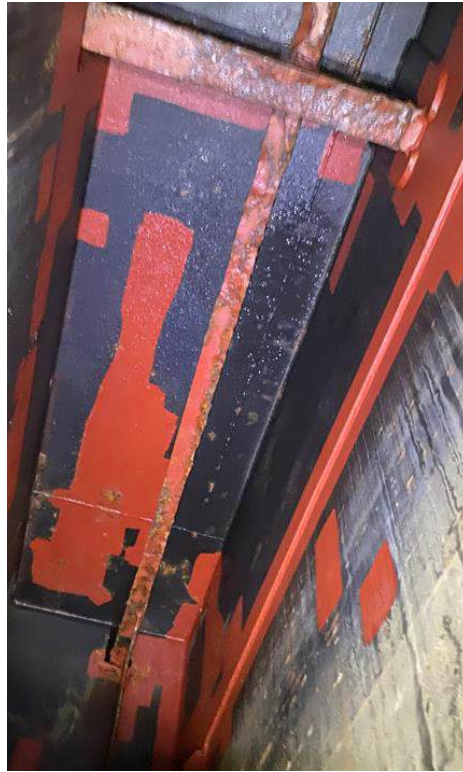
Photo 68 - Tank 1 AFT - S: Angled Reach Rod Guides

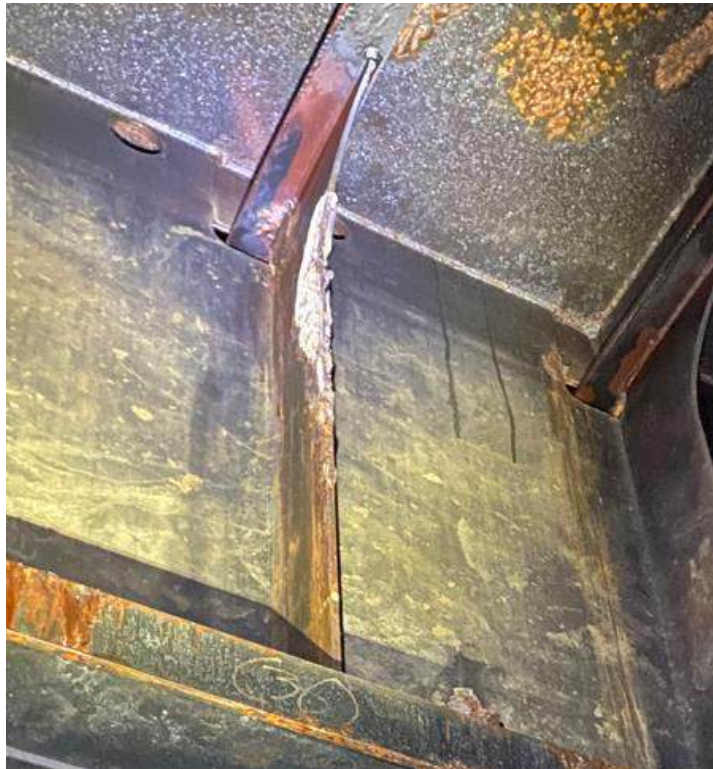
Photo 73 - Tank 2 FWD - P (Fr 182): OVHD FB on OCL WT BHD Scale/Notch

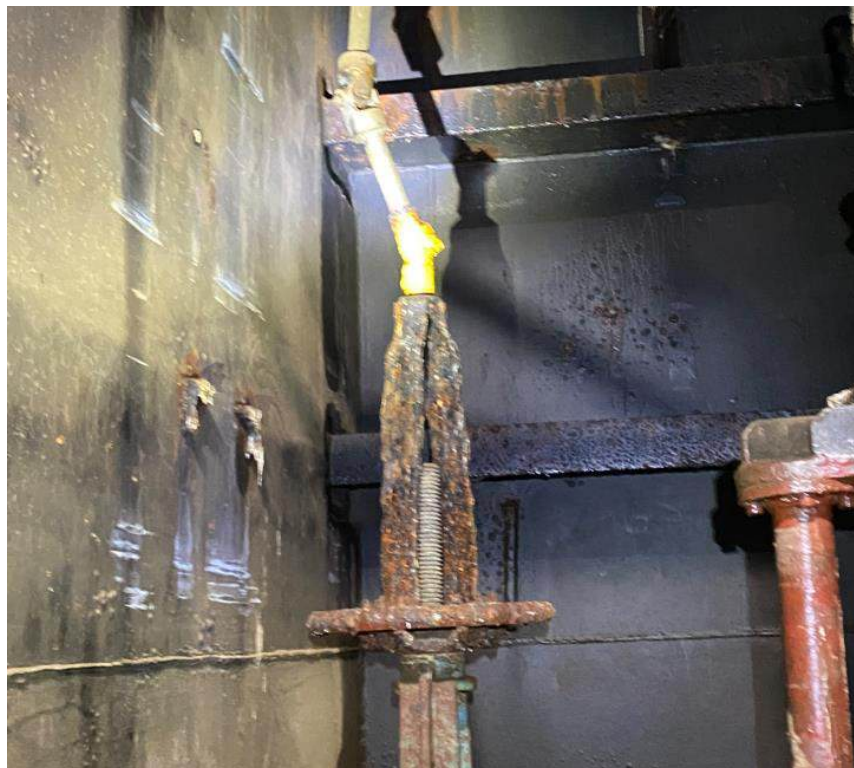
Photo 79 – Tank 2 AFT-S (FR 173-174): Pontoon deck stiffeners and flat bars have HRS/moderate notching at the off-CL longitudinal WT BHD

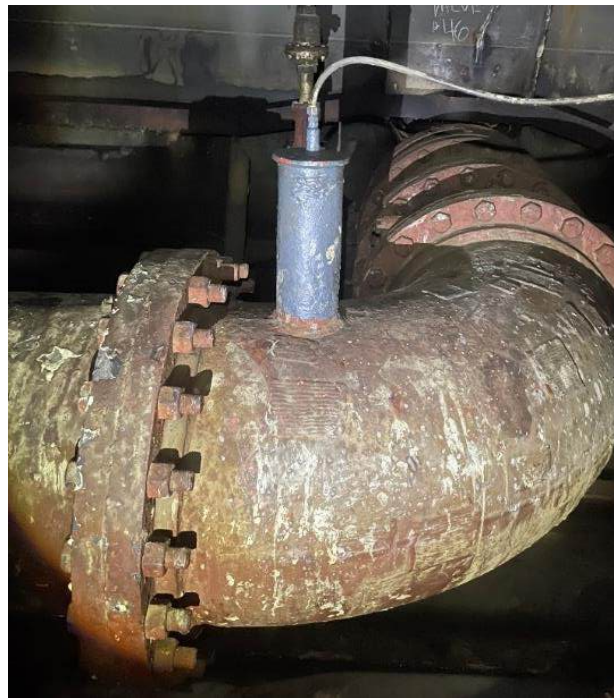
Photo 83 – Tank 4-S (FR 81): Discharge pipe has 1/2" diameter hole in doubler plate.

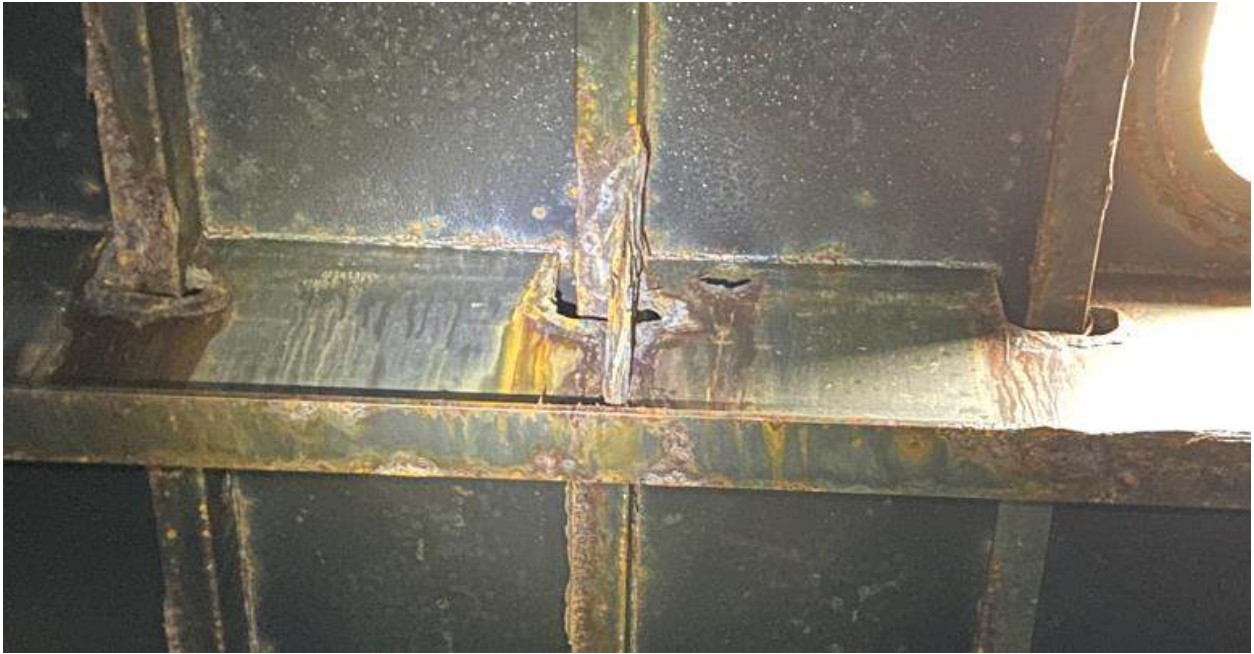
Photo 90 - Tank 5B AFT - P (Fr 41(12)): Brkt and Stiffener Wastage at 1 Long.

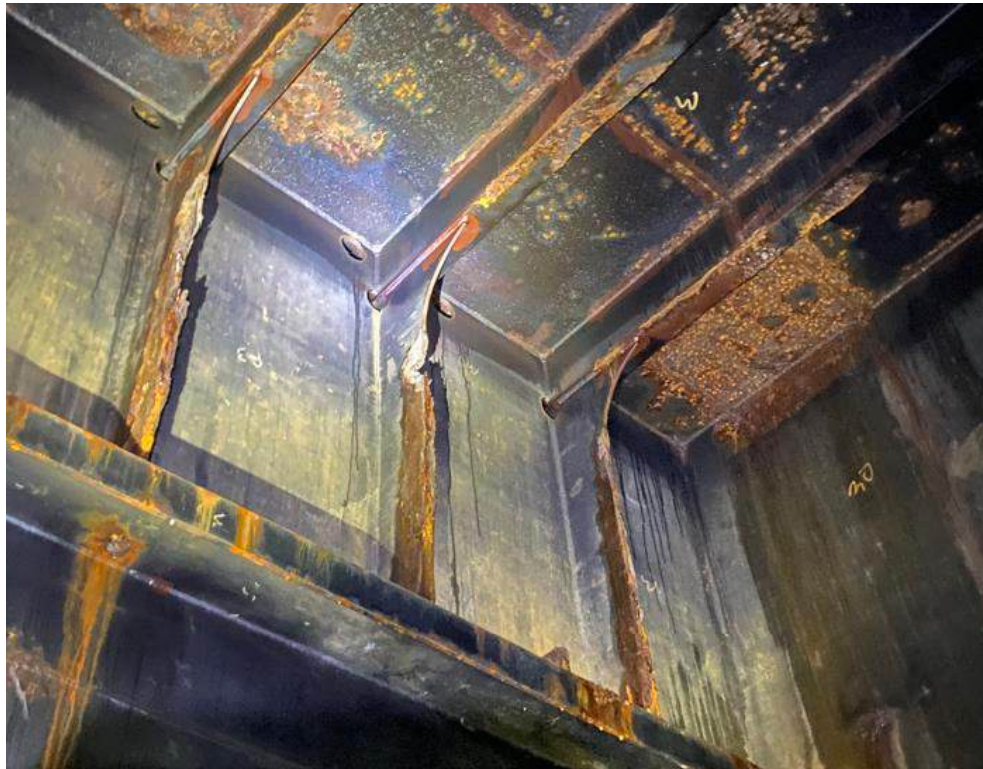
Photo 93 - Tank 6 FWD - P (Fr 31-36): OVHD FBs on OCL WT BHD Sever Notching and Scaling x34

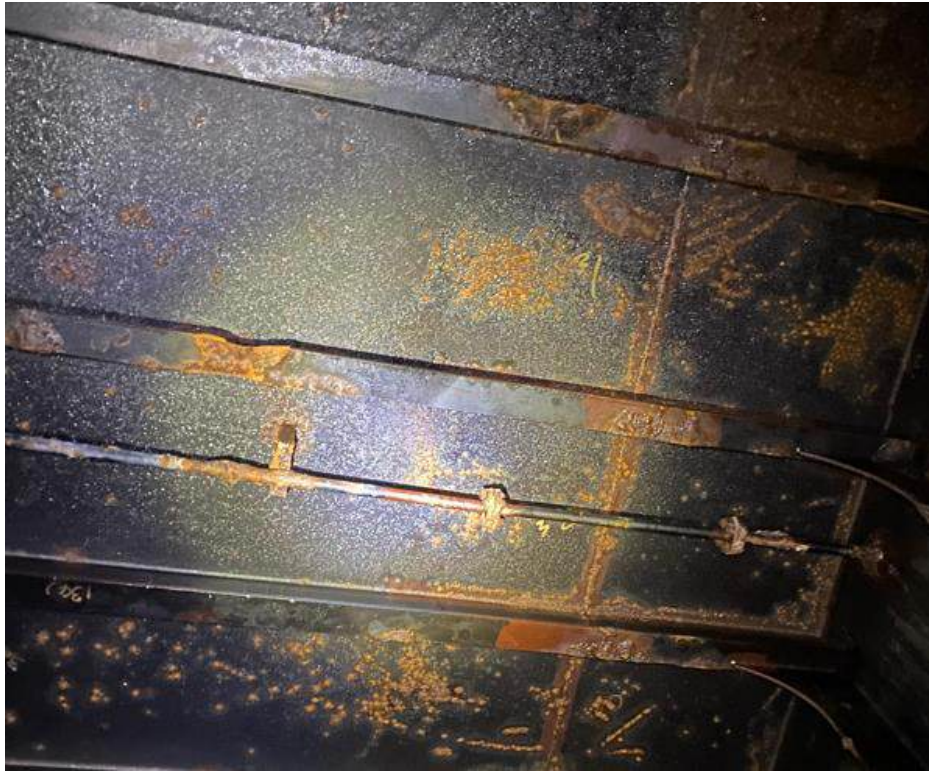
Photo 94 - Tank 6 FWD - P (Fr 29): PD Stiff Flange Notch at Midspan x36

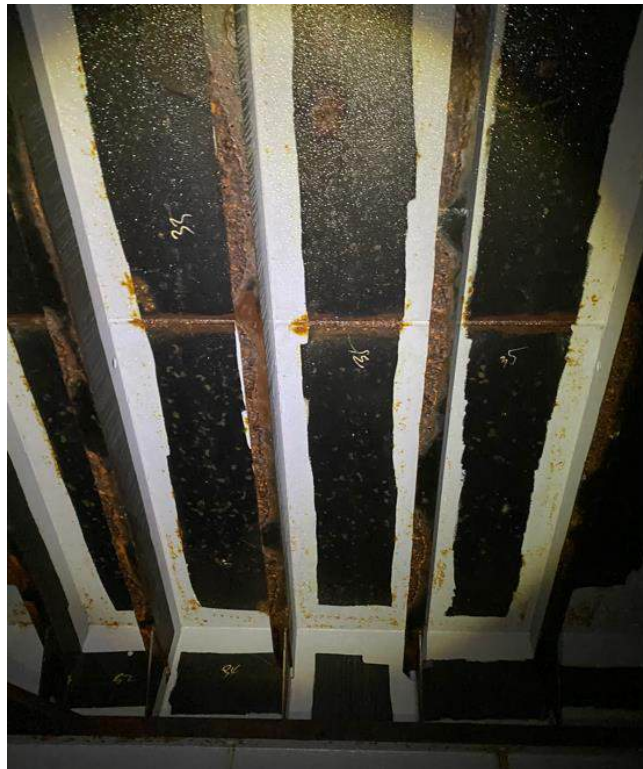
Photo 99 - Tank 6 AFT - P (Fr 6-11): PD Stiffeners in Bay 1 Flanges Notched x40

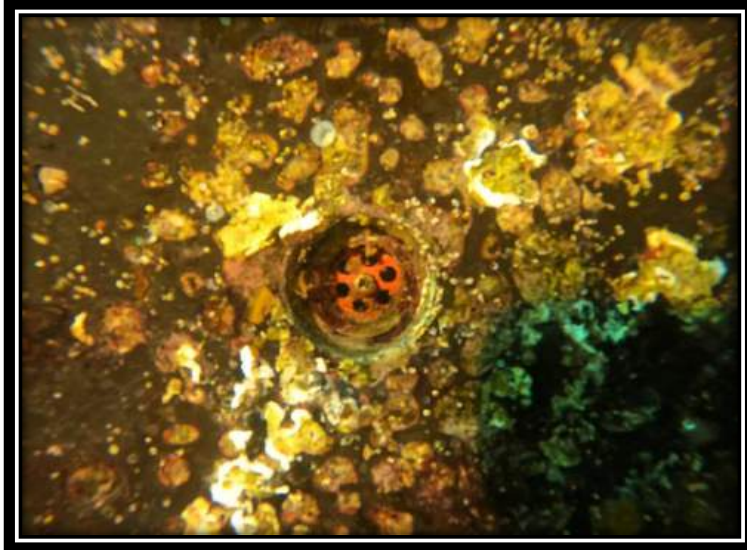
PHOTO 9:

TYPICAL REFERENCE
CELL CONDITION
